Town of Oxford

# ADA Self-Evaluation and Transition Plan

July 2024

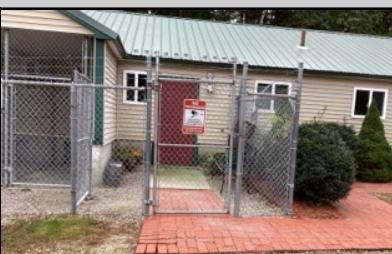
| ID | Location | Floor | Room | Element | Type | Photo | Issues | Current Measure | Recommendations | Quantity | Price | Cost Estimation |
|---|---|---|---|---|---|--|--|---|---|---|---|---|
| 1 | Main Entrance | Ext. | | Exterior Access Route | Walkway | | Level changes > 1/4" | 3" | Alter change in level to be 1/4" high max. | 1 | - | - |

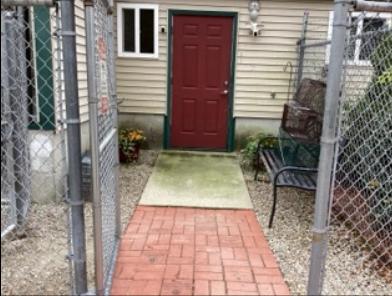
| ID | Location | Floor | Room | Element | Type | Photo | Issues | Current Measure | Recommendations | Quantity | Price | Cost Estimation |
|---|---|---|---|---|---|--|--|---|---|---|---|---|
| 2 | Main Entrance | Ext. | | Exterior Access Route | Walkway | | Level changes > 1/4" | 1" | Alter change in level to be 1/4" high max. | 1 | - | - |

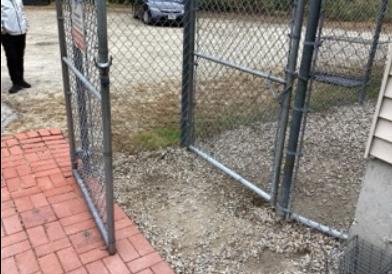
| ID | Location | Floor | Room | Element | Type | Photo | Issues | Current Measure | Recommendations | Quantity | Price | Cost Estimation |
|---|---|---|---|---|---|--|--|---|---|---|---|---|
| 3 | Route to Outdoor Kennels | Ext. | | Exterior Access Route | Route to Exterior Kennel Area | | Level changes > 1/4"<br>Accessible route not provided | -<br>- | Alter change in level to be 1/4" high max.<br>Ensure an accessible route is provided from the walkway to the exterior kennel entry. | 1 | - | - |

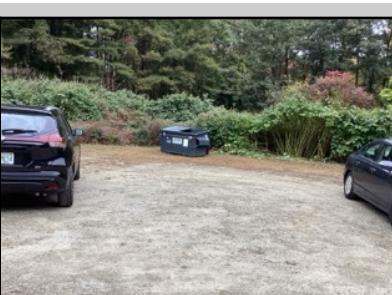
| ID | Location | Floor | Room | Element | Type | Photo | Issues | Current Measure | Recommendations | Quantity | Price | Cost Estimation |
|---|---|---|---|---|---|--|--|---|---|---|---|---|
| 4 | Parking | Ext. | | Off-Street Parking Lot or Garage | Visitor | | Total # of parking<br>Total # of designated car accessible parking spaces<br>Total # of designated van accessible spaces<br>Access aisle not provided<br>Sign with the International Symbol of Acc. not provided | 6<br>-<br>-<br>-<br>- | Provide a van accessible parking space 96" wide min. with a marked access aisle that is also 96" wide min.<br>Provide a sign with the International Symbol of Accessibility (ISA) with the bottom of the sign 60" min. above the ground and the top 96" max. above the ground.<br>Add the designation "Van Accessible" to the sign located at the van accessible parking space. | 1 | 500<br><br>500 | \$500 |

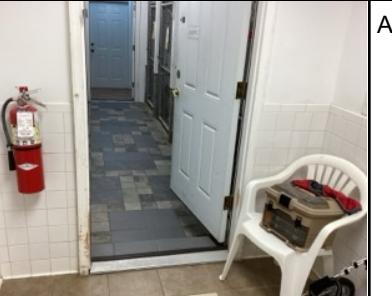
| ID | Location | Floor | Room | Element | Type | Photo | Issues | Current Measure | Recommendations | Quantity | Price | Cost Estimation |
|---|---|---|---|---|---|--|---|---|--|---|---|---|
| 5 | Interior Route to Kennels | 1 | | Interior Access Route | N/A | | Accessible route not provided | - | <b>Note:</b> IHCD team was told that staff will bring dogs and other animals from both the interior and exterior kennel areas to visitors waiting at an accessible location outside of the building as needed. | 1 | Labor | Labor |

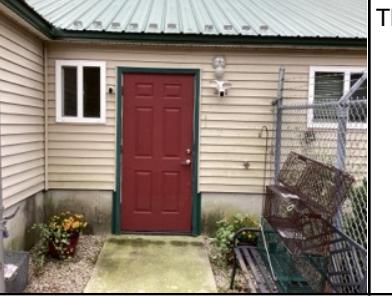
| ID | Location | Floor | Room | Element | Type | Photo | Issues | Current Measure | Recommendations | Quantity | Price | Cost Estimation |
|---|---|---|---|---|---|--|---|---|--|---|---|---|
| 6 | Main Entrance | Ext. | | Doors, Doorways, & Gates | Main Entrance | | Threshold > 1/2" high | 1" | Alter the threshold to be 1/2" high max. | 1 | 1000 | \$1000 |

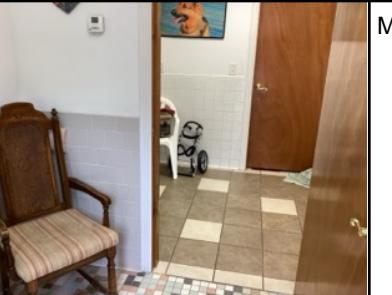
| ID | Location | Floor | Room | Element | Type | Photo | Issues | Current Measure | Recommendations | Quantity | Price | Cost Estimation |
|---|---|---|---|---|---|--|---|---|--|---|---|---|
| 7 | Entrance Vestibule | 1 | | Doors, Doorways, & Gates | Vestibule | | Maneuvering clearance(s) not provided | 3" | Relocate chair to provide 18" min. pull-side maneuvering clearance. | 1 | Labor | Labor |

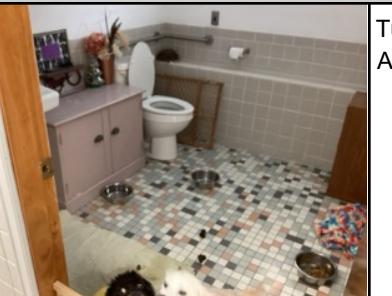
| ID | Location | Floor | Room | Element | Type | Photo | Issues | Current Measure | Recommendations | Quantity | Price | Cost Estimation |
|---|---|---|---|---|---|--|---|---|--|---|---|---|
| 8 | Single-User Toilet Room | 1 | | Overall Access | Toilet Room | | Turning space not provided<br>Accessible plumbing fixtures or stalls not provided | -<br>- | <b>Note:</b> While the toilet room could not be entered to be fully surveyed, it is apparent that it is not a compliant accessible single-user toilet room. IHCD team was told there is very limited public use of the toilet room. If the toilet room is available to members of the public going forward, it should be made accessible and an accessible sign with the International Symbol of Accessibility (ISA) should be provided. | 1 | - | - |

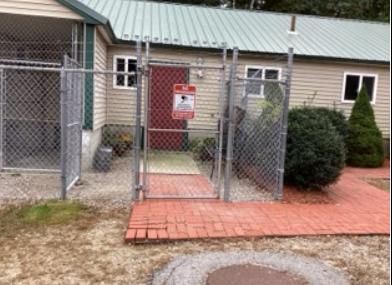
| ID | Location | Floor | Room | Element | Type | Photo | Issues | Current Measure | Recommendations | Quantity | Price | Cost Estimation |
|---|---|---|---|---|---|--|---|---|--|---|---|---|
| 9 | Main Entrance | Ext. | | Intercom | N/A | | | | Recommend providing an intercom at an accessible location outside of the gate so visitors with disabilities can notify staff inside of the building of their arrival. Ensure intercom controls are positioned no higher than 48" above the ground and that the controls can be used without requiring tight grasping, pinching or twisting of the wrist. | 1 | - | - |

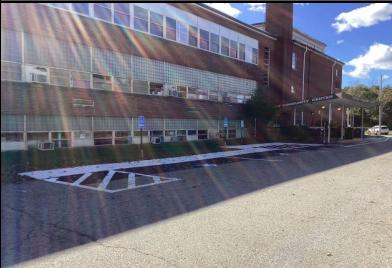
| ID | Location | Floor | Room | Element | Type | Photo | Issues | Current Measure | Recommendations | Quantity | Price | Cost Estimation |
|---|---|---|---|---|---|--|---|---|---|---|---|---|
| 1 | By Main Entrance | Ext. | | Off-Street Parking Lot or Garage | Visitor | | Total # of designated car accessible parking spaces<br>Total # of designated van accessible spaces<br>Access aisle < 96" wide at van space<br>Sign does not have the designation "Van Accessible"<br>Sign bottom < 60" above finished grade | 3<br>1<br>90"<br>—<br>48" | Provide a marked access aisle that is at least 96" wide at the van accessible parking space. Add the designation "Van Accessible" to the sign located at the van accessible space. Locate sign with the bottom of the sign 60" min. measured to the bottom of the sign and 96" max. measured to the top of the sign above the ground. | 1 | 500 | \$500 |

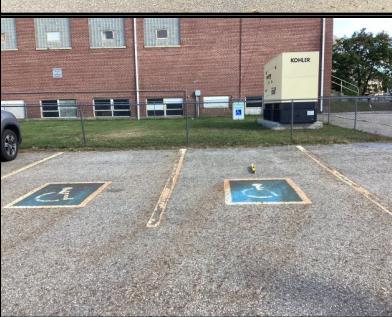
| ID | Location | Floor | Room | Element | Type | Photo | Issues | Current Measure | Recommendations | Quantity | Price | Cost Estimation |
|---|---|---|---|---|---|--|---|---|---|---|---|---|
| 2 | Reserved Accessible Parking | Ext. | | Off-Street Parking Lot or Garage | Employee | | Total # of designated car accessible parking spaces<br>Total # of designated van accessible spaces<br>Access aisle not provided<br>Running or cross slope at access aisle > 1:50 (2.00%)<br>Sign with the International Symbol of Acc. not provided<br>Sign bottom < 60" above finished grade | 2<br>-<br>4%<br>-<br>25" | Provide a marked access aisle that is at least 60" wide. Reduce running or cross slope to be no steeper than 1:50 (2.00%) in all directions. Provide a sign with the International Symbol of Accessibility (ISA) with the bottom of the sign 60" min. above the ground. Locate existing ISA sign with the bottom of the sign 60" min. above the ground. | 1 | 500 | \$500 |

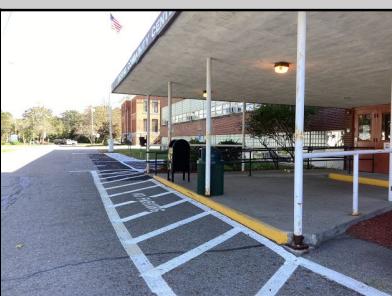
| ID | Location | Floor | Room | Element | Type | Photo | Issues | Current Measure | Recommendations | Quantity | Price | Cost Estimation |
|---|---|---|---|---|---|--|---|---|---|---|---|---|
| 3 | Main Entrance | Ext. | | Passenger Loading Zones | N/A | | Sign with ISA not provided (MAAB) | - | Provide a sign that includes the International Symbol of Accessibility (ISA) at the head of the space. Locate the sign so that the bottom is 60" min. above the ground and the top is 96" max. above the ground. | 1 | 500 | \$500 |

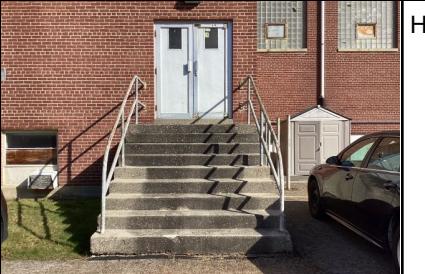
| ID | Location | Floor | Room | Element | Type | Photo | Issues | Current Measure | Recommendations | Quantity | Price | Cost Estimation |
|---|---|---|---|---|---|--|---|---|--|---|---|---|
| 5 | Secondary West Egress | Ext. | | Exterior Stair | N/A | | Handrails do not extend 12" from stair | - | Top: Ensure handrails extend horizontally above the landing for 12" min. beginning above the first riser nosing. Bottom: Ensure that the handrail extends at least 12" plus the width of one tread beyond the bottom riser. | 1 | - | - |

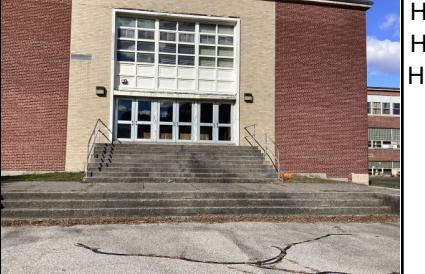
| ID | Location | Floor | Room | Element | Type | Photo | Issues | Current Measure | Recommendations | Quantity | Price | Cost Estimation |
|---|---|---|---|---|---|--|---|---|--|---|---|---|
| 6 | Secondary South Egress | Ext. | | Exterior Stair | | | Handrail height < 34" or > 38"<br>Handrails do not extend 12" from stair<br>Handrail is not continuous where required | 40" | Alter so the handrails are 34"- 38" high above the finished floor or ground.<br>Top: Ensure handrails extend horizontally above the landing for 12" min. beginning above the first riser nosing. Bottom: Ensure that the handrail extends at least 12" plus the width of one tread beyond the bottom riser.<br>Provide continuous handrails. | 1 | - | - |

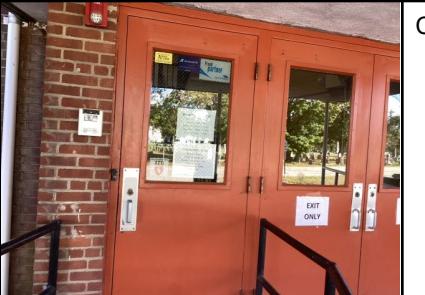
| ID | Location | Floor | Room | Element | Type | Photo | Issues | Current Measure | Recommendations | Quantity | Price | Cost Estimation |
|---|---|---|---|---|---|--|---|---|--|---|---|---|
| 7 | Main Entrance Ramp Door | Ext. | | Entrance | | | Clear width at door is < 32" | 30" | Widen the door so that there is 32" min. clear width. | 1 | 4376 | \$4376 |

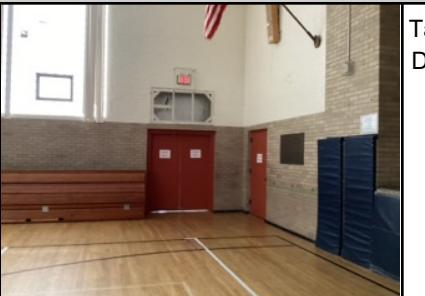
| ID | Location | Floor | Room | Element | Type | Photo | Issues | Current Measure | Recommendations | Quantity | Price | Cost Estimation |
|---|---|---|---|---|---|--|---|---|--|---|---|---|
| 8 | Basketball Gym West Egress to Stairs | 1 | | Means of Egress | N/A | | Tactile exit sign not provided<br>Directional sign to accessible emergency exit not provided | -<br>- | Ensure that a tactile exit sign with raised characters and braille is provided at the exit door. Mount the sign between 48"- 60" above the finished floor located on the latch side of the door.<br>Provide a directional sign indicating the location of the nearest accessible emergency exit. | 2 | 250 | \$500 |

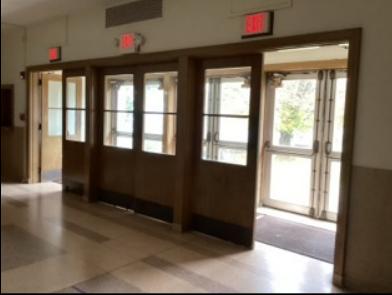
| ID | Location | Floor | Room | Element | Type | Photo | Issues | Current Measure | Recommendations | Quantity | Price | Cost Estimation |
|---|--|---|---|---|---|--|--|---|--|---|---|---|
| 9 | South Egress to Stairs | 1 | | Means of Egress | N/A | | Tactile exit sign not provided<br>Directional sign to accessible emergency exit not provided | -<br>- | Ensure that a tactile exit sign with raised characters and braille is provided at the exit door. Mount the sign between 48"- 60" above the finished floor located on the latch side of the door.<br>Provide a directional sign indicating the location of the nearest accessible emergency exit. | 2 | 250 | \$500 |

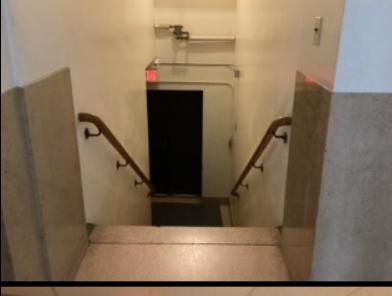
| ID | Location | Floor | Room | Element | Type | Photo | Issues | Current Measure | Recommendations | Quantity | Price | Cost Estimation |
|---|--|---|---|---|---|--|--|---|--|---|---|---|
| 10 | Egress at Stairs to Ground Level Near South Egress | 1 | | Means of Egress | | | Tactile exit sign not provided<br>Directional sign to accessible emergency exit not provided | -<br>- | Ensure that a tactile exit sign with raised characters and braille is provided at the exit door. Mount the sign between 48"- 60" above the finished floor located on the latch side of the door.<br>Provide a directional sign indicating the location of the nearest accessible emergency exit. | 2 | 250 | \$500 |

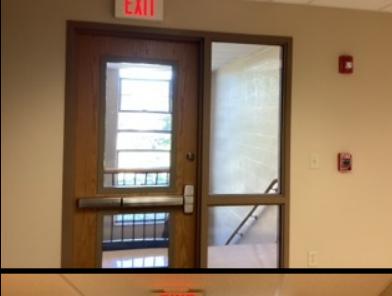
| ID | Location | Floor | Room | Element | Type | Photo | Issues | Current Measure | Recommendations | Quantity | Price | Cost Estimation |
|---|--|---|---|---|---|--|--|---|--|---|---|---|
| 11 | Stair 1 | 2 | | Means of Egress | N/A | | Tactile exit sign not provided | - | Ensure that a tactile exit sign with raised characters and braille is provided at the exit door. Mount the sign between 48"- 60" above the finished floor located on the latch side of the door. | 1 | 250 | \$250 |

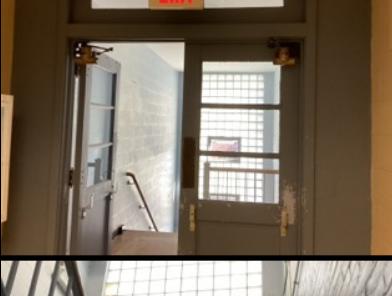
| ID | Location | Floor | Room | Element | Type | Photo | Issues | Current Measure | Recommendations | Quantity | Price | Cost Estimation |
|---|--|---|---|---|---|--|--|---|--|---|---|---|
| 12 | Stair 2 | 2 | | Means of Egress | N/A | | Tactile exit sign not provided | - | Ensure that a tactile exit sign with raised characters and braille is provided at the exit door. Mount the sign between 48"- 60" above the finished floor located on the latch side of the door. | 1 | 250 | \$250 |

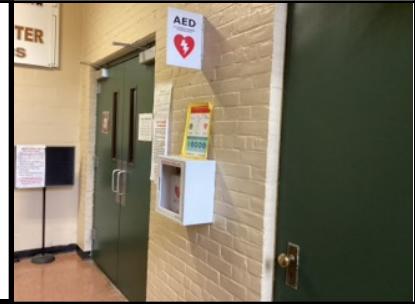
| ID | Location | Floor | Room | Element | Type | Photo | Issues | Current Measure | Recommendations | Quantity | Price | Cost Estimation |
|---|---|---|---|---|---|--|--|---|--|---|---|---|
| 14 | Hallway | 1 | | Interior Access Route | N/A | | Obstructed by protruding objects | 7" | Relocate defibrillator out of the accessible route or provide a cane-detectable barrier 27" max. above the ground under the defibrillator. | 1 | 398 | \$398 |

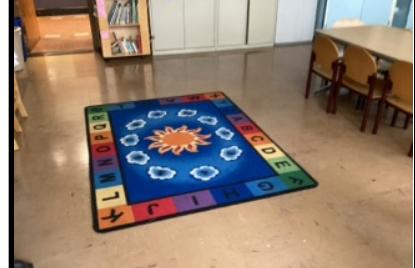
| ID | Location | Floor | Room | Element | Type | Photo | Issues | Current Measure | Recommendations | Quantity | Price | Cost Estimation |
|---|---|---|---|---|---|--|--|---|--|---|---|---|
| 15 | Craft Room/Babysitting | 1 | | Interior Access Route | N/A | | Surface not stable, firm, and slip-resistant | - | Secure rug to floor to prevent tripping hazard. | 1 | Labor | Labor |

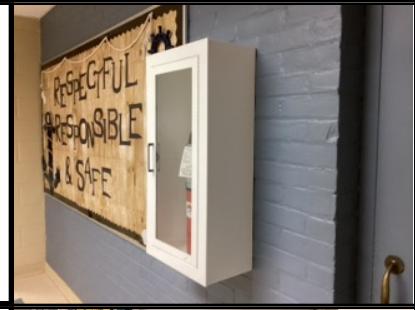
| ID | Location | Floor | Room | Element | Type | Photo | Issues | Current Measure | Recommendations | Quantity | Price | Cost Estimation |
|---|---|---|---|---|---|--|--|---|--|---|---|---|
| 16 | Hallway | 2 | | Interior Access Route | N/A | | Obstructed by protruding objects | 9" | Relocate fire extinguisher case out of the accessible route or provide a cane-detectable barrier 27" max. above the ground under the case. | 2 | 398 | \$796 |

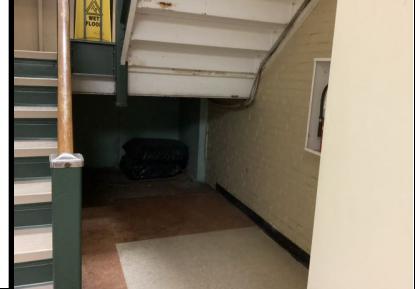
| ID | Location | Floor | Room | Element | Type | Photo | Issues | Current Measure | Recommendations | Quantity | Price | Cost Estimation |
|---|---|---|---|---|---|--|--|---|--|---|---|---|
| 17 | Stair 1 From Main Entry | G | | Interior Access Route | 193 | | Obstructed by protruding objects | - | Provide a cane-detectable barrier under stairs. | 1 | 1141 | \$1141 |

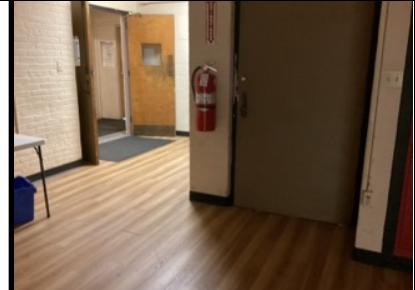
| ID | Location | Floor | Room | Element | Type | Photo | Issues | Current Measure | Recommendations | Quantity | Price | Cost Estimation |
|---|---|---|---|---|---|--|--|---|--|---|---|---|
| 18 | Food Pantry | G | | Interior Access Route | N/A | | Obstructed by protruding objects | 6.5" | Relocate fire extinguisher out of the accessible route or provide a cane-detectable barrier 27" max. above the finished floor under the fire extinguisher. | 1 | 398 | \$398 |

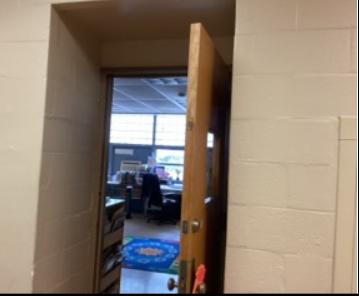
| ID | Location | Floor | Room | Element | Type | Photo | Issues | Current Measure | Recommendations | Quantity | Price | Cost Estimation |
|---|---|---|---|---|---|--|---|---|--|---|---|---|
| 19 | Craft Room/<br>Babysitting | 1 | | Doors,<br>Doorways,<br>& Gates | Other | | Maneuvering clearance not provided at recess > 6"<br>Hardware not compliant | 27"<br>- | Install an automatic door opener.<br>Provide hardware that can be operable with one hand and not require tight grasping, pinching, or twisting of the wrist. | 1 | 6000<br>750 | \$6750<br><br><b>6750</b> |

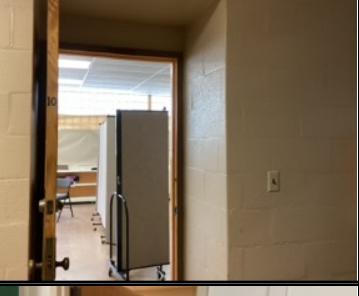
| ID | Location | Floor | Room | Element | Type | Photo | Issues | Current Measure | Recommendations | Quantity | Price | Cost Estimation |
|---|---|---|---|---|---|--|---|---|--|---|---|---|
| 20 | Community<br>Room | 1 | | Doors,<br>Doorways,<br>& Gates | Other | | Maneuvering clearance not provided at recess > 6"<br>Hardware not compliant | 27"<br>- | Install an automatic door opener./Reverse the swing of the door to provide maneuvering clearance.<br>Provide hardware that can be operable with one hand and not require tight grasping, pinching, or twisting of the wrist. | 1 | 6000<br>750 | \$6750<br><br><b>6750</b> |

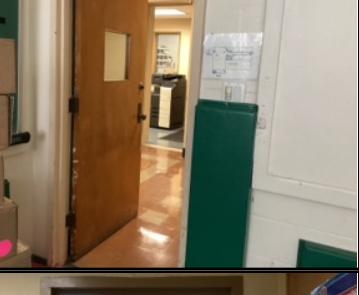
| ID | Location | Floor | Room | Element | Type | Photo | Issues | Current Measure | Recommendations | Quantity | Price | Cost Estimation |
|---|---|---|---|---|---|--|---|---|--|---|---|---|
| 21 | Babysitting<br>Room<br>Becoming<br>Multipurpose<br>Room | 1 | | Doors,<br>Doorways,<br>& Gates | Other | | Hardware not compliant | - | Provide hardware that can be operable with one hand and not require tight grasping, pinching, or twisting of the wrist. | 1 | 750 | \$750<br><br><b>750</b> |

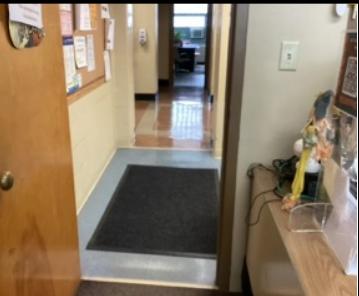
| ID | Location | Floor | Room | Element | Type | Photo | Issues | Current Measure | Recommendations | Quantity | Price | Cost Estimation |
|---|---|---|---|---|---|--|---|---|---|---|---|---|
| 24 | Main Office | 1 | | Doors, Doorways, & Gates | Office | | Mat not securely attached | - | Secure the mat. | 1 | Labor | Labor |

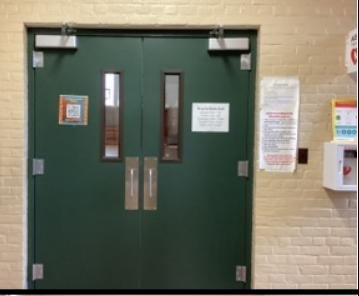
| ID | Location | Floor | Room | Element | Type | Photo | Issues | Current Measure | Recommendations | Quantity | Price | Cost Estimation |
|---|---|---|---|---|---|--|---|---|---|---|---|---|
| 25 | Basketball Gym | 1 | | Doors, Doorways, & Gates | | | If double-leaf door, neither compliant<br>Door requires > 5 lbs. of force to open | 29.75"<br>25 lbs. | Ensure that at least one of the active leaves is at least 32" min. wide.<br>Adjust closers so doors do not require more than 5 pounds of force to open. | 1 | 4376 | \$4376 |

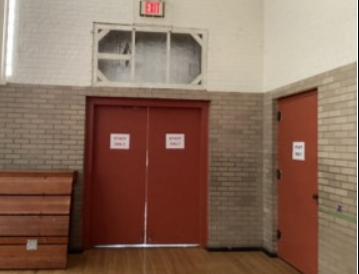
| ID | Location | Floor | Room | Element | Type | Photo | Issues | Current Measure | Recommendations | Quantity | Price | Cost Estimation |
|---|---|---|---|---|---|--|---|---|---|---|---|---|
| 26 | Basketball Gym West Egress to Stairs | 1 | | Doors, Doorways, & Gates | Emergency Egress | | If double-leaf door, neither compliant | 30" | Ensure that at least one of the active leaves is at least 32" min. wide. | 1 | 4376 | \$4376 |

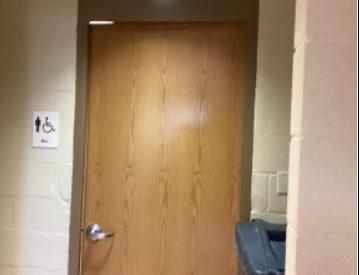
| ID | Location | Floor | Room | Element | Type | Photo | Issues | Current Measure | Recommendations | Quantity | Price | Cost Estimation |
|---|---|---|---|---|---|--|---|---|---|---|---|---|
| 27 | Men's Single-User Toilet Room | 2 | | Doors, Doorways, & Gates | | | Door requires > 5 lbs. of force to open | 10 lbs. | Adjust closers so doors do not require more than 5 pounds of force to open. | 1 | Labor | Labor |

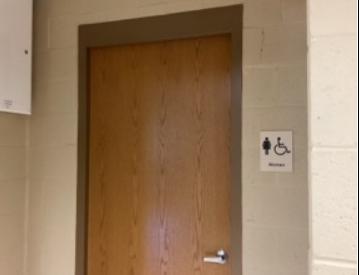
| ID | Location | Floor | Room | Element | Type | Photo | Issues | Current Measure | Recommendations | Quantity | Price | Cost Estimation |
|---|---|---|---|---|---|--|---|---|---|---|---|---|
| 28 | Women's Single-User Toilet Room | 2 | | Doors, Doorways, & Gates | | | Door requires > 5 lbs. of force to open | 10 lbs. | Adjust closers so doors do not require more than 5 pounds of force to open. | 1 | Labor | Labor |

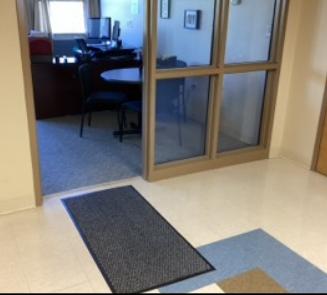
| ID | Location | Floor | Room | Element | Type | Photo | Issues | Current Measure | Recommendations | Quantity | Price | Cost Estimation |
|---|---|---|---|---|---|--|---|---|--|---|---|---|
| 29 | School Administration | 2 | | Doors, Doorways, & Gates | Office | | Mat not securely attached | - | Secure the mat. | 1 | Labor | Labor |

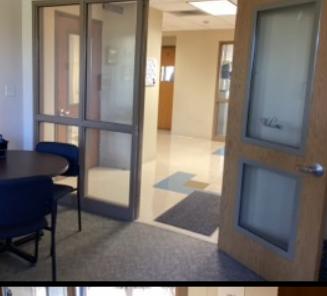
| ID | Location | Floor | Room | Element | Type | Photo | Issues | Current Measure | Recommendations | Quantity | Price | Cost Estimation |
|---|---|---|---|---|---|--|---|---|--|---|---|---|
| 30 | School Administration | 2 | | Doors, Doorways, & Gates | | | Maneuvering clearance(s) not provided | - | Relocate table and chairs to provide 18" min. pull-side maneuvering clearance at the door. | 1 | Labor | Labor |

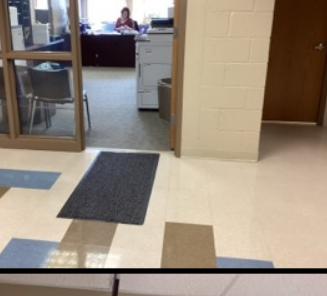
| ID | Location | Floor | Room | Element | Type | Photo | Issues | Current Measure | Recommendations | Quantity | Price | Cost Estimation |
|---|---|---|---|---|---|--|---|---|--|---|---|---|
| 31 | Title 1 | 2 | 210 | Doors, Doorways, & Gates | Office | | Mat not securely attached | - | Secure the mat. | 1 | Labor | Labor |

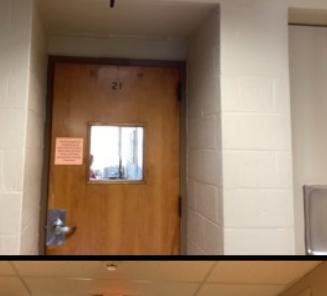
| ID | Location | Floor | Room | Element | Type | Photo | Issues | Current Measure | Recommendations | Quantity | Price | Cost Estimation |
|---|---|---|---|---|---|--|---|---|--|---|---|---|
| 32 | Superintendent's Office | 2 | 201 | Doors, Doorways, & Gates | | | Maneuvering clearance not provided at recess > 6" | 24" | Install an automatic door opener. | 1 | 6000 | \$6000 |

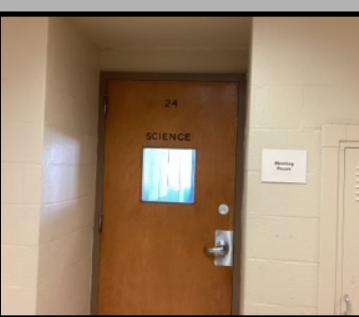
| ID | Location | Floor | Room | Element | Type | Photo | Issues | Current Measure | Recommendations | Quantity | Price | Cost Estimation |
|---|---|---|---|---|---|--|--|---|---|---|---|---|
| 34 | Conference Room | 2 | 221 | Doors, Doorways, & Gates | Meeting Room | | Maneuvering clearance not provided at recess > 6" | 24" | Install an automatic door opener. | 1 | 6000 | \$6000 |

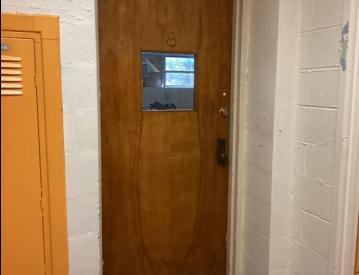
| ID | Location | Floor | Room | Element | Type | Photo | Issues | Current Measure | Recommendations | Quantity | Price | Cost Estimation |
|---|---|---|---|---|---|--|--|---|---|---|---|---|
| 35 | Spinning Room | G | | Doors, Doorways, & Gates | Classroom | | Hardware not compliant | - | Provide hardware that can be operable with one hand and not require tight grasping, pinching, or twisting of the wrist. | 1 | 750 | \$750 |

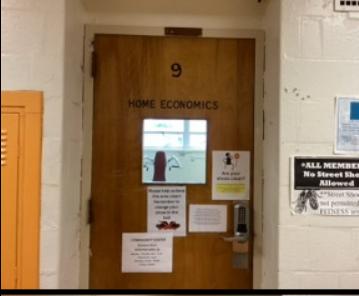
| ID | Location | Floor | Room | Element | Type | Photo | Issues | Current Measure | Recommendations | Quantity | Price | Cost Estimation |
|---|---|---|---|---|---|--|--|---|---|---|---|---|
| 36 | Cardio Room | G | | Doors, Doorways, & Gates | Other | | Maneuvering clearance not provided at recess > 6"<br>Door requires > 5 lbs. of force to open | 13"<br>8 lbs. | Install an automatic door opener.<br>Adjust closers so doors do not require more than 5 pounds of force to open. | 1 | 6000 | \$6000 |

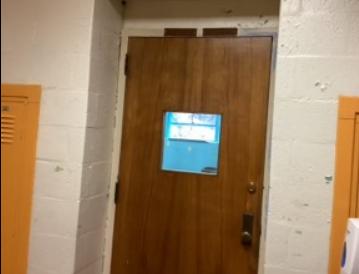
| ID | Location | Floor | Room | Element | Type | Photo | Issues | Current Measure | Recommendations | Quantity | Price | Cost Estimation |
|---|---|---|---|---|---|--|--|---|---|---|---|---|
| 37 | Group Fitness | G | | Doors, Doorways, & Gates | | | Maneuvering clearance not provided at recess > 6" | 13" | Install an automatic door opener. | 1 | 6000 | \$6000 |

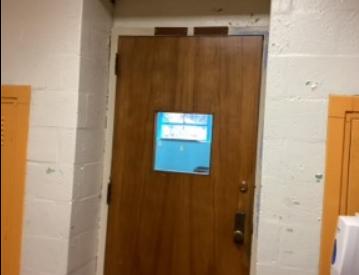
| ID | Location | Floor | Room | Element | Type | Photo | Issues | Current Measure | Recommendations | Quantity | Price | Cost Estimation |
|---|---|---|---|---|---|--|--|---|---|---|---|---|
| 38 | Group Fitness | G | | Doors, Doorways, & Gates | | | Hardware not compliant | - | Provide hardware that can be operable with one hand and not require tight grasping, pinching, or twisting of the wrist. | 1 | 750 | \$750 |

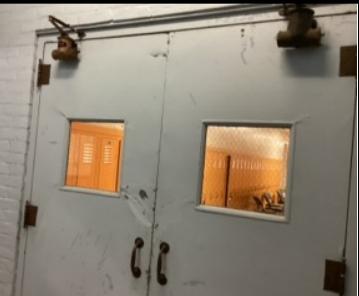
| ID | Location | Floor | Room | Element | Type | Photo | Issues | Current Measure | Recommendations | Quantity | Price | Cost Estimation |
|---|--|---|---|---|---|--|---|---|--|---|---|---|
| 39 | Doors to Stair 2 | G | | Doors, Doorways, & Gates | | | If double-leaf door, neither compliant | 30" | Ensure that at least one of the active leaves is at least 32" min. wide. | 1 | 4376 | \$4376 |

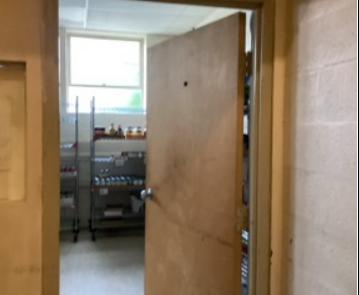
| ID | Location | Floor | Room | Element | Type | Photo | Issues | Current Measure | Recommendations | Quantity | Price | Cost Estimation |
|---|--|---|---|---|---|--|---|---|--|---|---|---|
| 40 | Food Pantry | G | | Doors, Doorways, & Gates | | | Hardware not compliant | - | Provide hardware that can be operable with one hand and not require tight grasping, pinching, or twisting of the wrist. | 1 | 750 | \$750 |

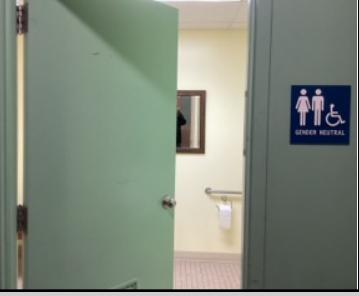
| ID | Location | Floor | Room | Element | Type | Photo | Issues | Current Measure | Recommendations | Quantity | Price | Cost Estimation |
|---|--|---|---|---|---|--|---|---|--|---|---|---|
| 41 | All-Gender Single-User Toilet Room | G | | Doors, Doorways, & Gates | Toilet Room | | Hardware not compliant | - | Provide hardware that can be operable with one hand and not require tight grasping, pinching, or twisting of the wrist. | 1 | 629 | \$629 |

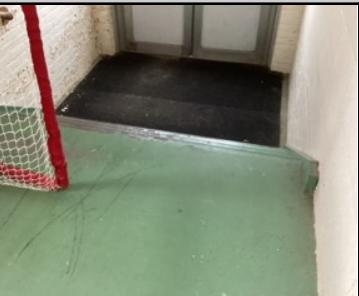
| ID | Location | Floor | Room | Element | Type | Photo | Issues | Current Measure | Recommendations | Quantity | Price | Cost Estimation |
|---|--|---|---|---|---|--|---|---|--|---|---|---|
| 42 | Basketball Gym West Egress Stairs | 1 | | Stairways | Egress | | Handrail height < 34" or > 38"<br>Handrails do not extend 12" from stairs<br>Handrails not provided | 30"<br>12"<br>- | Alter so the handrails are 34"- 38" high above the floor.<br>Top: Ensure handrails extend horizontally above the landing for 12" min. beginning above the first riser nosing. Bottom: Ensure that the handrail extends at least 12" plus the width of one tread beyond the bottom riser.<br>Provide handrails. | 1 | - | - |

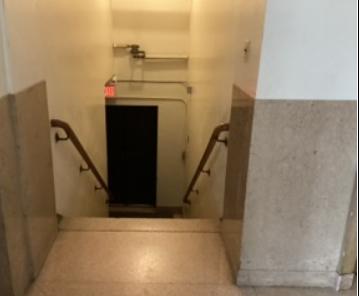
| ID | Location | Floor | Room | Element | Type | Photo | Issues | Current Measure | Recommendations | Quantity | Price | Cost Estimation |
|---|--|---|---|---|---|--|---|---|--|---|---|---|
| 43 | Stairs to Ground Level Near South Egress | 1 | | Stairways | Egress | | Handrail height < 34" or > 38"<br>Handrails do not extend 12" from stairs | 32"<br>12" | Alter so the handrails are 34"- 38" high above the floor.<br>Top: Ensure handrails extend horizontally above the landing for 12" min. beginning above the first riser nosing. Bottom: Ensure that the handrail extends at least 12" plus the width of one tread beyond the bottom riser. | 1 | - | - |

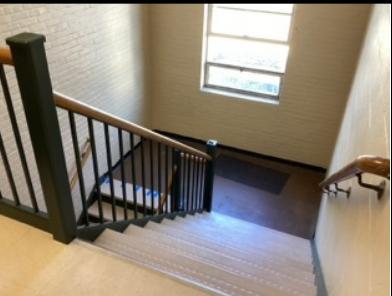
| ID | Location | Floor | Room | Element | Type | Photo | Issues | Current Measure | Recommendations | Quantity | Price | Cost Estimation |
|---|---|---|---|---|---|--|--|---|---|---|---|---|
| 44 | Stair 1 | 2 | | Stairways | Egress | | Handrail height < 34" or > 38"<br>Handrails do not extend 12" from stairs<br>Handrails not continuous where required | 31.5"<br>-<br>- | Alter so the handrails are 34"- 38" high above the floor.<br>Top: Ensure handrails extend horizontally above the landing for 12" min. beginning above the first riser nosing. Bottom: Ensure that the handrail extends at least 12" plus the width of one tread beyond the bottom riser.<br>Provide continuous handrails. | 1 | - | - |

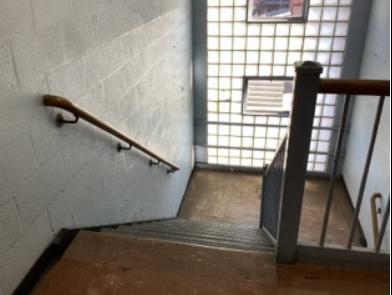
| ID | Location | Floor | Room | Element | Type | Photo | Issues | Current Measure | Recommendations | Quantity | Price | Cost Estimation |
|---|---|---|---|---|---|--|--|---|---|---|---|---|
| 45 | Stair 2 | 2 | | Stairways | Egress | | Handrails do not extend 12" from stairs<br>Handrails not continuous where required | -<br>- | Top: Ensure handrails extend horizontally above the landing for 12" min. beginning above the first riser nosing. Bottom: Ensure that the handrail extends at least 12" plus the width of one tread beyond the bottom riser.<br>Provide continuous handrails. | 1 | - | - |

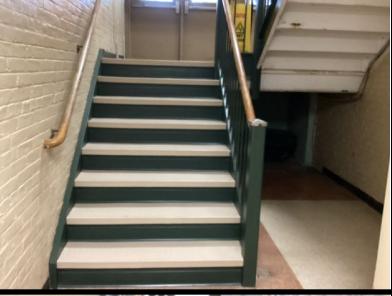
| ID | Location | Floor | Room | Element | Type | Photo | Issues | Current Measure | Recommendations | Quantity | Price | Cost Estimation |
|---|---|---|---|---|---|--|--|---|---|---|---|---|
| 46 | Stair 1 From Main Entry | G | | Stairways | Egress | | Handrails do not extend 12" from stairs<br>Handrails not continuous where required | -<br>- | Top: Ensure handrails extend horizontally above the landing for 12" min. beginning above the first riser nosing. Bottom: Ensure that the handrail extends at least 12" plus the width of one tread beyond the bottom riser.<br>Provide continuous handrails. | 1 | - | - |

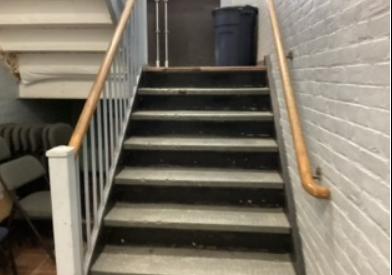
| ID | Location | Floor | Room | Element | Type | Photo | Issues | Current Measure | Recommendations | Quantity | Price | Cost Estimation |
|---|---|---|---|---|---|--|--|---|---|---|---|---|
| 47 | Stair 2 | G | | Stairways | Egress | | Handrails do not extend 12" from stairs<br>Handrails not continuous where required | -<br>- | Top: Ensure handrails extend horizontally above the landing for 12" min. beginning above the first riser nosing. Bottom: Ensure that the handrail extends at least 12" plus the width of one tread beyond the bottom riser.<br>Provide continuous handrails. | 1 | - | - |

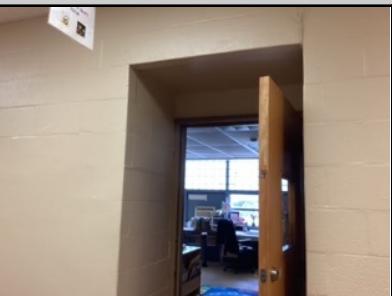
| ID | Location | Floor | Room | Element | Type | Photo | Issues | Current Measure | Recommendations | Quantity | Price | Cost Estimation |
|---|---|---|---|---|---|--|--|---|---|---|---|---|
| 48 | Craft Room/ Babysitting | 1 | | Signage | Designation | | Raised characters not provided on sign<br>Braille not provided on sign<br>Sign not located on the latch side of the door | -<br>-<br>- | Provide text with raised characters duplicated in braille on the sign.<br>Provide braille on the sign.<br>Locate the sign at permanent rooms alongside the door on the latch side. | 1 | 250 | \$250 |

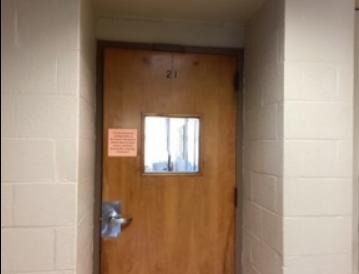
| ID | Location | Floor | Room | Element | Type | Photo | Issues | Current Measure | Recommendations | Quantity | Price | Cost Estimation |
|---|---|---|---|---|---|--|---|---|--|---|---|---|
| 54 | Superintendent's Office | 2 | 201 | Signage | | | Raised characters not provided on sign<br>Braille not provided on sign<br>Sign not located on the latch side of the door | | Provide text with raised characters duplicated in braille on the sign.<br>Provide braille on the sign.<br>Locate the sign at permanent rooms alongside the door on the latch side. | 1 | 250 | \$250 |

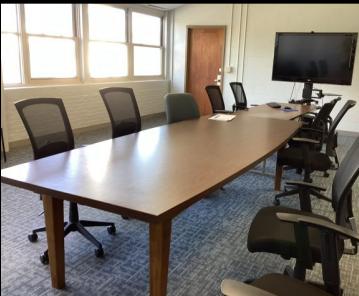
| ID | Location | Floor | Room | Element | Type | Photo | Issues | Current Measure | Recommendations | Quantity | Price | Cost Estimation |
|---|---|---|---|---|---|--|---|---|--|---|---|---|
| 55 | Conference Room | 2 | | Signage | Informational | | Int. Symbol of Acc. for Hearing Loss not provided | - | Provide a sign containing the International Symbol of Access for Hearing Loss. (IHCD team was told that the community center has a portable assistive listening system. Therefore, a sign with the International Symbol of Access for Hearing Loss should be displayed at a prominent location to let visitors know of the system's availability.) | 1 | 250 | \$250 |

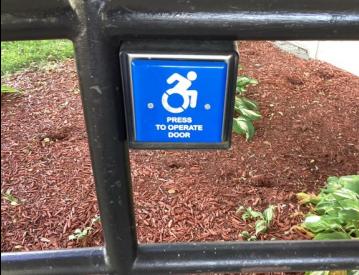
| ID | Location | Floor | Room | Element | Type | Photo | Issues | Current Measure | Recommendations | Quantity | Price | Cost Estimation |
|---|---|---|---|---|---|--|---|---|--|---|---|---|
| 56 | Main Entrance | Ext. | | Signage | N/A | | International Symbol of Acc. not compliant | - | Provide the required International Symbol of Accessibility (ISA). (The "active" International Symbol of Accessibility (ISA) is not compliant in Massachusetts.) | 1 | 250 | \$250 |

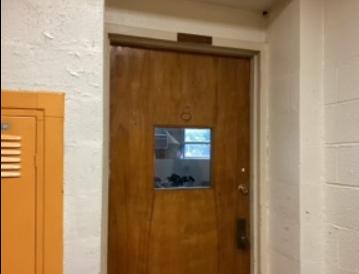
| ID | Location | Floor | Room | Element | Type | Photo | Issues | Current Measure | Recommendations | Quantity | Price | Cost Estimation |
|---|---|---|---|---|---|--|---|---|--|---|---|---|
| 57 | Spinning Room | G | | Signage | Designation | | Raised characters not provided on sign<br>Raised characters < 48" or > 60" above ground<br>Sign not located on the latch side of the door | | Provide text with raised characters duplicated in braille on the sign.<br>Mount the sign so that the baseline of the lowest tactile character is 48" min. above finished floor and the baseline of the highest tactile character is 60" max. above the finished floor.<br>Locate the sign at permanent rooms alongside the door on the latch side. | 1 | 250 | \$250 |

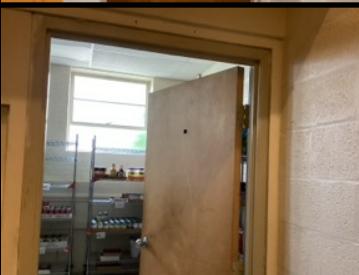
| ID | Location | Floor | Room | Element | Type | Photo | Issues | Current Measure | Recommendations | Quantity | Price | Cost Estimation |
|---|---|---|---|---|---|--|---|---|--|---|---|---|
| 58 | Food Pantry | G | | Signage | Designation | | Signage is not provided | - | Locate compliant signage with raised characters and braille alongside the door on the latch side. | 1 | 250 | \$250 |

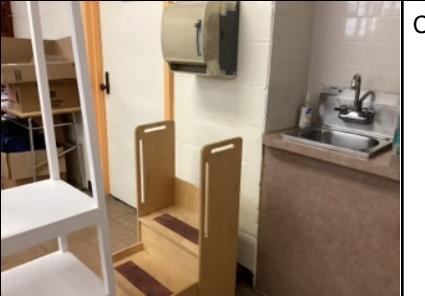
| ID | Location | Floor | Room | Element | Type | Photo | Issues | Current Measure | Recommendations | Quantity | Price | Cost Estimation |
|---|---|---|---|---|---|--|---|---|---|---|---|---|
| 59 | Community Room | 1 | | Operable Parts / Reach Range | Paper Towel Dispenser | | Clear floor space not provided. | | Ensure clear floor space is provided at the paper towel dispenser. (Relocate portable steps as needed.) | 1 | Labor | Labor |

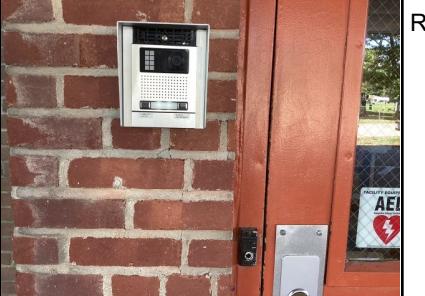
| ID | Location | Floor | Room | Element | Type | Photo | Issues | Current Measure | Recommendations | Quantity | Price | Cost Estimation |
|---|---|---|---|---|---|--|---|---|---|---|---|---|
| 60 | Main Entrance Intercom | Ext. | | Operable Parts / Reach Range | N/A | | Reach < 15" or > 48"(forward/side approach) | 56" | Relocate intercom controls so that controls are between 15"- 48" above the finished floor or ground | 1 | 500 | \$500 |

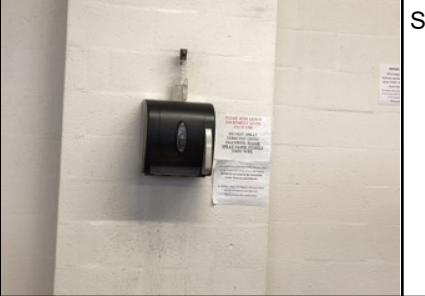
| ID | Location | Floor | Room | Element | Type | Photo | Issues | Current Measure | Recommendations | Quantity | Price | Cost Estimation |
|---|---|---|---|---|---|--|---|---|---|---|---|---|
| 61 | Cardio Room | G | | Operable Parts / Reach Range | Spray Bottle | | Side reach > 54" | 58" | Relocate spray bottle with cleanser used to clean machines to between 15" - 48" above the finished floor. | 2 | Labor | Labor |

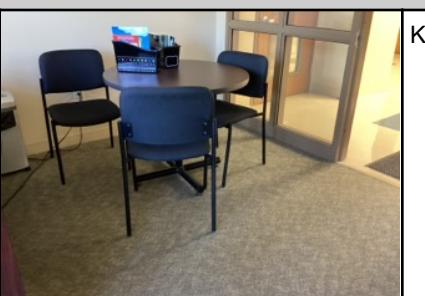
| ID | Location | Floor | Room | Element | Type | Photo | Issues | Current Measure | Recommendations | Quantity | Price | Cost Estimation |
|---|---|---|---|---|---|--|---|---|---|---|---|---|
| 62 | School Administration | 2 | | Dining or Work Surfaces | Work Surface | | Knee or toe clearance not provided | - | Provide at least one work surface with 27" min. high knee and toe clearance. For children, provide at least one dining or work surface with 24" min. high knee and toe clearance. | 1 | 450 | \$450 |

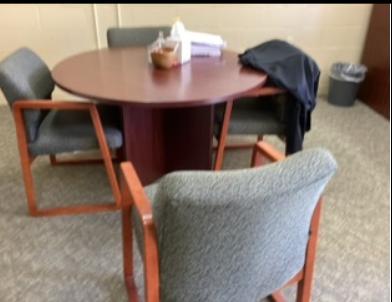
| ID | Location | Floor | Room | Element | Type | Photo | Issues | Current Measure | Recommendations | Quantity | Price | Cost Estimation |
|---|---|---|---|---|---|--|---|---|---|---|---|---|
| 64 | Superintendent's Office | 2 | | Dining or Work Surfaces | Work Surface | | Knee or toe clearance not provided | - | Provide at least one work surface with 27" min. high knee and toe clearance. For children, provide at least one dining or work surface with 24" min. high knee and toe clearance. | 1 | 450 | \$450 |

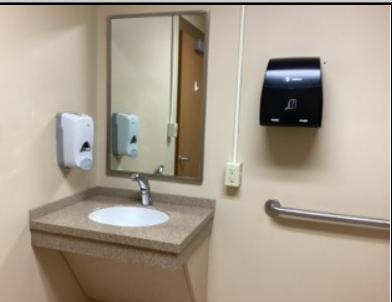
| 65 | Men's Single-User Toilet Room | 2 | | Lavatory | N/A | | Toe or knee clearances not provided | 7" | Provide at least one lavatory with knee and toe clearance positioned for a forward approach. (At least 8" of depth must be provided at the first 3" below the rim of the lavatory.) | 1 | 2192 | \$2192 |

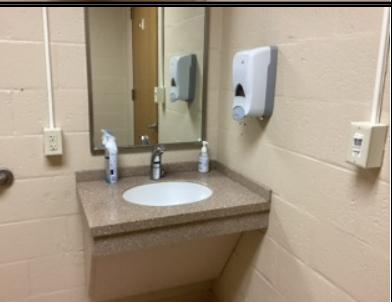
| 66 | Women's Single-User Toilet Room | 2 | | Lavatory | N/A | | Toe or knee clearances not provided | 7" | Provide at least one lavatory with knee and toe clearance positioned for a forward approach. (At least 8" of depth must be provided at the first 3" below the rim of the lavatory.) | 1 | 2192 | \$2192 |

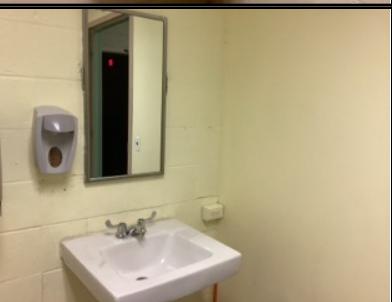
| 67 | All-Gender Single-User Toilet Room | G | | Lavatory | N/A | | Mirror above lavatory w/reflective surface > 40" | 42" | Lower mirror so that the bottom surface is at 40" max. above the finished floor. | 1 | 500 | \$500 |

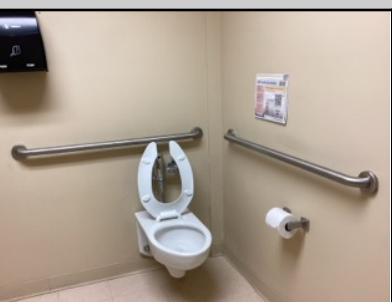
| 68 | Men's Single-User Toilet Room | 2 | | Single-User Toilet | | | Item mounted over grab bar (MAAB) | - | Relocate paper towel dispenser so that it is not mounted over the grab bar. | 1 | 333 | \$333 |

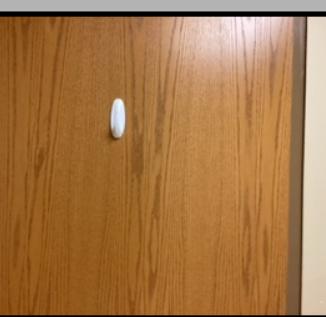
| ID | Location | Floor | Room | Element | Type | Photo | Issues | Current Measure | Recommendations | Quantity | Price | Cost Estimation |
|---|---|---|---|---|---|--|---|---|--|---|---|---|
| 69 | Men's Single-User Toilet Room | 2 | | Single-User Toilet | | | Hook located > 48" high (2010 ADA) | 65" | Locate the coat hook no higher than 48" above the finished floor. | 1 | 75 | \$75 |

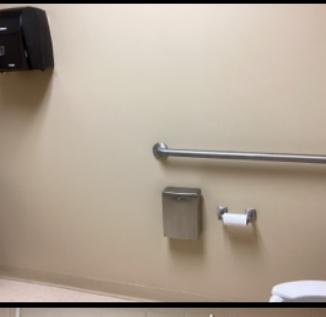
| ID | Location | Floor | Room | Element | Type | Photo | Issues | Current Measure | Recommendations | Quantity | Price | Cost Estimation |
|---|---|---|---|---|---|--|---|---|--|---|---|---|
| 70 | Women's Single-User Toilet Room | 2 | | Single-User Toilet | N/A | | Side grab bar < 54" from back wall | 48" | Provide a side wall grab bar that is 42" long min. located 12" max. from the rear wall and 54" from the back wall overall. (This grab bar is just 48" from the back wall.) | 1 | 459 | \$459 |

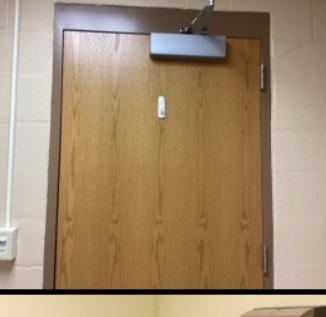
| ID | Location | Floor | Room | Element | Type | Photo | Issues | Current Measure | Recommendations | Quantity | Price | Cost Estimation |
|---|---|---|---|---|---|--|---|---|--|---|---|---|
| 71 | Women's Single-User Toilet Room | 2 | | Single-User Toilet | | | Hook located > 54" high | 75" | Locate the coat hook no higher than 48" above the finished floor. | 1 | 75 | \$75 |

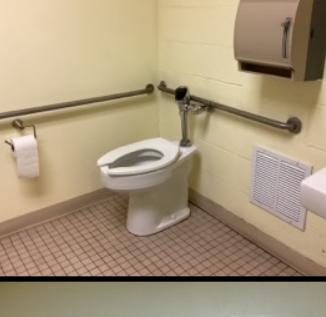
| ID | Location | Floor | Room | Element | Type | Photo | Issues | Current Measure | Recommendations | Quantity | Price | Cost Estimation |
|---|---|---|---|---|---|--|---|---|--|---|---|---|
| 72 | All-Gender Single-User Toilet Room | G | | Single-User Toilet | N/A | | Centerline < or > 18" (MAAB)<br>Side grab bar < 54" from back wall<br>Clearance at toilet < 60" clear width<br>Toilet paper dispenser is not compliant<br>Item mounted over grab bar (MAAB) | 16.5"<br>48"<br>58.5"<br>13"<br>- | Relocate toilet so that the centerline is 18" from the side wall. Provide a side wall grab bar that is 42" long min. located 12" max. from the rear wall. Relocate lavatory to provide 60" clear floor space at the toilet. Relocate toilet paper so that it is 24" min. high, under the grab bar, and between 7" and 9" from the front of the toilet. Relocate paper towel dispenser so that it is not mounted over the grab bar. | 1 | 3676<br>459<br>4022<br>500<br>459<br>9116 | \$9116 |

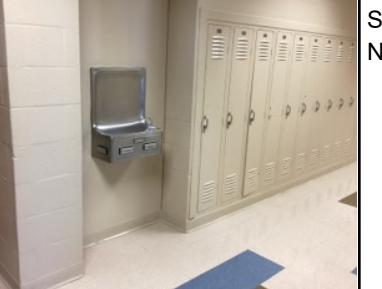
| ID | Location | Floor | Room | Element | Type | Photo | Issues | Current Measure | Recommendations | Quantity | Price | Cost Estimation |
|---|---|---|---|---|---|--|---|---|--|---|---|---|
| 75 | By Superintendent's Office | 2 | | Drinking Fountains | | | Spout > 36" high (wheelchair users)<br>No drinking fountain provided for standing users | 37"<br>- | Lower drinking fountain so that the spout is 36" max. above the finished floor or ground. Provide an additional drinking fountain for standing users or install a Hi-Lo drinking fountain. | 1 | 2028<br>4028 | \$6056<br><br><b>6056</b> |

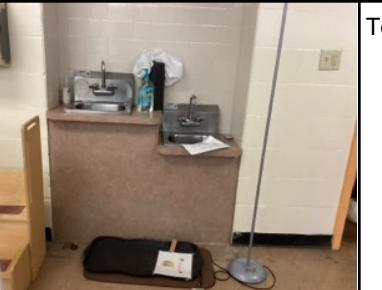
| ID | Location | Floor | Room | Element | Type | Photo | Issues | Current Measure | Recommendations | Quantity | Price | Cost Estimation |
|---|---|---|---|---|---|--|---|---|--|---|---|---|
| 76 | Community Room | 1 | | Sink | | | Toe and knee clearances not provided | - | Ensure there is a 27" min. knee clearance positioned for a forward approach. | 1 | 2192 | \$2192<br><br><b>2192</b> |

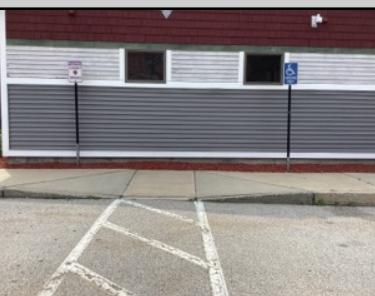
| ID | Location | Floor | Room | Element | Type | Photo | Issues | Current Measure | Recommendations | Quantity | Price | Cost Estimation |
|---|---|---|---|---|---|--|--|---|--|---|---|---|
| 1 | Accessible Parking by the Town Hall | Ext. | | Curb Ramp | N/A | | Transition from curb ramp to street not flush | 1" | Ensure transition from curb ramp to street is flush or free of changes in level. | 1 | - | - |

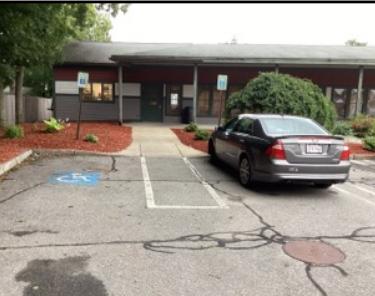
| ID | Location | Floor | Room | Element | Type | Photo | Issues | Current Measure | Recommendations | Quantity | Price | Cost Estimation |
|---|---|---|---|---|---|--|--|---|--|---|---|---|
| 2 | South Side Senior Center Parking | Ext. | | Off-Street Parking Lot or Garage | N/A | | Total # of parking<br>Total # of designated car accessible parking spaces<br>Total # of designated van accessible spaces<br>Van space < 132" or <96" wide<br>Access aisle not compliant<br>Access aisle < 96" wide at van space<br>Sign does not have the designation "Van Accessible" | 13<br>3<br>1<br>104"<br>-<br>48"<br>- | Provide a van accessible space that is at least 132" wide.<br>Provide a marked access aisle that is at least 60" wide. between the car and van space. (Re-stripe.)Add the designation "Van Accessible" to the sign located at the van accessible space.<br>(Van spaces and access aisles can be 8' and 8' or the space can be 11' with a 5' access aisle.<br>Price provided for an exterior sign.) | 1 | 450 | \$450 |

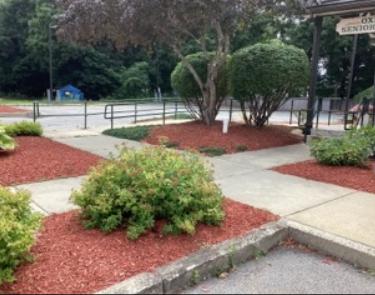
| ID | Location | Floor | Room | Element | Type | Photo | Issues | Current Measure | Recommendations | Quantity | Price | Cost Estimation |
|---|---|---|---|---|---|--|--|---|--|---|---|---|
| 3 | Main Entry Ramp | Ext. | | Exterior Ramp | N/A | | Edge protection < 4" high | - | Provide edge protection on the ramp that prevents the passage of a 4" diameter sphere, where any portion of the sphere is within 4" of the finished floor or ground surface. | 1 | - | - |

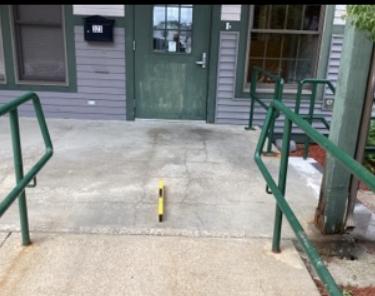
| ID | Location | Floor | Room | Element | Type | Photo | Issues | Current Measure | Recommendations | Quantity | Price | Cost Estimation |
|---|---|---|---|---|---|--|--|---|--|---|---|---|
| 4 | Main Entry Ramp | Ext. | | Exterior Ramp | N/A | | Landing has a slope > 1:50 in either direction | 3.0% | Alter so that the slope in all directions is no greater than 1:50 (2.00%)./Rebuild the ramp to ensure that the slope of the landing does not exceed 1:50 (2.00%). | 1 | - | - |

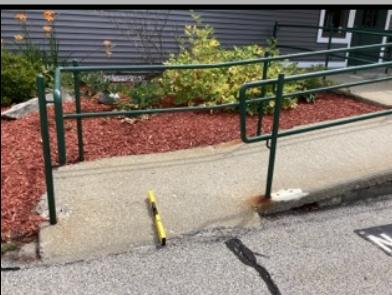
| ID | Location | Floor | Room | Element | Type | Photo | Issues | Current Measure | Recommendations | Quantity | Price | Cost Estimation |
|---|---|---|---|---|---|--|---|---|---|---|---|---|
| 5 | Southwest Side Ramp Bottom Landing | Ext. | | Exterior Ramp | N/A | | Landing has a slope > 1:50 in either direction<br>Edge protection < 4" high<br>Not maintained in operable working condition | 12%<br>-<br>- | Alter so that the slope in all directions is no greater than 1:50 (2.00%) at the landing and 1:12 (8.33%) on the ramp.<br>Provide edge protection that prevents the passage of a 4" diameter sphere, where any portion of the sphere is within 4" of the finished floor or ground surface.<br>Ensure the ramp landing is maintained in operable working condition. | 1 | - | - |

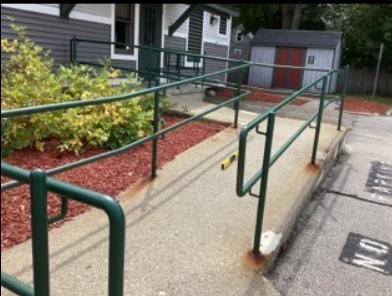
| ID | Location | Floor | Room | Element | Type | Photo | Issues | Current Measure | Recommendations | Quantity | Price | Cost Estimation |
|---|---|---|---|---|---|--|---|---|---|---|---|---|
| 6 | Southwest Side Ramp | Ext. | | Exterior Ramp | | | Running slope > 1:12 (8.33%) | 10.0% | Reduce running slope to be no steeper than 1:12 (8.33%). | 1 | - | - |

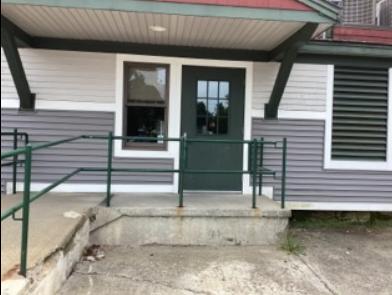
| ID | Location | Floor | Room | Element | Type | Photo | Issues | Current Measure | Recommendations | Quantity | Price | Cost Estimation |
|---|---|---|---|---|---|--|---|---|---|---|---|---|
| 7 | Southwest Side Ramp | Ext. | | Exterior Ramp | | | Ramp < 48" wide<br>Landing < 60" min. long | 43"<br>44.75" | The width of this ramp complies with the 2010 Standards for Accessible Design, but 521 CMR, the regulations of the Massachusetts Architectural Access Board (MAAB) call for a minimum width of 48". The landing at the door is also less than 60" long. Since the main entry ramp is wide enough and near by, we recommend providing a sign at this ramp directing visitors to the main entrance. | 1 | 250 | \$250 |

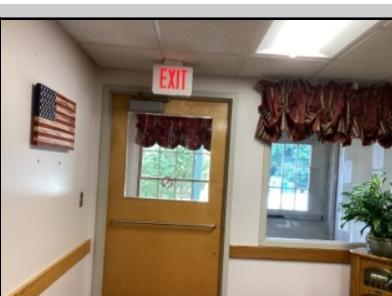
| ID | Location | Floor | Room | Element | Type | Photo | Issues | Current Measure | Recommendations | Quantity | Price | Cost Estimation |
|---|---|---|---|---|---|--|---|---|---|---|---|---|
| 8 | Main Entrance and Egress | 1 | | Means of Egress | N/A | | Tactile exit sign not provided<br>Illuminated ISA symbol not provided (MAAB) | -<br>- | Ensure that a tactile exit sign with raised characters and braille is provided at the exit door. Mount the sign between 48"- 60" above the finished floor located on the latch side of the door.<br>Provide an illuminated sign with the International Symbol of Accessibility (ISA)./When the illuminated exit sign is repaired or replaced, provide an illuminated sign with the International | 1 | 250<br>200 | \$450<br><br><b>450</b> |

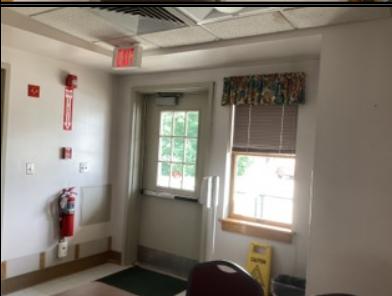
| ID | Location | Floor | Room | Element | Type | Photo | Issues | Current Measure | Recommendations | Quantity | Price | Cost Estimation |
|---|---|---|---|---|---|--|---|---|---|---|---|---|
| 9 | Main Meeting Room Egress to Ramp | 1 | | Means of Egress | N/A | | Tactile exit sign not provided<br>Illuminated ISA symbol not provided (MAAB) | -<br>- | Ensure that a tactile exit sign with raised characters and braille is provided at the exit door. Mount the sign between 48"- 60" above the finished floor located on the latch side of the door.<br>Provide an illuminated sign with the International Symbol of Accessibility (ISA)./When the illuminated exit sign is repaired or replaced, provide an illuminated sign with the International | 1 | 250<br>200 | \$450<br><br><b>450</b> |

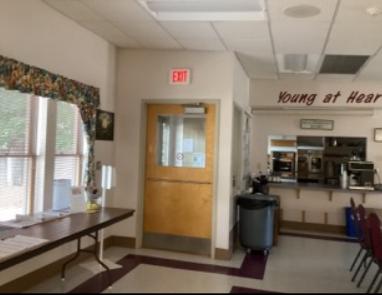
| ID | Location | Floor | Room | Element | Type | Photo | Issues | Current Measure | Recommendations | Quantity | Price | Cost Estimation |
|---|---|---|---|---|---|--|--|---|--|---|---|---|
| 10 | Main Meeting Room Southwest Egress | 1 | | Means of Egress | N/A | | Tactile exit sign not provided<br>Illuminated ISA symbol not provided (MAAB) | -<br>- | Ensure that a tactile exit sign with raised characters and braille is provided at the exit door. Mount the sign between 48"- 60" above the finished floor located on the latch side of the door.<br>Provide an illuminated sign with the International Symbol of Accessibility (ISA)./When the illuminated exit sign is repaired or replaced, provide an illuminated sign with the International | 1 | 250<br>200<br><br><b>450</b> | \$450 |

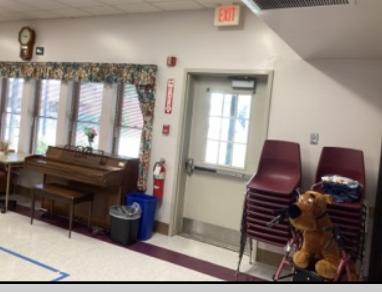
| ID | Location | Floor | Room | Element | Type | Photo | Issues | Current Measure | Recommendations | Quantity | Price | Cost Estimation |
|---|---|---|---|---|---|--|--|---|--|---|---|---|
| 11 | Main Meeting Room South Egress | 1 | | Means of Egress | N/A | | Tactile exit sign not provided<br>Illuminated ISA symbol not provided (MAAB) | -<br>- | Ensure that a tactile exit sign with raised characters and braille is provided at the exit door. Mount the sign between 48"- 60" above the finished floor located on the latch side of the door.<br>Provide an illuminated sign with the International Symbol of Accessibility (ISA)./When the illuminated exit sign is repaired or replaced, provide an illuminated sign with the International | 1 | 250<br>200<br><br><b>450</b> | \$450 |

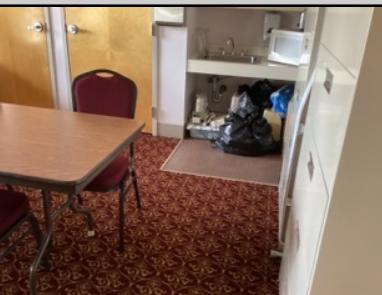
| ID | Location | Floor | Room | Element | Type | Photo | Issues | Current Measure | Recommendations | Quantity | Price | Cost Estimation |
|---|---|---|---|---|---|--|--|---|--|---|---|---|
| 12 | Conference Room | 1 | | Interior Access Route | N/A | | Route < 36" wide | 31" | Ensure that a clear width of 36" min. is maintained at the accessible route.(Reposition table.) | 1 | Labor | Labor |
