Town of Oxford

# ADA Self-Evaluation and Transition Plan

July 2024

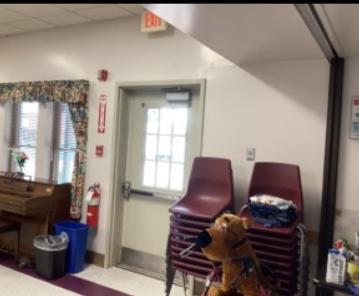
| ID | Location | Floor | Room | Element | Type | Photo | Issues | Current Measure | Recommendations | Quantity | Price | Cost Estimation |
|---|---|---|---|---|---|--|--|---|--|---|---|---|
| 16 | Main Meeting Room South Egress | 1 | | Doors, Doorways, & Gates | Emergency Egress | | Maneuvering clearance(s) not provided | 7" | Remove trash container and fire extinguisher to provide 12" min. maneuvering clearance on the push side of the door. | 1 | Labor | Labor |

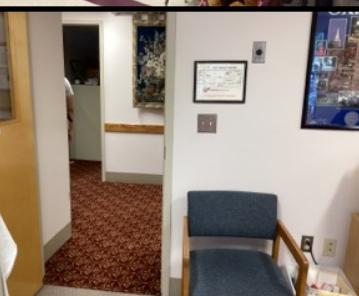
| ID | Location | Floor | Room | Element | Type | Photo | Issues | Current Measure | Recommendations | Quantity | Price | Cost Estimation |
|---|---|---|---|---|---|--|--|---|--|---|---|---|
| 17 | Director's Office | 1 | | Doors, Doorways, & Gates | Circulation | | Maneuvering clearance(s) not provided | - | Relocate furniture to provide 18" min. pull-side maneuvering clearance at the door. | 1 | Labor | Labor |

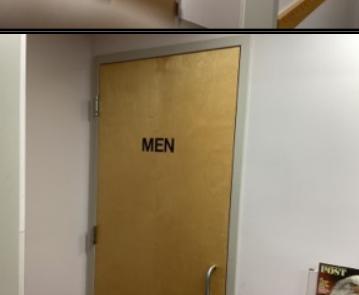
| ID | Location | Floor | Room | Element | Type | Photo | Issues | Current Measure | Recommendations | Quantity | Price | Cost Estimation |
|---|---|---|---|---|---|--|--|---|--|---|---|---|
| 19 | Men's Multi-User Toilet Room Near Main Entrance | 1 | | Signage | Designation | | Raised characters not provided on sign<br>Braille not provided on sign<br>Sign not located on the latch side of the door | -<br>-<br>- | Provide text with raised characters duplicated in braille on the sign.<br>Locate the sign at permanent rooms alongside the door on the latch side. | 1<br><br><b>250</b> | 250 | \$250 |

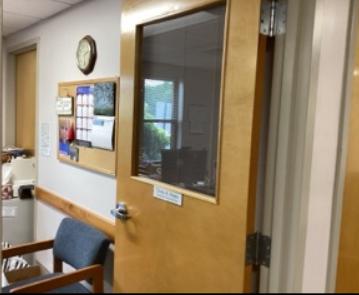
| ID | Location | Floor | Room | Element | Type | Photo | Issues | Current Measure | Recommendations | Quantity | Price | Cost Estimation |
|---|---|---|---|---|---|--|--|---|--|---|---|---|
| 20 | Outreach Office | 1 | | Signage | Designation | | Raised characters not provided on sign<br>Braille not provided on sign<br>Sign not located on the latch side of the door | -<br>-<br>- | Provide text with raised characters duplicated in braille on the sign.<br>Locate the sign at permanent rooms alongside the door on the latch side. | 1 | 250 | \$250 |

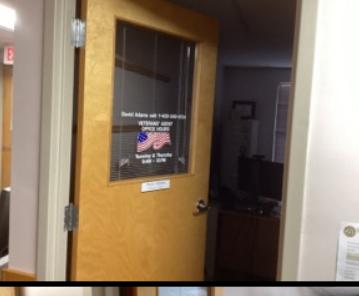
| ID | Location | Floor | Room | Element | Type | Photo | Issues | Current Measure | Recommendations | Quantity | Price | Cost Estimation |
|---|---|---|---|---|---|--|--|---|--|---|---|---|
| 21 | Veterans Office | 1 | | Signage | Designation | | Raised characters not provided on sign<br>Braille not provided on sign<br>Sign not located on the latch side of the door | -<br>-<br>- | Provide text with raised characters duplicated in braille on the sign.<br>Locate the sign at permanent rooms alongside the door on the latch side. | 1 | 250 | \$250 |

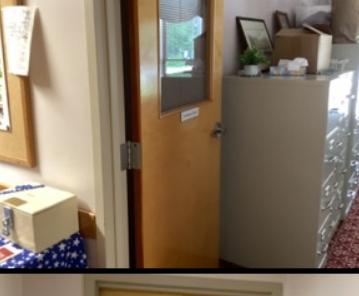
| ID | Location | Floor | Room | Element | Type | Photo | Issues | Current Measure | Recommendations | Quantity | Price | Cost Estimation |
|---|---|---|---|---|---|--|--|---|--|---|---|---|
| 22 | Conference Room | 1 | | Signage | Designation | | Raised characters not provided on sign<br>Braille not provided on sign<br>Sign not located on the latch side of the door | -<br>-<br>- | Provide text with raised characters duplicated in braille on the sign.<br>Locate the sign at permanent rooms alongside the door on the latch side. | 1 | 250 | \$250 |

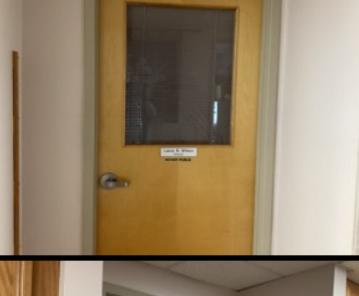
| ID | Location | Floor | Room | Element | Type | Photo | Issues | Current Measure | Recommendations | Quantity | Price | Cost Estimation |
|---|---|---|---|---|---|--|--|---|--|---|---|---|
| 23 | Director's Office | 1 | | Signage | Designation | | Raised characters not provided on sign<br>Braille not provided on sign<br>Sign not located on the latch side of the door | -<br>-<br>- | Provide text with raised characters duplicated in braille on the sign.<br>Locate the sign at permanent rooms alongside the door on the latch side. | 1 | 250 | \$250 |

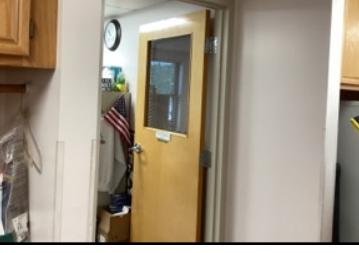
| ID | Location | Floor | Room | Element | Type | Photo | Issues | Current Measure | Recommendations | Quantity | Price | Cost Estimation |
|---|---|---|---|---|---|--|--|---|--|---|---|---|
| 24 | Director's Office | 1 | | Signage | Designation | | Raised characters not provided on sign<br>Braille not provided on sign<br>Sign not located on the latch side of the door | -<br>-<br>- | Provide text with raised characters duplicated in braille on the sign.<br>Locate the sign at permanent rooms alongside the door on the latch side. | 1 | 250 | \$250 |

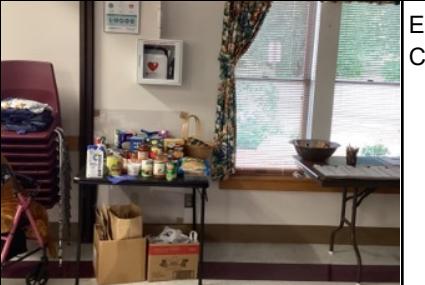
| ID | Location | Floor | Room | Element | Type | Photo | Issues | Current Measure | Recommendations | Quantity | Price | Cost Estimation |
|---|---|---|---|---|---|--|---|---|--|---|---|---|
| 25 | Main Meeting Room | 1 | | Operable Parts / Reach Range | Defibrillator | | Element not on an accessible route<br>Clear floor space is not provided | -<br>- | Ensure the defibrillator is located on an accessible route.<br>Provide a 30" min. by 48" min. clear floor space at the defibrillator. (Relocate defibrillator or relocate the table and stored items under the defibrillator.) | 1 | 500 | \$500 |

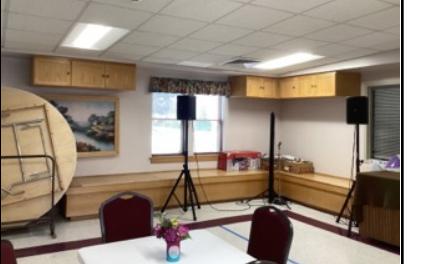
| ID | Location | Floor | Room | Element | Type | Photo | Issues | Current Measure | Recommendations | Quantity | Price | Cost Estimation |
|---|---|---|---|---|---|--|---|---|--|---|---|---|
| 26 | Main Meeting Room | 1 | | Operable Parts / Reach Range | Storage | | | | If used by members of the public, 50% or storage is not accessible. Ensure that staff is available to assist visitors who need assistance. | 1 | - | - |

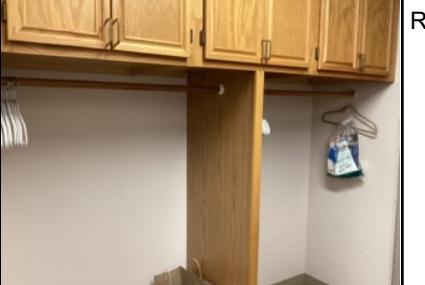
| ID | Location | Floor | Room | Element | Type | Photo | Issues | Current Measure | Recommendations | Quantity | Price | Cost Estimation |
|---|---|---|---|---|---|--|---|---|--|---|---|---|
| 27 | By Main Meeting Room | 1 | | Operable Parts / Reach Range | Clothes Rod/Hooks | | Reach < 15" or > 48"(forward/side approach) | 59" | Provide a clothes rod or hook between 15"- 48" above the finished floor. | 1 | 75 | \$75 |

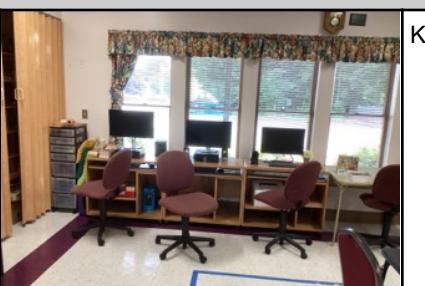
| ID | Location | Floor | Room | Element | Type | Photo | Issues | Current Measure | Recommendations | Quantity | Price | Cost Estimation |
|---|---|---|---|---|---|--|---|---|--|---|---|---|
| 28 | Main Meeting Room and Cafe | 1 | | Dining or Work Surfaces | Work Surface | | Knee or toe clearance not provided | - | Provide at least one computer work surface with 27" min. high knee and toe clearance. For children, provide at least one dining or work surface with 24" min. high knee and toe clearance. | 1 | 450 | \$450 |

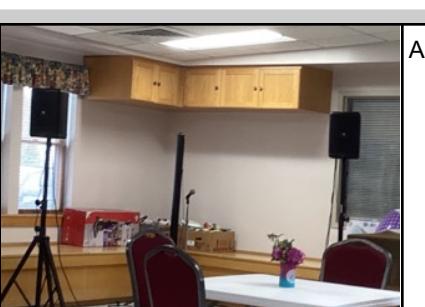
| ID | Location | Floor | Room | Element | Type | Photo | Issues | Current Measure | Recommendations | Quantity | Price | Cost Estimation |
|---|---|---|---|---|---|--|---|---|--|---|---|---|
| 29 | Main Meeting Room and Cafe | 1 | | Assembly Area | N/A | | Assistive listening devices not provided | - | If audible communication is integral to the use of the space, provide an assistive listening system. | 1 | 1578 | \$1578 |

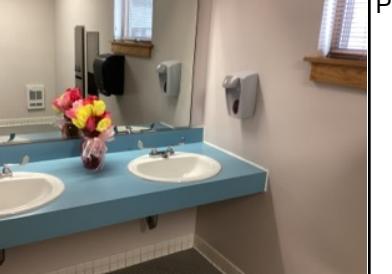
| ID | Location | Floor | Room | Element | Type | Photo | Issues | Current Measure | Recommendations | Quantity | Price | Cost Estimation |
|---|---|---|---|---|---|--|--|---|---|---|---|---|
| 31 | Women's Multi-User Toilet Room Near Main Entrance | 1 | | Lavatory | N/A | | Plumbing underneath is exposed | - | Insulate or otherwise configure pipes to prevent contact for at least one lavatory. | 1 | 150 | \$150 |

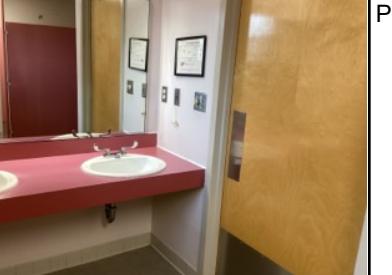
| ID | Location | Floor | Room | Element | Type | Photo | Issues | Current Measure | Recommendations | Quantity | Price | Cost Estimation |
|---|---|---|---|---|---|--|--|---|---|---|---|---|
| 32 | Men's Multi-User Toilet Room Near Main Entrance | 1 | | Lavatory | | | Plumbing underneath is exposed | - | Insulate or otherwise configure pipes to prevent contact for at least one lavatory. | 1 | 150 | \$150 |

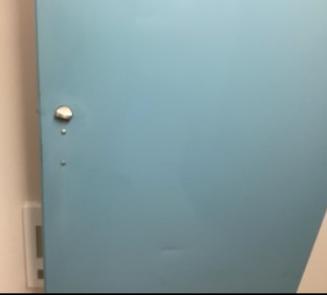
| ID | Location | Floor | Room | Element | Type | Photo | Issues | Current Measure | Recommendations | Quantity | Price | Cost Estimation |
|---|---|---|---|---|---|---|---|---|--|---|---|---|
| 34 | Women's Multi-User Toilet Room Near Main Entrance | 1 | | Toilet Compartment | Accessible Compartment | | Door has noncompliant hardware | - | Provide hardware that can be operable with one hand and not require tight grasping, pinching, or twisting of the wrist. (Install an accessible door pull.) | 1 | 91 | \$91 |

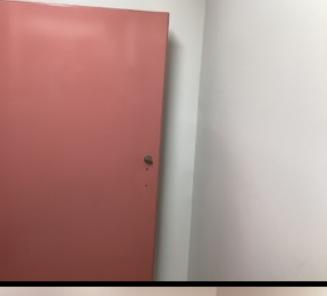
| ID | Location | Floor | Room | Element | Type | Photo | Issues | Current Measure | Recommendations | Quantity | Price | Cost Estimation |
|---|---|---|---|---|---|---|---|---|--|---|---|---|
| 35 | Men's Multi-User Toilet Room Near Main Entrance | 1 | | Toilet Compartment | Accessible Compartment | | Door has noncompliant hardware | - | Provide hardware that can be operable with one hand and not require tight grasping, pinching, or twisting of the wrist. (Install an accessible door pull.) | 1 | 70 | \$70 |

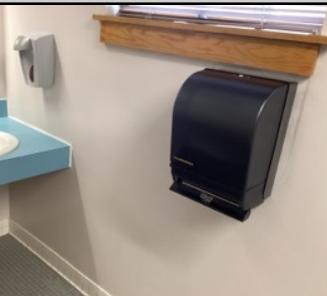
| 37 | Women's Multi-User Toilet Room Near Main Entrance | 1 | | Dispensers | Paper Towel Dispenser | | Dispenser acts as a protruding object | 10" | Relocate paper towel dispenser out of the circulation path or provide a cane-detectable barrier 27" max. above the finished floor under the paper towel dispenser. | 1 | 398 | \$398 |

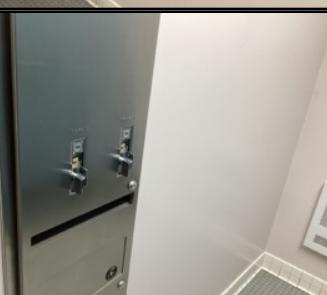
| 38 | Women's Multi-User Toilet Room Near Main Entrance | 1 | | Dispensers | Tampon Dispenser | | Noncompliant operable part | - | Provide a tampon dispenser that can be operable with one hand and not require tight grasping, pinching, or twisting of the wrist. | 1 | 1000 | \$1000 |

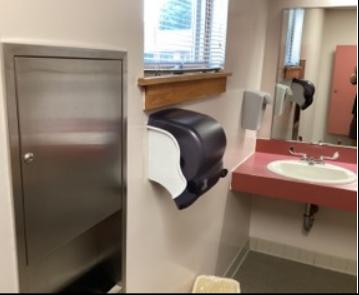
| ID | Location | Floor | Room | Element | Type | Photo | Issues | Current Measure | Recommendations | Quantity | Price | Cost Estimation |
|---|---|---|---|---|---|--|--|---|---|---|---|---|
| 39 | Men's Multi-User Toilet Room Near Main Entrance | 1 | | Dispensers | Paper Towel Dispenser | | Dispenser acts as a protruding object | 10" | Relocate paper towel dispenser out of the circulation path or provide a cane-detectable barrier 27" max. above the finished floor under the paper towel dispenser. | 1 | 398 | \$398 |

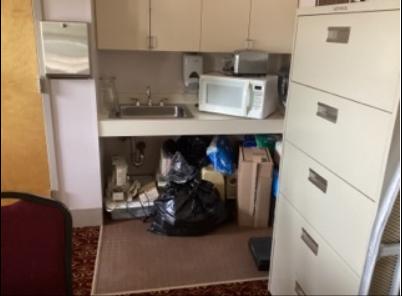
| ID | Location | Floor | Room | Element | Type | Photo | Issues | Current Measure | Recommendations | Quantity | Price | Cost Estimation |
|---|---|---|---|---|---|--|--|---|---|---|---|---|
| 40 | Conference Room | 1 | | Sink | N/A | | Toe and knee clearances not provided<br>Exposed plumbing underneath sink | -<br>- | Ensure there is a 27" min. knee clearance positioned for a forward approach.<br>Insulate or otherwise configure pipes at sink. | 1 | 150 | \$150 |

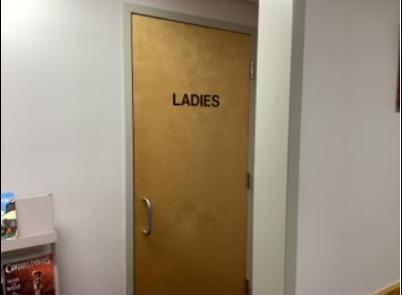
| ID | Location | Floor | Room | Element | Type | Photo | Issues | Current Measure | Recommendations | Quantity | Price | Cost Estimation |
|---|---|---|---|---|---|--|--|---|---|---|---|---|
| 41 | Toilet Rooms and Main Entrance | 1 | | Automatic Door Opener | N/A | | | | IHCD team was told by senior center staff that some visitors have expressed having difficulty in opening the main entry and egress door and the doors to the two multi-user toilet rooms. The staff indicated that there had been requests to have automatic door openers installed at each of these locations in order to make it easier for all visitors to use the main entrance and egress and to enter and exit from the toilet rooms. | 3 | Labor | Labor |

- Recommend relocating the two (2) accessible parking spaces that are at the far side of the parking lot and that are beyond the minimum required number of accessible parking spaces to a location that is closer to the building entrance.
- Recommend an adjustable height podium with knee and toe clearance.
- Recommend considering referring to the facility as the Oxford Social Center on signage, online and elsewhere. (There are online references to a 2019 vote in which the Council on Aging voted to switch to that name.)
- Recommend installing an automatic door opener at the main entrance and egress door and at the doors to the two (2) multi-user toilet rooms.

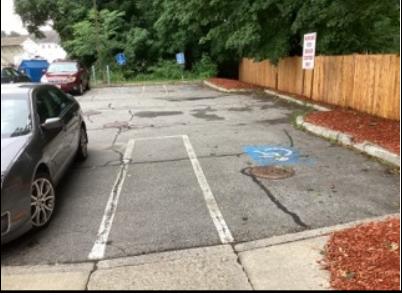
| ID | Location | Floor | Room | Element | Type | Photo | Issues | Current Measure | Recommendations | Quantity | Price | Cost Estimation |
|---|---|---|---|---|---|--|--|---|---|---|---|---|
| 42 | South Side Senior Center Parking | Ext. | | Parking | N/A | | | | If accessible spaces in excess of the required number are provided, recommend locating them at the shortest distance to the accessible entrance. The spaces shown at the far side of the lot in this image are not at as close as they could be to the accessible entrance in this lot. | 1 | - | - |

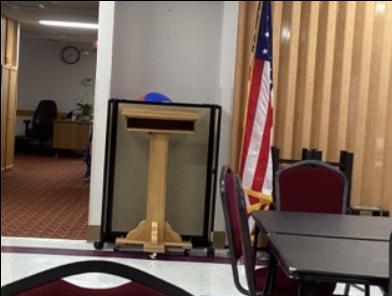
| ID | Location | Floor | Room | Element | Type | Photo | Issues | Current Measure | Recommendations | Quantity | Price | Cost Estimation |
|---|---|---|---|---|---|--|---|---|---|---|---|---|
| 43 | Main Meeting Room and Cafe | 1 | | Podium | N/A | | | | Recommend an accessible adjustable height podium with knee and toe clearance. | 1 | - | - |

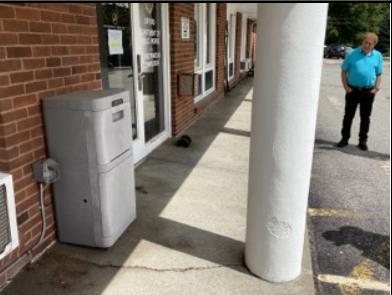
| ID | Location | Floor | Room | Element | Type | Photo | Issues | Current Measure | Recommendations | Quantity | Price | Cost Estimation |
|---|---|---|---|---|---|--|---|---|---|---|---|---|
| 1 | By Main Entrance | Ext. | | Exterior Access Route | Walkway | | Exterior route < 36" wide | 34" | Ensure that a clear width of 36" min. is maintained at the accessible route. (Relocate time stamp case.) | 1 | - | - |

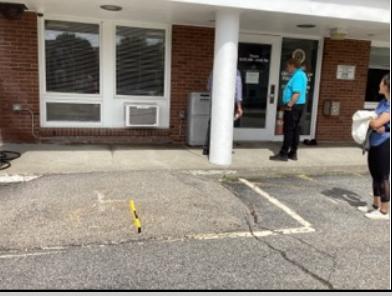
| ID | Location | Floor | Room | Element | Type | Photo | Issues | Current Measure | Recommendations | Quantity | Price | Cost Estimation |
|---|---|---|---|---|---|--|---|---|---|---|---|---|
| 2 | By Main Entrance | Ext. | | Exterior Access Route | Exterior | | Running slope > 1:20 (5.00%)<br>Level changes > 1/4" | 12.3%<br>1" | Reduce running slope to be no steeper than 1:20 (5.00%).<br>Alter change in level to be 1/4" high max. | 1 | - | - |

- Recommend reducing the change in level at the walkway directly in front of the main entry door so that, once issues with the landing at the main entry door have been corrected, there is a straight forward-facing accessible route to the main entrance. (At present, a partially accessible route to the main entry door requires accessing the walkway north of the main entrance, and then turning towards the main entry.)

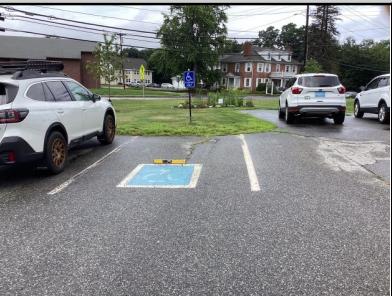
| ID | Location | Floor | Room | Element | Type | Photo | Issues | Current Measure | Recommendations | Quantity | Price | Cost Estimation |
|---|---|---|---|---|---|--|---|---|---|---|---|---|
| 3 | Parking | Ext. | | Off-Street Parking Lot or Garage | Visitor | | Total # of parking<br>Total # of designated van accessible spaces<br>Running or cross slope at space > 1:50 (2.00%)<br>Access aisle not provided<br>Sign does not have the designation "Van Accessible"<br>Sign bottom < 60" above finished grade | 19<br>1<br>5.3%<br>-<br>-<br>47" | Provide a compliant van accessible parking space. Reduce running or cross slope to be no steeper than 1:50 (2.00%). Provide a marked access aisle that is at least 96" wide.<br>Add the designation "Van Accessible" to the sign located at the van accessible space.<br>Locate sign with the bottom of the sign 60" above the ground.<br>(Cost is for a parking designation sign.) | 1 | 500 | \$500 |

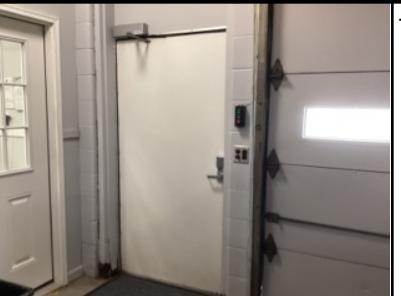
| ID | Location | Floor | Room | Element | Type | Photo | Issues | Current Measure | Recommendations | Quantity | Price | Cost Estimation |
|---|---|---|---|---|---|--|--|---|--|---|---|---|
| 5 | Southeast Side Egress | 1 | | Means of Egress | N/A | | Tactile exit sign not provided<br>Directional sign to accessible emergency exit not provided | -<br>- | Ensure that a tactile exit sign with raised characters and braille is provided at the exit door. Mount the sign between 48"- 60" above the finished floor located on the latch side of the door.<br>Provide a directional sign indicating the location of the nearest accessible emergency exit. | 2 | 250 | \$500 |

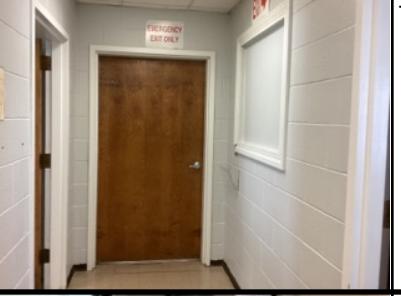
| ID | Location | Floor | Room | Element | Type | Photo | Issues | Current Measure | Recommendations | Quantity | Price | Cost Estimation |
|---|---|---|---|---|---|--|--|---|--|---|---|---|
| 6 | Route to Southeast Egress | 1 | | Means of Egress | N/A | | Tactile exit sign not provided<br>Directional sign to accessible emergency exit not provided | -<br>- | Ensure that a tactile exit sign with raised characters and braille is provided at the exit door. Mount the sign between 48"- 60" above the finished floor located on the latch side of the door.<br>Provide a directional sign indicating the location of the nearest accessible emergency exit. | 1 | 250 | \$250 |

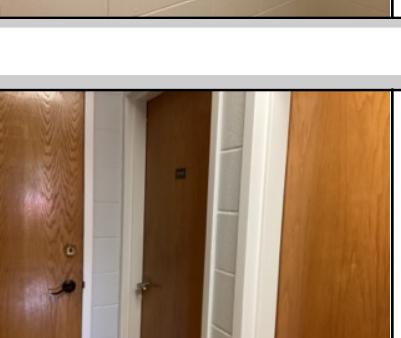
| ID | Location | Floor | Room | Element | Type | Photo | Issues | Current Measure | Recommendations | Quantity | Price | Cost Estimation |
|---|---|---|---|---|---|--|--|---|--|---|---|---|
| 9 | Women's Single-User Toilet Room | 1 | | Doors, Doorways, & Gates | Toilet Room | | Maneuvering clearance(s) not provided | 3 | If when this toilet room is renovated this push-side door has a latch and a closer but lacks the minimum required 12" maneuvering clearance at the door, provide an automatic door opener. | 1 | - | - |

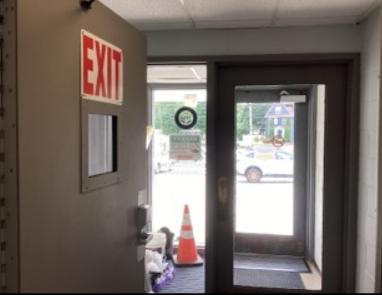
| ID | Location | Floor | Room | Element | Type | Photo | Issues | Current Measure | Recommendations | Quantity | Price | Cost Estimation |
|---|---|---|---|---|---|--|--|---|---|---|---|---|
| 10 | Main Egress | 1 | | Doors, Doorways, & Gates | Emergency Egress | | Door requires > 5 lbs. of force to open | 15 lbs. | Adjust closers on the two interior doors so doors do not require more than 5 pounds of force to open. | 2 | Labor | Labor |

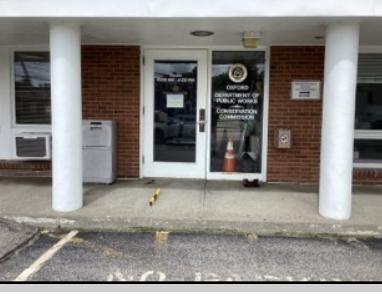
| ID | Location | Floor | Room | Element | Type | Photo | Issues | Current Measure | Recommendations | Quantity | Price | Cost Estimation |
|---|---|---|---|---|---|--|--|---|---|---|---|---|
| 11 | Main Entrance | Ext. | | Doors, Doorways, & Gates | Emergency Egress | | Maneuvering clearance at door > 1:50 (2.00%) | 5.6% | Alter so that the slope in all directions is no greater than 1:50 (2.00%). | 1 | - | - |

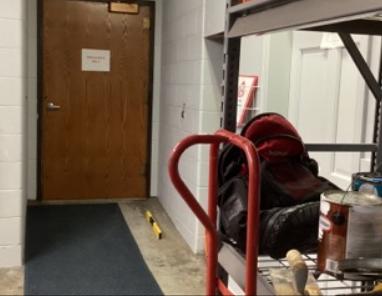
| ID | Location | Floor | Room | Element | Type | Photo | Issues | Current Measure | Recommendations | Quantity | Price | Cost Estimation |
|---|---|---|---|---|---|--|--|---|---|---|---|---|
| 12 | Route to Southeast Egress | 1 | | Ramps | Interior | | Running slope >1:12 (8.33%) | 8.9% | Further study will be needed to determine whether it is technically feasible to bring the ramp into full compliance with the ADA Standards. | 1 | - | - |

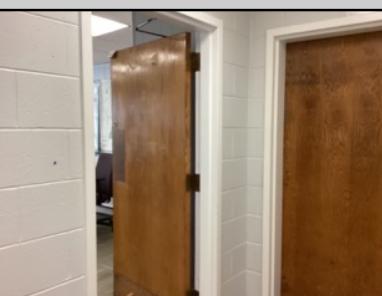
| ID | Location | Floor | Room | Element | Type | Photo | Issues | Current Measure | Recommendations | Quantity | Price | Cost Estimation |
|---|---|---|---|---|---|--|--|---|---|---|---|---|
| 13 | Conference Room | 1 | | Signage | Designation | | Signage is not provided | - | Locate compliant signage with raised characters and braille alongside the door on the latch side. | 1 | 250 | \$250 |

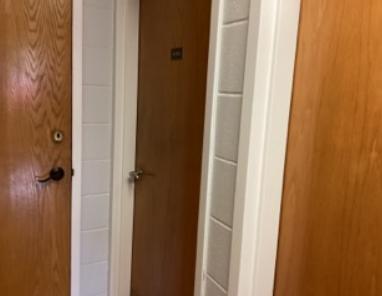
| ID | Location | Floor | Room | Element | Type | Photo | Issues | Current Measure | Recommendations | Quantity | Price | Cost Estimation |
|---|---|---|---|---|---|--|--|---|---|---|---|---|
| 14 | Women's Single-User Toilet Room | 1 | | Signage | Designation | | Raised characters not provided on sign<br>Braille not provided on sign<br>Sign not located on the latch side of the door | -<br>-<br>- | Provide text with raised characters duplicated in braille on the sign.<br>Locate the sign at permanent rooms alongside the door on the latch side.<br>Note: Recommend making this an accessible all-gender toilet room with an all-gender toilet room sign once the toilet room has been made accessible. | 1 | 250 | \$250 |

Note: Three (3) other toilet rooms have more significant accessibility issues than what are present in the women's single-user toilet room. Recommend designating the neighboring women's and men's single-user toilet rooms as all-gender, correcting the accessibility issues in the women's single-user toilet room, and providing signs at the three other toilet rooms identifying the location of the accessible all-gender single-user toilet room once the women's single-user toilet room has been renovated and made accessible.

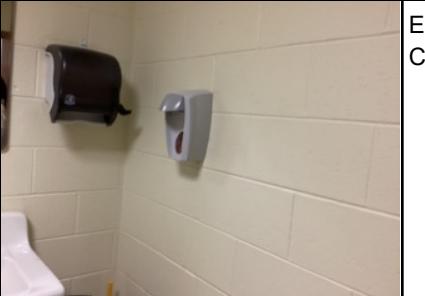
| ID | Location | Floor | Room | Element | Type | Photo | Issues | Current Measure | Recommendations | Quantity | Price | Cost Estimation |
|---|---|---|---|---|---|--|---|---|---|---|---|---|
| 15 | Women's Single-User Toilet Room | 1 | | Operable Parts / Reach Range | Paper Towel Dispenser | | Element not on an accessible route<br>Clear floor space is not provided | -<br>- | Ensure paper towel dispenser is located on an accessible route. Provide a 30" min. by 48" min. clear floor space at the dispenser, and ensure the control for dispensing paper towels is 48" max. above the finished floor. When paper towel dispenser is relocated ensure it does not protrude more than 4" into the circulation path or provide a cane-detectable barrier under the dispenser. | 1 | 500 | \$500 |

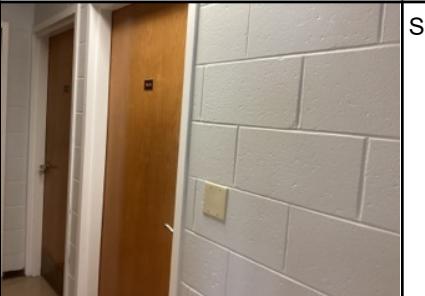
| ID | Location | Floor | Room | Element | Type | Photo | Issues | Current Measure | Recommendations | Quantity | Price | Cost Estimation |
|---|---|---|---|---|---|--|---|---|---|---|---|---|
| 16 | Men's Single-User Toilet Room | 1 | | Overall Access | Toilet Room | | Sign to accessible toilet not provided | - | Provide a directional sign indicating the location of the nearest accessible toilet room. (Provide directional signs to the accessible all-gender toilet room at the three other inaccessible toilet rooms once the women's single user toilet room has been made accessible and designated as all-gender. The men's single user toilet room should also be designated as all-gender as well, but it does not need to be made accessible. | 3 | 250 | \$750 |

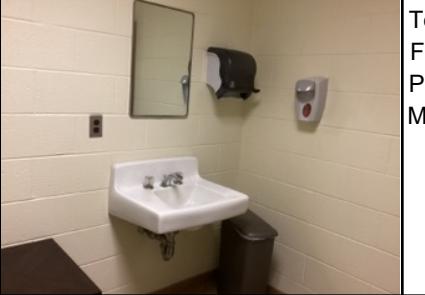
| ID | Location | Floor | Room | Element | Type | Photo | Issues | Current Measure | Recommendations | Quantity | Price | Cost Estimation |
|---|---|---|---|---|---|--|---|---|---|---|---|---|
| 17 | Women's Single-User Toilet Room | 1 | | Lavatory | N/A | | Toe or knee clearances not provided<br>Faucet is not compliant<br>Plumbing underneath is exposed<br>Mirror above lavatory w/reflective surface > 40" | 25"<br>-<br>-<br>48" | Provide at least one lavatory with knee and toe clearance positioned for a forward approach.<br>Provide a faucet that can be operable with one hand and not require tight grasping, pinching, or twisting of the wrist for at least one lavatory.<br>Insulate or otherwise configure pipes to prevent contact for at least one lavatory.<br>Lower mirror so that the bottom surface is at 40" max. above the finished floor. | 1 | 2192<br>1282<br>150<br>500 | \$4124 |

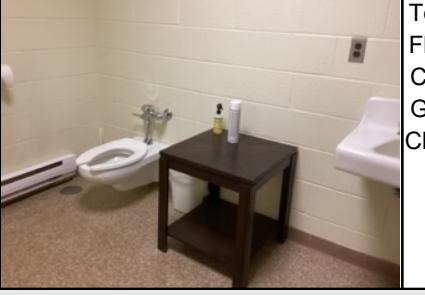
| ID | Location | Floor | Room | Element | Type | Photo | Issues | Current Measure | Recommendations | Quantity | Price | Cost Estimation |
|---|---|---|---|---|---|--|---|---|---|---|---|---|
| 18 | Women's Single-User Toilet Room | 1 | | Single-User Toilet | N/A | | Toilet seat < 17" or > 19" high<br>Flush control not on open side<br>Centerline < or > 18" (MAAB)<br>Grab bar not provided<br>Clearance at toilet < 60" clear width | 16.5"<br>-<br>24"<br>-<br>- | Install a toilet with a seat between 17"- 19" high above the finished floor.<br>Relocate the flush control to the open side.<br>Relocate toilet so that the centerline is 18" from the side wall.<br>Provide one grab bar on the side wall of the toilet and one on the rear wall.<br>Relocate table to ensure that there is 60" wide min. clear floor space at the toilet. | 1 | -<br>486<br>3676<br>1950<br>- | \$6112 |

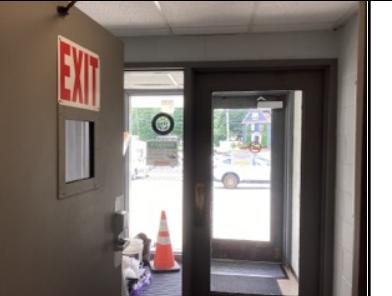
| ID | Location | Floor | Room | Element | Type | Photo | Issues | Current Measure | Recommendations | Quantity | Price | Cost Estimation |
|---|---|---|---|---|---|--|---|---|--|---|---|---|
| 19 | Main Egress | 1 | | Egress Signage | N/A | | | | Recommend, at the final egress door that leads directly to the exterior of the building, providing an illuminated exit sign with an illuminated International Symbol of Accessibility (ISA). | 1 | - | - |

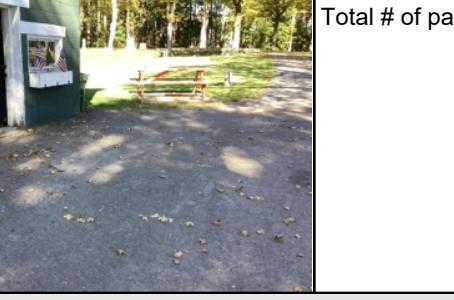
| ID | Location | Floor | Room | Element | Type | Photo | Issues | Current Measure | Recommendations | Quantity | Price | Cost Estimation |
|---|---|---|---|---|---|--|---|---|---|---|---|---|
| 1 | Parking | | | Off-Street Parking Lot or Garage | Visitor | | Total # of parking | 1 | Provide a marked access aisle 96' wide min. <b>Note:</b> When just one parking space is available to members of the public, an identification sign with the international Symbol of Accessibility (ISA) is not required, and all visitors can use the parking space. <b>Recommend as a best practice recommendation</b> , if space permits, marking the space and access aisle in the unpaved lot as shown in the narrative report. | 1 | Labor | Labor |

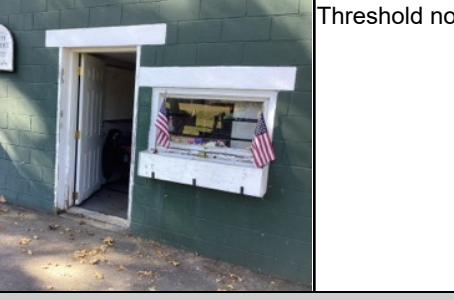
| ID | Location | Floor | Room | Element | Type | Photo | Issues | Current Measure | Recommendations | Quantity | Price | Cost Estimation |
|---|---|---|---|---|---|--|---|---|---|---|---|---|
| 2 | Entrance | | | Doors, Doorways, & Gates | Office | | Threshold not beveled | 2" | Bevel the threshold and ensure it is no higher than 1/2" .. | 1 | 1000 | \$1000 |

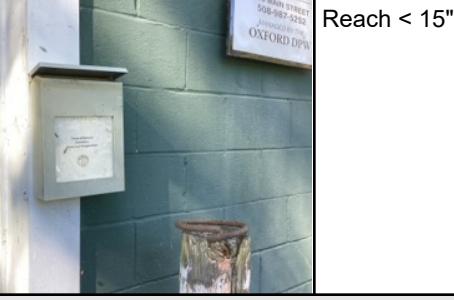
| ID | Location | Floor | Room | Element | Type | Photo | Issues | Current Measure | Recommendations | Quantity | Price | Cost Estimation |
|---|---|---|---|---|---|--|---|---|---|---|---|---|
| 3 | By Main Entrance | | | Operable Parts / Reach Range | Other | | Reach < 15" or > 48"(forward/side approach) | 62" | Relocate the opening of the dispenser with cemetery information to between 15"- 48" above the ground. | 1 | Labor | Labor |

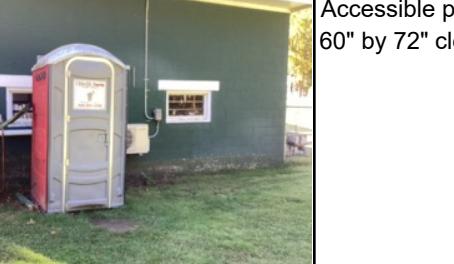
| ID | Location | Floor | Room | Element | Type | Photo | Issues | Current Measure | Recommendations | Quantity | Price | Cost Estimation |
|---|---|---|---|---|---|--|---|---|---|---|---|---|
| 4 | By Building | | | Portable Toilet | N/A | | Accessible portable toilets not provided<br>60" by 72" clear space not provided | - | Ensure that at least 5% of portable toilets are accessible.<br>Provide an accessible portable toilet that has 60" wide and 72" deep at the toilet. | 1 | 4600 | \$4600 |

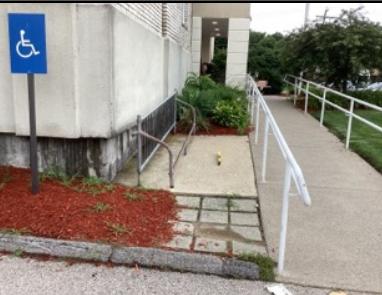
| ID | Location | Floor | Room | Element | Type | Photo | Issues | Current Measure | Recommendations | Quantity | Price | Cost Estimation |
|---|---|---|---|---|---|--|---|---|--|---|---|---|
| 1 | By Ramp | Ext. | | Exterior Access Route | Exterior | | Accessible route not provided | 4" | Ensure an accessible route is provided to the bike rack or relocate bike rack to an accessible location.<br><b>Note:</b> The slope at the bike rack should be no more than 1:50 (2.00%) in all directions. | 1 | - | - |

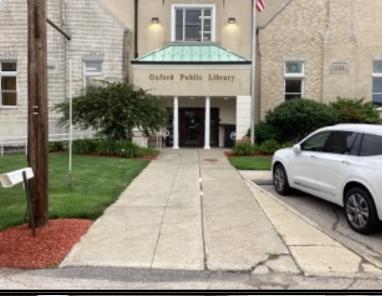
| ID | Location | Floor | Room | Element | Type | Photo | Issues | Current Measure | Recommendations | Quantity | Price | Cost Estimation |
|---|---|---|---|---|---|--|---|---|--|---|---|---|
| 2 | Walkway to Main Entrance | Ext. | | Exterior Access Route | Walkway | | Running slope > 1:20 (5.00%) | 7.4% | Reduce running slope to be no steeper than 1:20 (5.00%). | 1 | - | - |

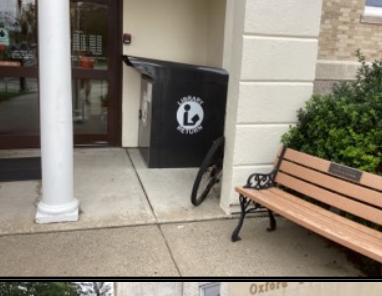
| ID | Location | Floor | Room | Element | Type | Photo | Issues | Current Measure | Recommendations | Quantity | Price | Cost Estimation |
|---|---|---|---|---|---|--|---|---|--|---|---|---|
| 3 | By Main Entrance | Ext. | | Exterior Access Route | Exterior | | Obstructed by protruding objects | 11" | Provide a cane-detectable barrier skirt similar to what would be provided at a standing height drinking fountain if it protruded into the accessible route. | 1 | 398 | \$398 |

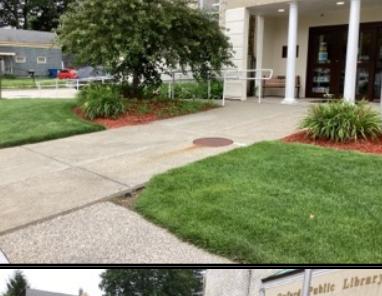
| ID | Location | Floor | Room | Element | Type | Photo | Issues | Current Measure | Recommendations | Quantity | Price | Cost Estimation |
|---|---|---|---|---|---|--|---|---|--|---|---|---|
| 4 | By Main Entrance | Ext. | | Exterior Access Route | Walkway | | Level changes > 1/4" | 1." | Alter change in level to be 1/4" high max. | 1 | - | - |

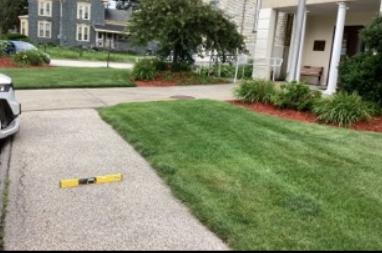
| ID | Location | Floor | Room | Element | Type | Photo | Issues | Current Measure | Recommendations | Quantity | Price | Cost Estimation |
|---|---|---|---|---|---|--|---|---|--|---|---|---|
| 5 | By Main Entrance | Ext. | | Exterior Access Route | Walkway | | Cross slope > 1:50 (2.00%) | 4% | Reduce cross slope to be no steeper than 1:50 (2.00%). | 1 | - | - |

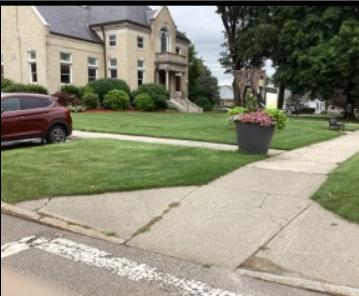
| ID | Location | Floor | Room | Element | Type | Photo | Issues | Current Measure | Recommendations | Quantity | Price | Cost Estimation |
|---|---|---|---|---|---|--|---|---|---|---|---|---|
| 6 | Sigourney Street | Ext. | | Exterior Access Route | Exterior | | Route not maintained in operable working condition | - | Ensure the accessible route is maintained in operable working condition. | 1 | - | - |

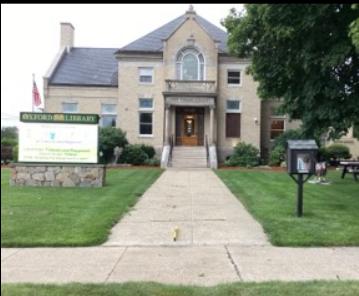
| ID | Location | Floor | Room | Element | Type | Photo | Issues | Current Measure | Recommendations | Quantity | Price | Cost Estimation |
|---|---|---|---|---|---|--|---|---|---|---|---|---|
| 7 | Main Street Entrance | Ext. | | Exterior Access Route | Walkway | | Running slope > 1:20 (5.00%) | 14.% | Reduce running slope to be no steeper than 1:20 (5.00%). | 1 | - | - |

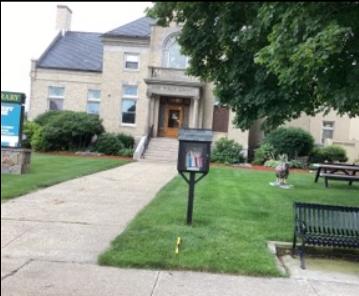
| ID | Location | Floor | Room | Element | Type | Photo | Issues | Current Measure | Recommendations | Quantity | Price | Cost Estimation |
|---|---|---|---|---|---|--|---|---|---|---|---|---|
| 8 | Main Street | Ext. | | Exterior Access Route | Exterior | | Running slope > 1:20 (5.00%)<br>Accessible route not provided | 14%<br>- | Reduce running slope to be no steeper than 1:20 (5.00%).<br>Ensure an accessible route is provided to book exchange. | 1 | - | - |

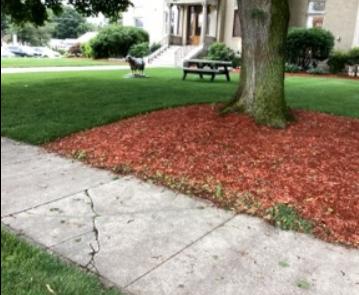
| ID | Location | Floor | Room | Element | Type | Photo | Issues | Current Measure | Recommendations | Quantity | Price | Cost Estimation |
|---|---|---|---|---|---|--|---|---|---|---|---|---|
| 9 | Main Street | Ext. | | Exterior Access Route | Walkway | | Route not maintained in operable working condition | - | Ensure the accessible route is maintained in operable working condition. | 1 | - | - |

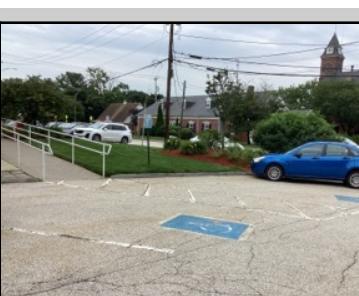
| ID | Location | Floor | Room | Element | Type | Photo | Issues | Current Measure | Recommendations | Quantity | Price | Cost Estimation |
|---|---|---|---|---|---|--|---|---|---|---|---|---|
| 10 | Parking | Ext. | | Off-Street Parking Lot or Garage | N/A | | Total # of parking<br>Total # of designated car accessible parking spaces<br>Total # of designated van accessible spaces<br>Access aisle < 96" wide at van space<br>Sign does not have the designation "Van Accessible"<br>Sign bottom < 60" above finished grade | 14<br>1<br>1<br>60"<br>-<br>48" | Provide a marked access aisle that is at least 96" wide. (Re-stripe access aisle.)<br><b>Note:</b> With angled parking spaces, the access aisle serving a van accessible parking space must be on the passenger side.<br>Add the designation "Van Accessible" to the sign located at the van accessible space.<br>Locate sign with the bottom of the sign 60" above the ground. | 1 | 300<br>500<br><br><b>800</b> | \$800 |

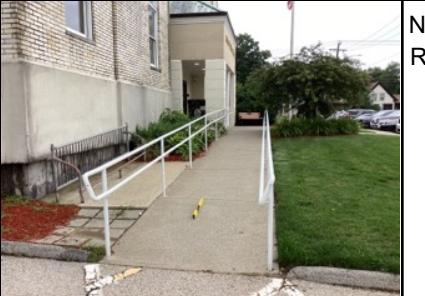
| ID | Location | Floor | Room | Element | Type | Photo | Issues | Current Measure | Recommendations | Quantity | Price | Cost Estimation |
|---|---|---|---|---|---|--|--|---|---|---|---|---|
| 11 | Main Entry Ramp | Ext. | | Exterior Ramp | N/A | | No lower handrail 18"-20" high provided<br>Running slope > 1:12 (8.33%) | 27"<br>12% | Provide a lower handrail between 18" to 20" high above the ground.<br>Reduce running slope on ramp to be no steeper than 1:12 (8.33%). | 1 | - | - |

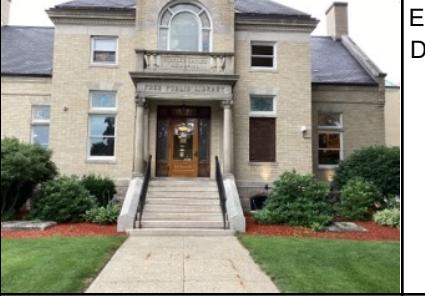
| ID | Location | Floor | Room | Element | Type | Photo | Issues | Current Measure | Recommendations | Quantity | Price | Cost Estimation |
|---|---|---|---|---|---|--|--|---|---|---|---|---|
| 12 | Main Street Entrance | Ext. | | Entrance | Secondary Entrance | | Entrance not on an accessible route<br>Directional sign to accessible entrance not provided | -<br>- | Provide a directional sign indicating the location of the nearest accessible entrance. | 1 | 450 | \$450 |

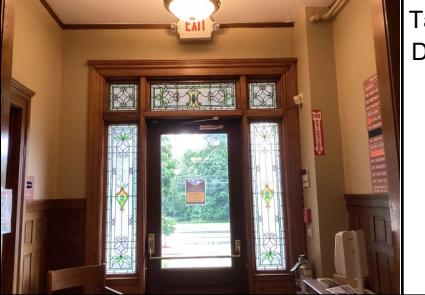
| ID | Location | Floor | Room | Element | Type | Photo | Issues | Current Measure | Recommendations | Quantity | Price | Cost Estimation |
|---|---|---|---|---|---|--|--|---|---|---|---|---|
| 13 | Main Street Egress | 1 | 103 | Means of Egress | N/A | | Tactile exit sign not provided<br>Directional sign to accessible emergency exit not provided | +- | Ensure that a tactile exit sign with raised characters and braille is provided at the exit door. Mount the sign between 48"- 60" above the finished floor located on the latch side of the door.<br>Provide a directional sign indicating the location of the nearest accessible emergency exit. | 2 | 250 | \$500 |

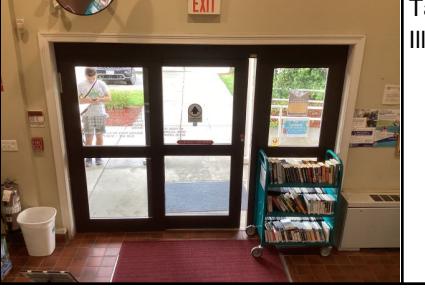
| ID | Location | Floor | Room | Element | Type | Photo | Issues | Current Measure | Recommendations | Quantity | Price | Cost Estimation |
|---|---|---|---|---|---|--|--|---|---|---|---|---|
| 14 | Main Egress | 1 | 213 | Means of Egress | N/A | | Tactile exit sign not provided<br>Illuminated ISA symbol not provided (MAAB) | -<br>- | Ensure that a tactile exit sign with raised characters and braille is provided at the exit door. Mount the sign between 48"- 60" above the finished floor located on the latch side of the door.<br>When the illuminated exit sign is repaired or replaced, provide an illuminated sign with the International Symbol of Accessibility (ISA). | 1 | 250<br>200 | \$450 |

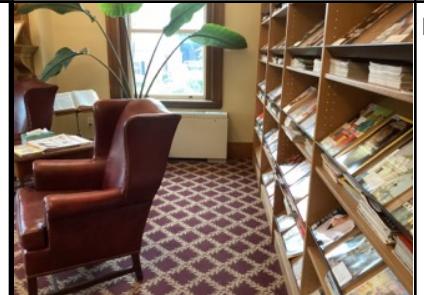
| ID | Location | Floor | Room | Element | Type | Photo | Issues | Current Measure | Recommendations | Quantity | Price | Cost Estimation |
|---|---|---|---|---|---|--|---|---|--|---|---|---|
| 15 | Reading Area | 1 | 103 | Interior Access Route | N/A | | Route < 36" wide | 26" | Ensure that a clear width of 36" min. is maintained at the accessible route.(Relocate furniture.) | 1 | Labor | Labor |

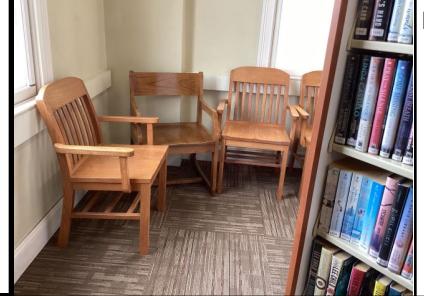
| ID | Location | Floor | Room | Element | Type | Photo | Issues | Current Measure | Recommendations | Quantity | Price | Cost Estimation |
|---|---|---|---|---|---|--|---|---|--|---|---|---|
| 16 | Stacks | 1 | | Interior Access Route | N/A | | Route < 36" wide | 34" | Ensure that a clear width of 36" min. is maintained at the accessible route. (Relocate furniture.) | 1 | Labor | Labor |

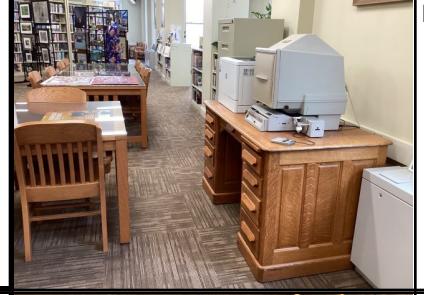
| ID | Location | Floor | Room | Element | Type | Photo | Issues | Current Measure | Recommendations | Quantity | Price | Cost Estimation |
|---|---|---|---|---|---|--|---|---|--|---|---|---|
| 17 | Reading Area | 1 | | Interior Access Route | N/A | | Route < 36" wide | 28" | Ensure that a clear width of 36" min. is maintained at the accessible route. (Reposition furniture.) | 1 | Labor | Labor |

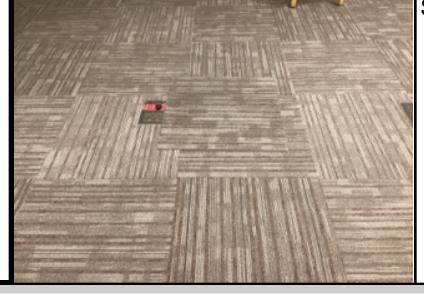
| ID | Location | Floor | Room | Element | Type | Photo | Issues | Current Measure | Recommendations | Quantity | Price | Cost Estimation |
|---|---|---|---|---|---|--|---|---|--|---|---|---|
| 18 | Meeting Room | B | B15 | Interior Access Route | N/A | | Surface not stable, firm, and slip-resistant | - | Repair surface. Secure loose carpet squares. | 1 | Labor | Labor |

Accessibility issues include lack of the minimum required clear width at multiple locations due to the location of furniture and stored items. There is also lack of a stable, firm and slip resistant surface at multiple locations in the basement meeting room due to the presence of loose carpet squares.

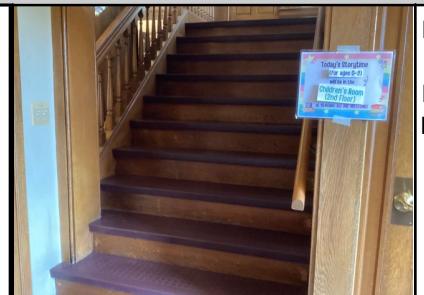
| ID | Location | Floor | Room | Element | Type | Photo | Issues | Current Measure | Recommendations | Quantity | Price | Cost Estimation |
|---|---|---|---|---|---|--|---|---|--|---|---|---|
| 19 | Third Staircase | 1 | | Stairways | Interior | | Handrail height < 34" or > 38"<br>Handrails do not extend 12" from stairs<br>Handrails have noncompliant cross section<br>Handrails not continuous where required | 32"<br>-<br>- | Alter so the handrails are 34"- 38" high above the floor.<br>Bottom: Ensure that the handrail extends at least 12" plus the width of one tread beyond the bottom riser or return properly.<br>Provide handrails with 1 1/4" - 2" circular cross sections.<br>Provide continuous handrails on both sides. | 1 | - | - |

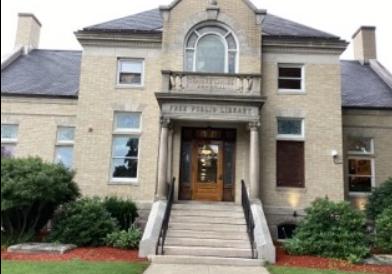
| ID | Location | Floor | Room | Element | Type | Photo | Issues | Current Measure | Recommendations | Quantity | Price | Cost Estimation |
|---|---|---|---|---|---|--|--|---|---|---|---|---|
| 20 | Main Street Entrance | Ext. | | Stairways | Exterior | | Handrails do not extend 12" from stairs | 9" | Top: Ensure handrails extend horizontally above the landing for 12" min. beginning above the first riser nosing. Bottom: Ensure that the handrail extends at least 12" plus the width of one tread beyond the bottom riser. | 1 | - | - |

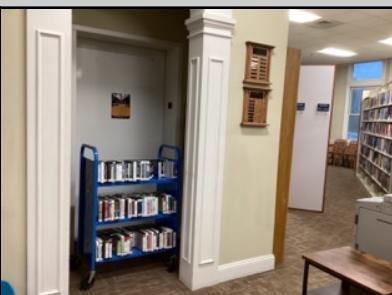
| ID | Location | Floor | Room | Element | Type | Photo | Issues | Current Measure | Recommendations | Quantity | Price | Cost Estimation |
|---|---|---|---|---|---|--|--|---|---|---|---|---|
| 21 | Elevator | B | | Elevator | Interior | | | | <b>Note:</b> On the day of the survey the elevator was in the process of being refurbished and serviced and was not surveyed because it was not available for use. | 1 | - | - |

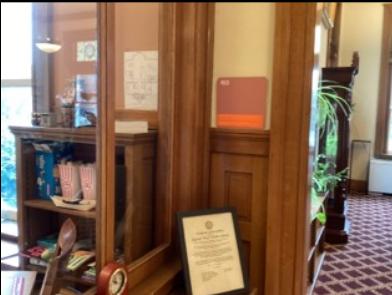
| ID | Location | Floor | Room | Element | Type | Photo | Issues | Current Measure | Recommendations | Quantity | Price | Cost Estimation |
|---|---|---|---|---|---|--|--|---|---|---|---|---|
| 22 | Reading Area | 1 | 103 | Signage | Designation | | Signage lacks 18" by 18" clear floor space | - | Relocate stored items to provide a clear floor space of 18" min. by 18" min. at the sign. | 1 | Labor | Labor |

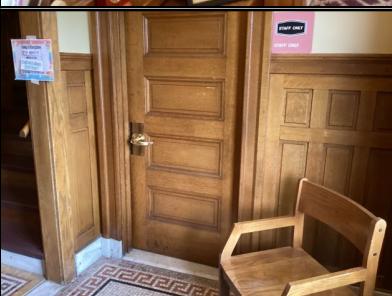
| ID | Location | Floor | Room | Element | Type | Photo | Issues | Current Measure | Recommendations | Quantity | Price | Cost Estimation |
|---|---|---|---|---|---|--|--|---|---|---|---|---|
| 23 | By Main Street Egress | 1 | | Signage | Designation | | Sign not located on the latch side of the door<br>Signage lacks 18" by 18" clear floor space | -<br>- | Locate the sign at permanent rooms alongside the door on the latch side.<br>Relocate the sign to provide a clear floor space of 18" min. by 18" min. | 1 | Labor | Labor |

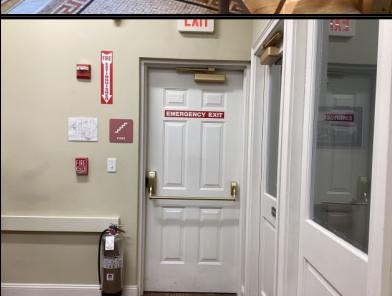
| ID | Location | Floor | Room | Element | Type | Photo | Issues | Current Measure | Recommendations | Quantity | Price | Cost Estimation |
|---|---|---|---|---|---|--|--|---|---|---|---|---|
| 24 | By Director's Office | 1 | | Signage | Designation | | Signage lacks 18" by 18" clear floor space | - | Relocate fire extinguisher to provide a clear floor space of 18" min. by 18" min. below the sign. | 1 | Labor | Labor |

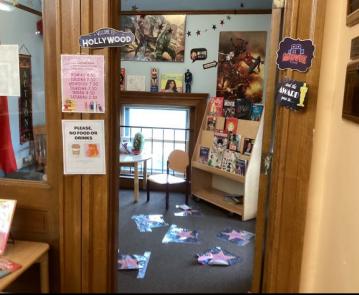
| ID | Location | Floor | Room | Element | Type | Photo | Issues | Current Measure | Recommendations | Quantity | Price | Cost Estimation |
|---|---|---|---|---|---|--|--|---|--|---|---|---|
| 25 | Children's Discovery Room | 2 | | Signage | Designation | | Raised characters not provided on sign<br>Braille not provided on sign | -<br>- | Provide text with raised characters duplicated in braille on the sign.<br>Provide braille on the sign. | 1 | 250 | \$250 |

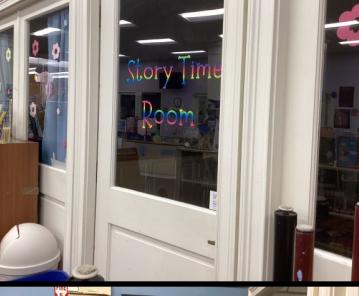
| ID | Location | Floor | Room | Element | Type | Photo | Issues | Current Measure | Recommendations | Quantity | Price | Cost Estimation |
|---|---|---|---|---|---|--|--|---|--|---|---|---|
| 26 | Story Time Room | 2 | | Signage | Designation | | Raised characters not provided on sign<br>Braille not provided on sign<br>Sign not located on the latch side of the door | -<br>-<br>+ | Provide text with raised characters duplicated in braille on the sign.<br>Provide braille on the sign.<br>Locate the sign at permanent rooms alongside the door on the latch side. | 1 | 250 | \$250 |

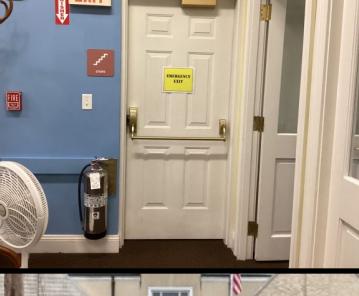
| ID | Location | Floor | Room | Element | Type | Photo | Issues | Current Measure | Recommendations | Quantity | Price | Cost Estimation |
|---|---|---|---|---|---|--|--|---|--|---|---|---|
| 27 | Near Children's Librarian Office | 2 | | Signage | Designation | | Signage lacks 18" by 18" clear floor space | - | Relocate fire extinguisher to provide a clear floor space of 18" min. by 18" min. below the sign. | 1 | Labor | Labor |

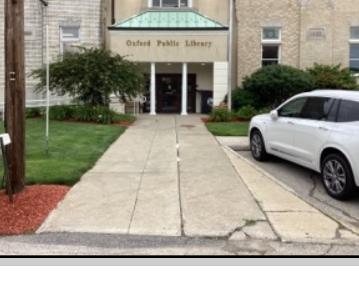
| ID | Location | Floor | Room | Element | Type | Photo | Issues | Current Measure | Recommendations | Quantity | Price | Cost Estimation |
|---|---|---|---|---|---|--|--|---|--|---|---|---|
| 28 | Walkway to Main Entrance | Ext. | | Signage | Designation | | Signage is not provided | - | Locate compliant signage with raised characters and braille alongside the entry door on the latch side. (Sign should duplicate the "Oxford Public Library" text written above the main entrance to the library.) | 1 | 450 | \$450 |

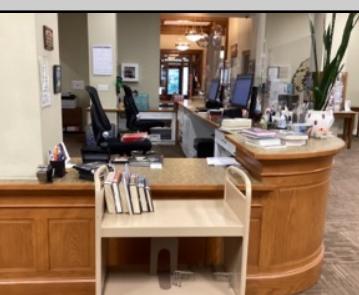
| ID | Location | Floor | Room | Element | Type | Photo | Issues | Current Measure | Recommendations | Quantity | Price | Cost Estimation |
|---|---|---|---|---|---|--|--|---|--|---|---|---|
| 29 | Checkout Counter | 1 | | Service Counter | N/A | | Counter not connected to an accessible route | - | Ensure the counter is connected to an accessible route. (Relocate cart stored in front of the accessible portion of the counter.) | 1 | Labor | Labor |

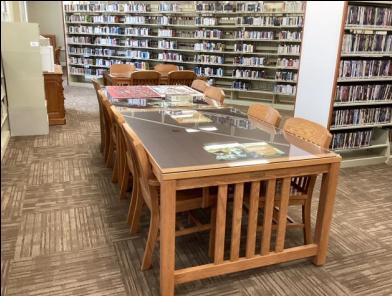
| ID | Location | Floor | Room | Element | Type | Photo | Issues | Current Measure | Recommendations | Quantity | Price | Cost Estimation |
|---|---|---|---|---|---|--|---|---|---|---|---|---|
| 30 | Reading Area | 1 | | Dining or Work Surfaces | Work Surface | | Knee or toe clearance not provided | 25.5" | Provide at least one work surface with 27" min. high knee and toe clearance. For children, provide at least one dining or work surface with 24" min. high knee and toe clearance. | 1 | 910 | \$910 |

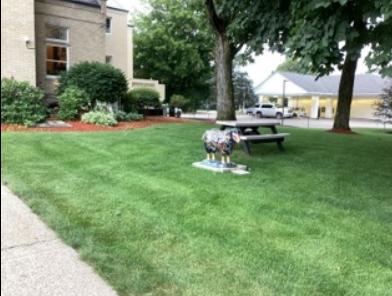
| ID | Location | Floor | Room | Element | Type | Photo | Issues | Current Measure | Recommendations | Quantity | Price | Cost Estimation |
|---|---|---|---|---|---|--|---|---|---|---|---|---|
| 31 | Main Street | Ext. | | Dining or Work Surfaces | Dining Surface | | Not on a accessible route<br>At least one or 5% accessible tables not provided<br>Knee clearance less than 19" deep | -<br>-<br>8" | Ensure at least one surfaces are located on an accessible route.<br>Ensure that at least one dining surface is accessible with knee clearance at least 27" high min. and 19" deep min.<br>(Cost based on an accessible picnic table.) | 1 | 1400 | \$1400 |

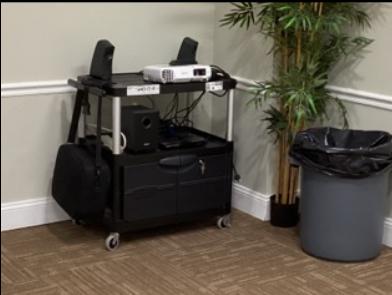
| ID | Location | Floor | Room | Element | Type | Photo | Issues | Current Measure | Recommendations | Quantity | Price | Cost Estimation |
|---|---|---|---|---|---|--|---|---|---|---|---|---|
| 32 | Meeting Room | B | B15 | Assembly Area | N/A | | Assistive listening devices not provided | - | If audible communication is integral to the use of the space, provide an assistive listening system. | 1 | 1578 | \$1578 |

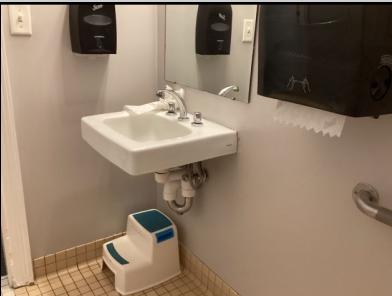
| ID | Location | Floor | Room | Element | Type | Photo | Issues | Current Measure | Recommendations | Quantity | Price | Cost Estimation |
|---|---|---|---|---|---|--|---|---|---|---|---|---|
| 33 | All-Gender Family Toilet Room | 2 | | Lavatory | N/A | | Clear floor space not provided at lavatory<br>Plumbing underneath is exposed | -<br>- | Provide at least one lavatory with a 30" min. by 48" min. clear floor space positioned for a forward approach. (Relocate stored item from under lavatory.)<br>Insulate or otherwise configure pipes to prevent contact for at least one lavatory. | 1 | 150 | \$150 |

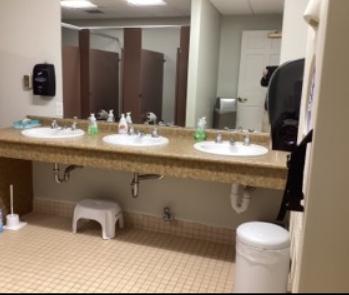
| ID | Location | Floor | Room | Element | Type | Photo | Issues | Current Measure | Recommendations | Quantity | Price | Cost Estimation |
|---|---|---|---|---|---|--|---|---|---|---|---|---|
| 34 | Women's Multi-User Toilet Room | B | B 11 | Lavatory | N/A | | Clear floor space not provided at lavatory<br>Plumbing underneath is exposed | -<br>- | Provide at least one lavatory with a 30" min. by 48" min. clear floor space positioned for a forward approach. The paper towel dispenser interferes with the clear floor space at the sink. Wrap the exposed plumbing at one of the other lavatories to resolve this issue. | 1 | 150 | \$150 |

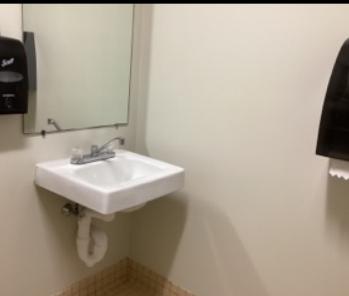
| ID | Location | Floor | Room | Element | Type | Photo | Issues | Current Measure | Recommendations | Quantity | Price | Cost Estimation |
|---|---|---|---|---|---|--|---|---|---|---|---|---|
| 35 | Men's Single-User Toilet Room | B | B 12 | Lavatory | N/A | | Toe or knee clearances not provided | 22" | Provide at least one lavatory with knee and toe clearance positioned for a forward approach. | 1 | 2192 | \$2192 |

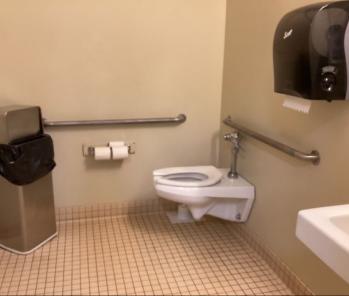
| ID | Location | Floor | Room | Element | Type | Photo | Issues | Current Measure | Recommendations | Quantity | Price | Cost Estimation |
|---|---|---|---|---|---|--|---|---|---|---|---|---|
| 36 | All-Gender Single-User Toilet Room | 1 | | Single-User Toilet | N/A | | Toilet seat < 17" or > 19" high<br>Clearance at toilet < 72" clear depth (MAAB) | 20"<br>53" | Install a toilet with a seat between 17"- 19" high above the finished floor.<br>Provide a directional sign to an accessible toilet room./Renovate the toilet room to ensure that there is 72" deep min. clear floor space at the toilet. (Relocate trash container.) | 1 | 2816 | \$2816 |

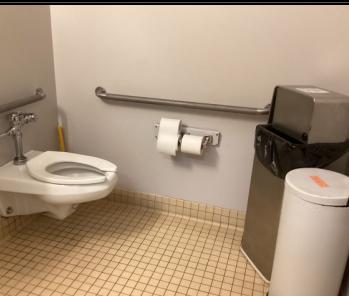
| ID | Location | Floor | Room | Element | Type | Photo | Issues | Current Measure | Recommendations | Quantity | Price | Cost Estimation |
|---|---|---|---|---|---|--|---|---|---|---|---|---|
| 37 | All-Gender Family Toilet Room | 2 | | Single-User Toilet | N/A | | Toilet seat < 17" or > 19" high<br>Centerline < or > 18" (MAAB)<br>Clearance at toilet < 72" clear depth (MAAB) | 20"<br>20"<br>32"<br>53" | Install a toilet with a seat between 17"- 19" high above the finished floor.<br>Relocate toilet so that the centerline is 18" from the side wall.<br>Relocate trash receptacles to provide 72" clear depth at the toilet. | 1 | 2816 | \$2816 |

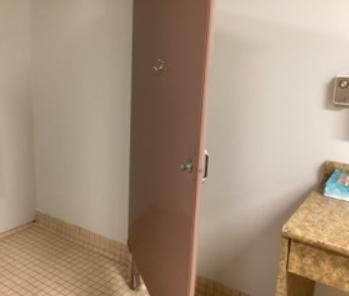
| ID | Location | Floor | Room | Element | Type | Photo | Issues | Current Measure | Recommendations | Quantity | Price | Cost Estimation |
|---|---|---|---|---|---|--|---|---|---|---|---|---|
| 38 | Women's Multi-User Toilet Room | B | B 11 | Toilet Compartment | Accessible Compartment | | Door has malfunctioning self-closing hinge<br>Door pull not provided | -<br>- | Repair hinge.<br>Provide a door pull on each side of the door between 34" to 48" above the finished floor that does not require tight grasping, pinching or twisting of the wrist. | 1 | 91 | \$91 |
