Town of Oxford

# ADA Self-Evaluation and Transition Plan

July 2024

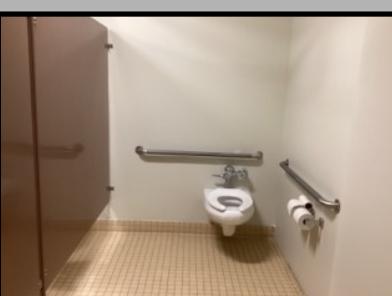
| ID | Location | Floor | Room | Element | Type | Photo | Issues | Current Measure | Recommendations | Quantity | Price | Cost Estimation |
|---|---|---|---|---|---|--|---|---|--|---|---|---|
| 39 | Women's Multi-User Toilet Room | B | B 11 | Toilet Compartment | Accessible Compartment | | Side or rear grab bar < 33" or >36" high | 30" | Locate grab bars between 33"- 36" above the finished floor. | 2 | 333 | \$666 |

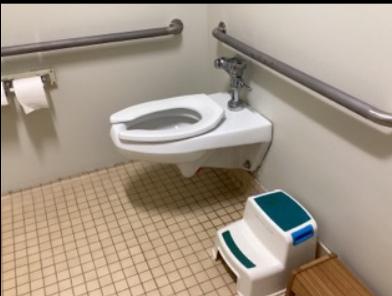
| ID | Location | Floor | Room | Element | Type | Photo | Issues | Current Measure | Recommendations | Quantity | Price | Cost Estimation |
|---|---|---|---|---|---|--|---|---|--|---|---|---|
| 40 | Men's Single-User Toilet Room | B | B 12 | Toilet Compartment | Accessible Compartment | | Toilet seat <17" or > 19" high<br>Side or rear grab bar < 33" or >36" high<br>Clearance at toilet < 60" clear width | 21"<br>30"<br>- | Install a toilet with a seat height 17"- 19" above the finished floor.<br>Locate grab bars between 33"- 36" above the finished floor.<br>Provide a wheelchair accessible compartment that is 60" wide min. (Relocate stored items out of the clear floor space at the side of the toilet.) | 1 | 2816<br>333<br>333<br>Labor | \$3482 |

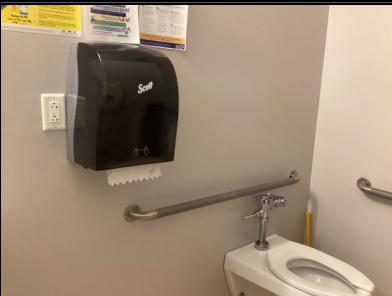
| ID | Location | Floor | Room | Element | Type | Photo | Issues | Current Measure | Recommendations | Quantity | Price | Cost Estimation |
|---|---|---|---|---|---|--|---|---|--|---|---|---|
| 42 | All-Gender Family Toilet Room | 2 | | Dispensers | Paper Towel Dispenser | | Noncompliant operable part | - | Relocate paper towel dispenser so it is not located above the grab bar. Ensure that at the new location the dispenser control is 48" max. above the finished floor at that the dispenser is out of the circulation path or has a cane detectable barrier such as a trash receptacle below it positioned 27" max. above the finished floor. | 1 | 500 | \$500 |

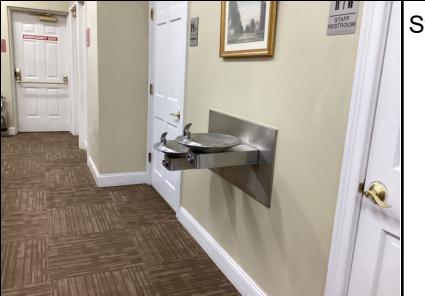
| ID | Location | Floor | Room | Element | Type | Photo | Issues | Current Measure | Recommendations | Quantity | Price | Cost Estimation |
|---|---|---|---|---|---|--|--|---|---|---|---|---|
| 44 | By Staff Toilet Rooms | 1 | | Drinking Fountains | Hi-Lo | | Standing height fountain does not have cane protection | - | Provide a cane-detectable barrier skirt under the high unit. | 1 | 1157 | \$1157 |

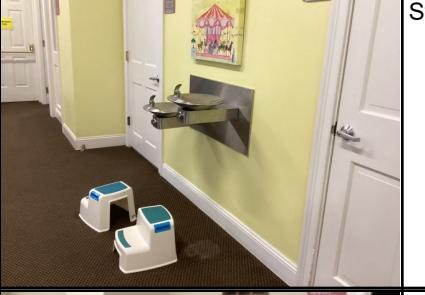
| ID | Location | Floor | Room | Element | Type | Photo | Issues | Current Measure | Recommendations | Quantity | Price | Cost Estimation |
|---|---|---|---|---|---|--|--|---|---|---|---|---|
| 45 | By All-Gender Family Toilet Room | 2 | | Drinking Fountains | Hi-Lo | | Standing height fountain does not have cane protection | - | Provide a cane-detectable barrier skirt under the high unit. | 1 | 1157 | \$1157 |

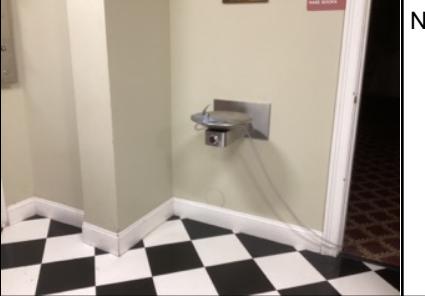
| ID | Location | Floor | Room | Element | Type | Photo | Issues | Current Measure | Recommendations | Quantity | Price | Cost Estimation |
|---|---|---|---|---|---|--|--|---|---|---|---|---|
| 46 | Near B19 | B | | Drinking Fountains | Low | | No drinking fountain provided for standing users | - | Provide an additional drinking fountain for standing users or install a Hi-Lo drinking fountain. | 1 | 4028 | \$4028 |

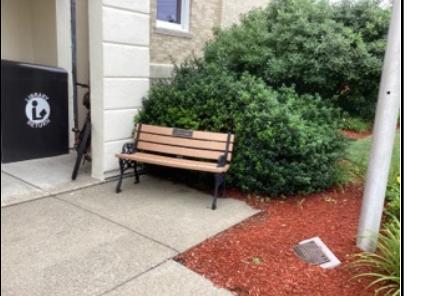
| ID | Location | Floor | Room | Element | Type | Photo | Issues | Current Measure | Recommendations | Quantity | Price | Cost Estimation |
|---|---|---|---|---|---|--|--|---|---|---|---|---|
| 47 | Main Entrance | Ext. | | Bench | N/A | | | | Recommend providing a 36" by 48" min. stable, firm and slip-resistant area at the bench extending 8" beyond the back support of the bench so that a person using a wheelchair or other mobility device is able to sit alongside someone seated on the bench with their shoulders aligned. | 1 | - | - |

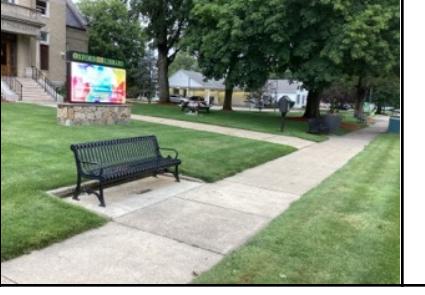
| ID | Location | Floor | Room | Element | Type | Photo | Issues | Current Measure | Recommendations | Quantity | Price | Cost Estimation |
|---|---|---|---|---|---|--|--|---|---|---|---|---|
| 48 | Main Street | Ext. | | Bench | Exterior Bench | | | | Recommend providing a 36" by 48" min. stable, firm and slip-resistant area at the bench extending 8" beyond the back support of the bench so that a person using a wheelchair or other mobility device is able to sit alongside someone seated on the bench with their shoulders aligned. | 1 | - | - |

- Recommend providing a 36" by 48" min. stable, firm and slip-resistant area at the bench extending 8" beyond the back support of the bench so that a person using a wheelchair or other mobility device is able to sit alongside someone seated on the bench with their shoulders aligned.

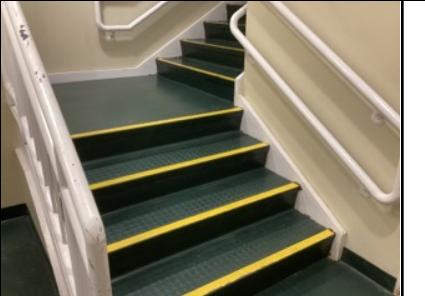
| ID | Location | Floor | Room | Element | Type | Photo | Issues | Current Measure | Recommendations | Quantity | Price | Cost Estimation |
|---|---|---|---|---|---|--|---|---|---|---|---|---|
| 49 | Stairwell | B | | Contrasting Color on Stair Nosings | N/A | | | | Recommend providing a contrasting color on the nosings of all interior and exterior staircases at the library similar to what is shown here at one of the interior library egress stairs. | 1 | Labor | Labor |

- Recommend providing contrasting color strips on the nosings of all interior and exterior stairs at the library. (One set of interior egress stairs has contrasting color on the stair nosings.)

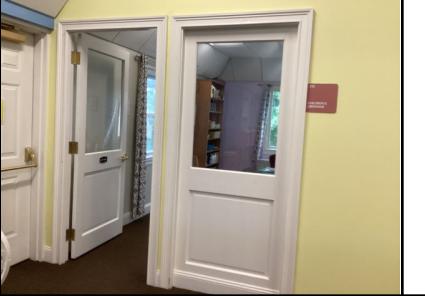
| ID | Location | Floor | Room | Element | Type | Photo | Issues | Current Measure | Recommendations | Quantity | Price | Cost Estimation |
|---|---|---|---|---|---|--|---|---|---|---|---|---|
| 52 | Children's Librarian Office | 2 | 213 | Signage | | | | | Recommend moving the sign to the glass area closer to the latch side of the door. | 1 | Labor | Labor |

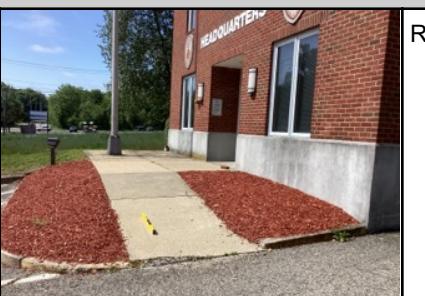
| ID | Location | Floor | Room | Element | Type | Photo | Issues | Current Measure | Recommendations | Quantity | Price | Cost Estimation |
|---|---|---|---|---|---|--|--|---|--|---|---|---|
| 1 | Walkway to Main Entrance | Ext. | | Exterior Access Route | Walkway | | Running slope > 1:20 (5.00%) | 14% | Reduce running slope to be no steeper than 1:20 (5.00%) or 1:12 (8.33%) if treated as a compliant ramp with landings, railings, edge protection, etc. | 1 | - | - |

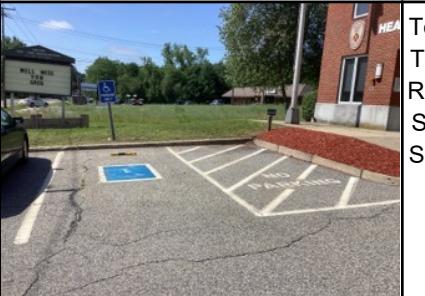
| ID | Location | Floor | Room | Element | Type | Photo | Issues | Current Measure | Recommendations | Quantity | Price | Cost Estimation |
|---|---|---|---|---|---|--|--|---|--|---|---|---|
| 2 | Accessible Parking | Ext. | | Off-Street Parking Lot or Garage | N/A | | Total # of parking<br>Total # of designated van accessible spaces<br>Running or cross slope at space > 1:50 (2.00%)<br>Sign does not have the designation "Van Accessible"<br>Sign bottom < 60" above finished grade | 2<br>1<br>6.4%<br>-<br>41" | Reduce running or cross slope to be no steeper than 1:50 (2.00%).<br>Add the designation "Van Accessible" to the sign located at the van accessible space.<br>Locate sign with the bottom of the sign 60" above the ground.<br>Cost based on the provision of a sign with the designation, "Van Accessible". | 1 | 500 | \$500<br><br>500 |

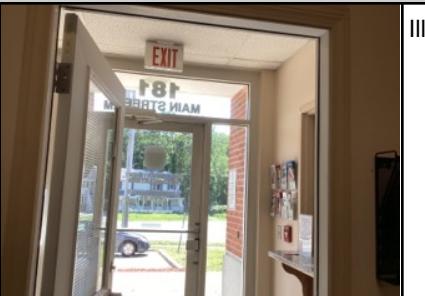
| ID | Location | Floor | Room | Element | Type | Photo | Issues | Current Measure | Recommendations | Quantity | Price | Cost Estimation |
|---|---|---|---|---|---|--|--|---|--|---|---|---|
| 3 | Main Egress | 1 | | Means of Egress | N/A | | Illuminated ISA symbol not provided (MAAB) | - | When the illuminated exit sign is repaired or replaced, provide an illuminated sign with the International Symbol of Accessibility (ISA). | 1 | 260 | \$260<br><br>260 |

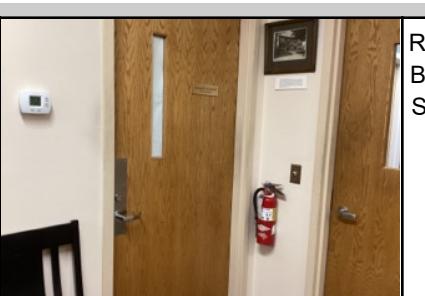
| ID | Location | Floor | Room | Element | Type | Photo | Issues | Current Measure | Recommendations | Quantity | Price | Cost Estimation |
|---|---|---|---|---|---|--|--|---|--|---|---|---|
| 4 | Chief's Office | 1 | | Signage | Designation | | Raised characters not provided on sign<br>Braille not provided on sign<br>Sign not located on the latch side of the door | -<br>-<br>- | Provide text with raised characters duplicated in braille on the sign.<br>Locate the sign at permanent rooms alongside the door on the latch side. | 1 | 250 | \$250<br><br>250 |

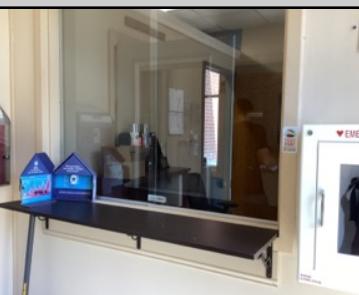
| ID | Location | Floor | Room | Element | Type | Photo | Issues | Current Measure | Recommendations | Quantity | Price | Cost Estimation |
|---|--|---|---|---|---|--|--|---|---|---|---|---|
| 6 | Reception Area Service Counter | 1 | | Service Counter | N/A | | Counter > 36" high | 41" | Provide a counter that is 36" max. above the ground or finished floor. | 1 | 1144 | \$1144 |

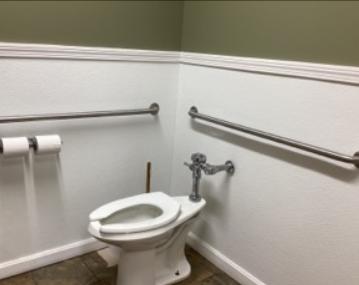
| ID | Location | Floor | Room | Element | Type | Photo | Issues | Current Measure | Recommendations | Quantity | Price | Cost Estimation |
|---|--|---|---|---|---|--|--|---|---|---|---|---|
| 7 | Men's and Women's Single-User Toilet Rooms | 1 | | Overall Access | Toilet Room | | | | <b>Note:</b> As there are two single-user toilet rooms for the public that each lack clear floor space at the toilet, the option exists to make just one of the toilet rooms fully accessible, designate both toilet rooms as all-gender, and then provide a directional sign at the inaccessible single-user all-gender toilet room directing visitors to the accessible single-user all-gender toilet room. See narrative for more information. | 1 | - | - |

Accessibility (ISA) at the inaccessible single-user all-gender toilet room directing visitors to the accessible single-user all-gender toilet room. In this narrative and in the survey catalog IHCD team is recommending making the women's toilet room fully accessible and placing a directional sign with an ISA at the men's toilet room that directs visitors to the women's toilet room once the women's toilet room has been made fully accessible. If it turns out there is a significant costs savings or other advantage in changing which toilet room is made accessible, or the decision is made to make both toilet rooms fully accessible, those are acceptable options as well.

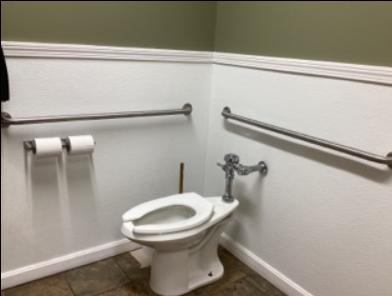
| ID | Location | Floor | Room | Element | Type | Photo | Issues | Current Measure | Recommendations | Quantity | Price | Cost Estimation |
|---|---|---|---|---|---|--|---|---|---|---|---|---|
| 9 | Women's Single-User Toilet Room | 1 | | Single-User Toilet | N/A | | Flush control not on open side<br>Centerline < or > 18" (MAAB)<br>Side grab bar < 54" from back wall<br>Side or rear grab bar < 33" or > 36" high | -<br>17"<br>49.5"<br>37" | Relocate the flush control to the open side.<br>Relocate toilet so that the centerline is 18" from the side wall.<br>Provide a side wall grab bar that is 42" long min. located 12" max. from the rear wall.<br>Mount grab bars 33"- 36" above the finished floor.<br><b>Note:</b> Costs to renovate toilet room are included in ID #10. | 1 | - | - |

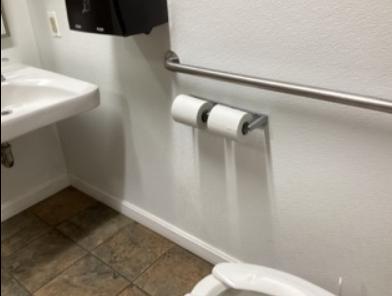
| ID | Location | Floor | Room | Element | Type | Photo | Issues | Current Measure | Recommendations | Quantity | Price | Cost Estimation |
|---|---|---|---|---|---|--|---|---|---|---|---|---|
| 10 | Women's Single-User Toilet Room | 1 | | Single-User Toilet | N/A | | Clearance at toilet < 72" clear depth (MAAB) | 30" | Renovate the toilet room to ensure that there is 72" deep min. clear floor space at the toilet. | 1 | 31985 | \$31985 |

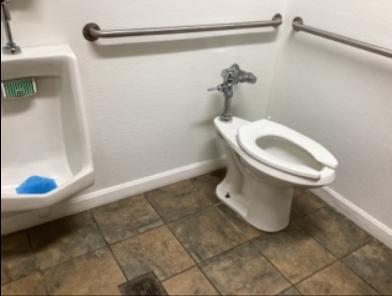
| ID | Location | Floor | Room | Element | Type | Photo | Issues | Current Measure | Recommendations | Quantity | Price | Cost Estimation |
|---|---|---|---|---|---|--|---|---|---|---|---|---|
| 11 | Men's Single-User Toilet Room | 1 | | Single-User Toilet | N/A | | Side grab bar < 54" from back wall<br>Side or rear grab bar < 33" or > 36" high<br>Clearance at toilet < 60" clear width | 46.5"<br>37"<br>26" | Provide a side wall grab bar that is 42" long min. located 12" max. from the rear wall.<br>Mount grab bars 33"- 36" above the finished floor. Renovate the toilet room to ensure that there is 60" wide min. clear floor space at the toilet. <b>Recommend an all-gender sign at this men's toilet with a directional sign including an ISA to the women's all-gender single-user once it has been made accessible.</b> | 1 | - | - |

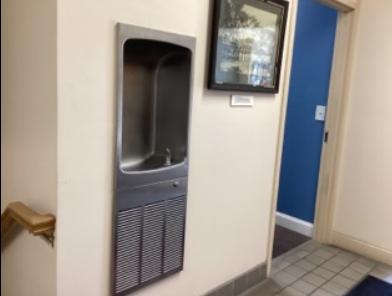
| ID | Location | Floor | Room | Element | Type | Photo | Issues | Current Measure | Recommendations | Quantity | Price | Cost Estimation |
|---|---|---|---|---|---|--|---|---|---|---|---|---|
| 12 | Lobby | 1 | | Drinking Fountains | High | | No drinking fountain provided for seated users | - | Provide an additional drinking fountain for seated users or install a new Hi-Lo drinking fountain. | 1 | 4028 | \$4028 |

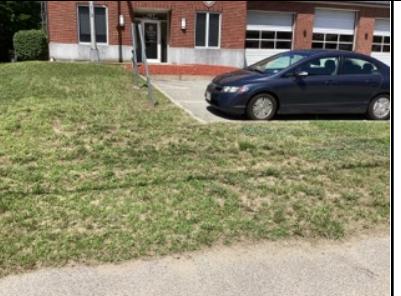
| ID | Location | Floor | Room | Element | Type | Photo | Issues | Current Measure | Recommendations | Quantity | Price | Cost Estimation |
|---|---|---|---|---|---|---|---|---|--|---|---|---|
| 13 | Exterior of Fire Station | Ext. | | Exterior Access Route | N/A | | | | Recommend considering this location to provide an accessible route from the accessible parking to the main entry door that is 48" wide min. with a running slope of 1:20 (5.00%) and a max. cross slope of 1:50 (2.00%). | 1 | - | - |

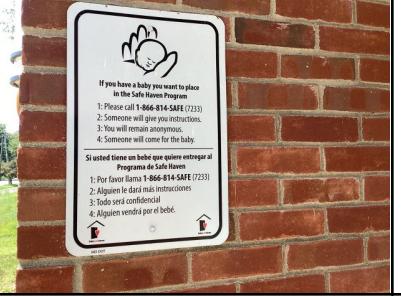
| ID | Location | Floor | Room | Element | Type | Photo | Issues | Current Measure | Recommendations | Quantity | Price | Cost Estimation |
|---|---|---|---|---|---|---|---|---|--|---|---|---|
| 14 | Exterior of Fire Station | Ext. | | Sign | N/A | | | | Recommend providing external lighting at the Baby Safe Haven program sign to make it easier for visitors to locate the sign in low light. | 1 | - | - |

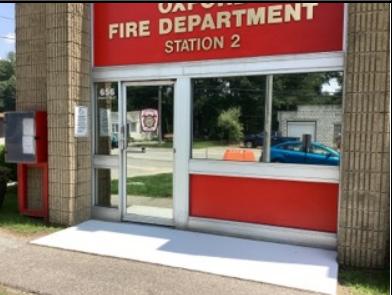
| ID | Location | Floor | Room | Element | Type | Photo | Issues | Current Measure | Recommendations | Quantity | Price | Cost Estimation |
|---|--|---|---|---|---|---|---|---|---|---|---|---|
| 1 | Main Entrance Doorbell | Ext. | | Exterior Access Route | Walkway | | Level changes > 1/4" | .75" | Alter change in level to be 1/4" high max. | 1 | - | - |

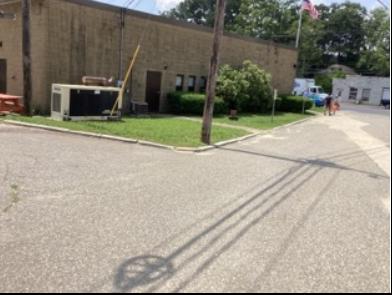
| ID | Location | Floor | Room | Element | Type | Photo | Issues | Current Measure | Recommendations | Quantity | Price | Cost Estimation |
|---|--|---|---|---|---|---|---|---|---|---|---|---|
| 2 | Parking at Little League Baseball Lot Adjacent to Fire Station Main Entry Doorbell | Ext. | | Parking | N/A | | | | Recommend providing one compliant van accessible parking space with a marked access aisle and compliant signage at a location across the street from the Little League parking lot that is on the closest accessible route to the fire station main entry doorbell. | 1 | - | - |

- Recommend providing a compliant van accessible parking space with a marked access aisle and proper signage on the northeast side of the fire station across the street from a little league field at the nearest safe location to the fire station entry door.

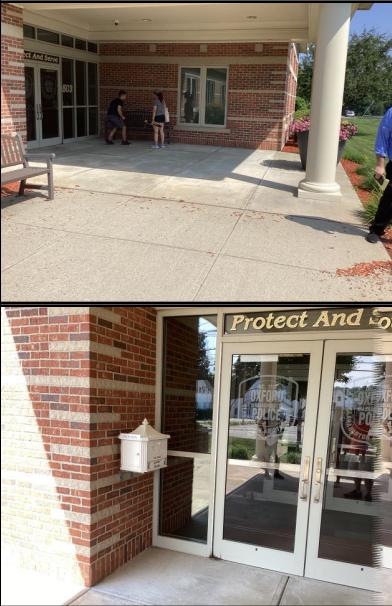
| ID | Location | Floor | Room | Element | Type | Photo | Issues | Current Measure | Recommendations | Quantity | Price | Cost Estimation |
|---|---|---|---|---|---|--|--|---|--|---|---|---|
| 1 | By Main Entrance | Ext. | | Exterior Access Route | Walkway | | Surface openings > 1/2" | 1" | Reduce surface openings in the accessible route to 1/2" max. | 1 | - | - |

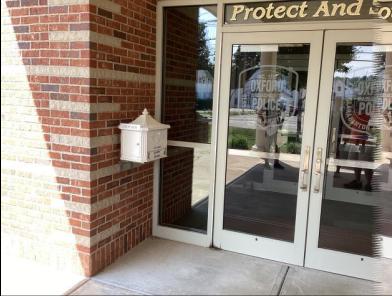
| ID | Location | Floor | Room | Element | Type | Photo | Issues | Current Measure | Recommendations | Quantity | Price | Cost Estimation |
|---|---|---|---|---|---|--|--|---|--|---|---|---|
| 2 | Main Entrance | | | Exterior Access Route | | | Obstructed by protruding objects | 12." | Provide a cane-detectable barrier below the receptacle located 27" max. above the ground or relocate item out of the accessible route. | 1 | Labor | Labor |

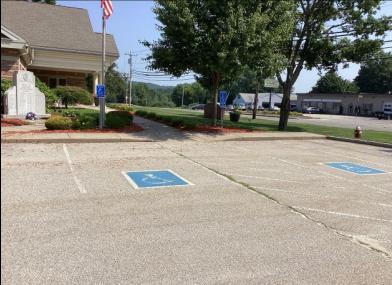
| ID | Location | Floor | Room | Element | Type | Photo | Issues | Current Measure | Recommendations | Quantity | Price | Cost Estimation |
|---|---|---|---|---|---|--|--|---|--|---|---|---|
| 3 | Parking | Ext. | | Off-Street Parking Lot or Garage | N/A | | Total # of parking<br>Total # of designated car accessible parking spaces<br>Total # of designated van accessible spaces<br>Sign bottom < 60" above finished grade | 15<br>1<br>1<br>41.5" | Locate sign with the bottom of the sign 60" above the ground. | 1 | - | - |

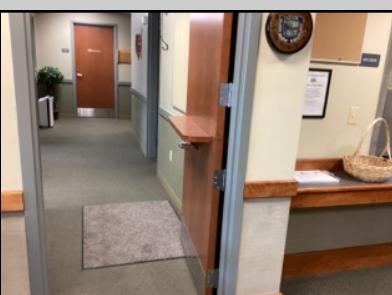
| ID | Location | Floor | Room | Element | Type | Photo | Issues | Current Measure | Recommendations | Quantity | Price | Cost Estimation |
|---|---|---|---|---|---|--|--|---|--|---|---|---|
| 4 | Administrative Assistant | 1 | | Interior Access Route | N/A | | Obstructed by protruding objects | 6" | Provide a cane-detectable barrier on the door 27" max. above the finished floor on the door below the shelf. | 1 | 398 | \$398 |

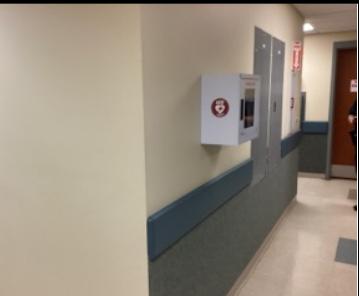
| ID | Location | Floor | Room | Element | Type | Photo | Issues | Current Measure | Recommendations | Quantity | Price | Cost Estimation |
|---|---|---|---|---|---|--|--|---|--|---|---|---|
| 5 | Near Communications | 1 | | Interior Access Route | | | Obstructed by protruding objects | 8.5" | Relocate defibrillator out of the accessible route or provide a cane-detectable barrier below the defibrillator located 27" max. above the finished floor. | 1 | 398 | \$398 |

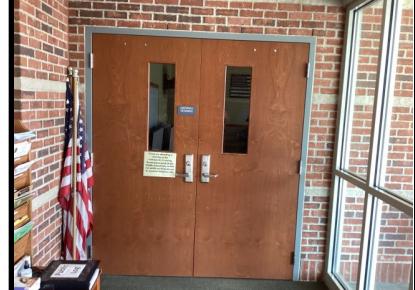
| ID | Location | Floor | Room | Element | Type | Photo | Issues | Current Measure | Recommendations | Quantity | Price | Cost Estimation |
|---|---|---|---|---|---|--|--|---|--|---|---|---|
| 6 | Meeting/Training Room | 1 | | Signage | Designation | | Raised characters not provided on sign<br>Braille not provided on sign<br>Sign not located on the latch side of the door | -<br>-<br>- | Provide text with raised characters duplicated in braille on the sign.<br>Locate the sign at permanent rooms alongside the door on the latch side. If both leaves of a double door are active, locate the sign on the right side of the door on the right. | 1 | 250 | \$250 |

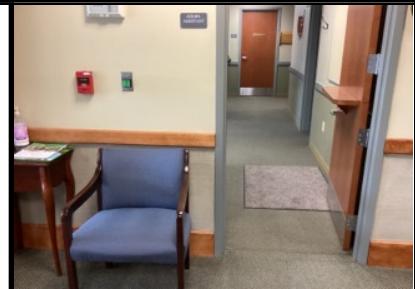
| ID | Location | Floor | Room | Element | Type | Photo | Issues | Current Measure | Recommendations | Quantity | Price | Cost Estimation |
|---|---|---|---|---|---|--|--|---|--|---|---|---|
| 7 | Administrative Assistant | 1 | | Signage | Designation | | Signage lacks 18" by 18" clear floor space | 8" | Relocate furniture to provide a clear floor space of 18" min. by 18" min. at the sign. | 1 | Labor | Labor |

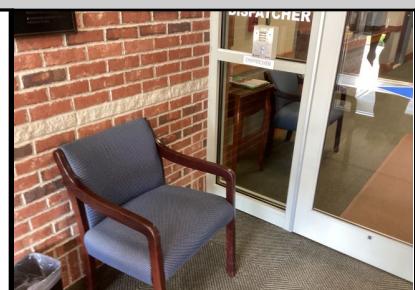
| ID | Location | Floor | Room | Element | Type | Photo | Issues | Current Measure | Recommendations | Quantity | Price | Cost Estimation |
|---|---|---|---|---|---|--|--|---|--|---|---|---|
| 8 | Main Entrance | | | Operable Parts / Reach Range | Other | | Element not on an accessible route<br>Clear floor space is not provided | -<br>- | Relocate furniture to provide 30" min. by 48" min. clear floor space at the intercom. | 1 | Labor | Labor |

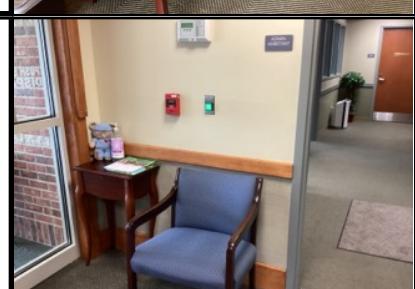
| ID | Location | Floor | Room | Element | Type | Photo | Issues | Current Measure | Recommendations | Quantity | Price | Cost Estimation |
|---|---|---|---|---|---|--|--|---|--|---|---|---|
| 9 | Automatic Door Control Button by Administrative Assistant | 1 | | Operable Parts / Reach Range | Automatic Door Control Button | | Clear floor space is not provided | - | Relocate furniture to provide a 30" min. by 48" min. clear floor space at the automatic door control button. | 1 | Labor | Labor |

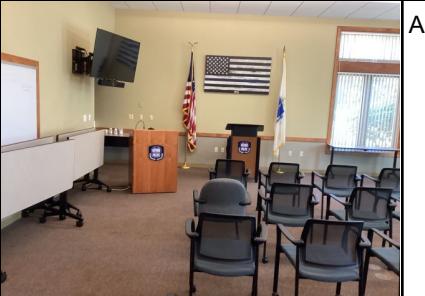
| ID | Location | Floor | Room | Element | Type | Photo | Issues | Current Measure | Recommendations | Quantity | Price | Cost Estimation |
|---|--|---|---|---|---|--|---|---|---|---|---|---|
| 10 | Meeting/<br>Training<br>Room | 1 | | Assembly<br>Area | N/A | | Assistive listening devices not provided | - | If audible communication is integral to the use of the space, provide an assistive listening system. (Cost for a transmitter, receiver, ear speaker, neck loop and USB charger - Capacity: 50 or less.) | 1 | 1578 | \$1578 |

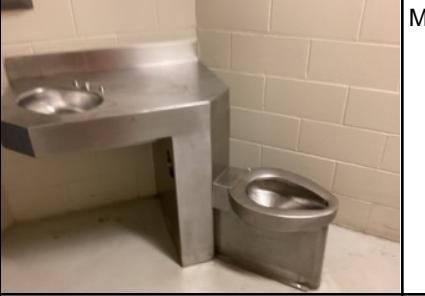
| ID | Location | Floor | Room | Element | Type | Photo | Issues | Current Measure | Recommendations | Quantity | Price | Cost Estimation |
|---|--|---|---|---|---|--|---|---|---|---|---|---|
| 11 | Juvenile Cell | 1 | | Detention<br>Facilities | Juvenile | | Mobility cell lacks access to accessible toilet/lavatory | - | Provide a grab bar on the side wall that is at least 42 inches long and on the rear wall that is at least 36" long with both 33 to 36 inches above the floor. (Grab bars can be designed so they do not increase suicide risk. See DOJ document ADA/Section 504 Design Guide: Accessible Cells in Correctional Facilities at: <a href="https://archive.ada.gov/accessiblecells.htm">https://archive.ada.gov/accessiblecells.htm</a> ) | 2 | - | - |

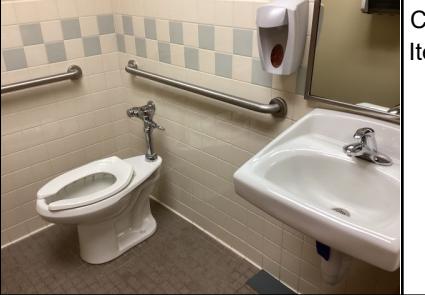
| ID | Location | Floor | Room | Element | Type | Photo | Issues | Current Measure | Recommendations | Quantity | Price | Cost Estimation |
|---|--|---|---|---|---|--|---|---|---|---|---|---|
| 12 | Women's<br>Single-User<br>Toilet Room | 1 | | Single-User<br>Toilet | N/A | | Centerline < or > 18" (MAAB)<br>Item mounted over grab bar (MAAB) | 17"<br>- | Relocate toilet so that the centerline is 18" from the side wall.<br>Relocate soap dispenser so that it is not mounted over the grab bar. | 1 | 3676<br>500 | \$4176<br><br>4176 |

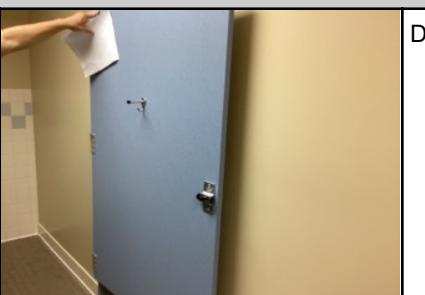
| ID | Location | Floor | Room | Element | Type | Photo | Issues | Current Measure | Recommendations | Quantity | Price | Cost Estimation |
|---|--|---|---|---|---|--|---|---|---|---|---|---|
| 13 | Men's and<br>Women's<br>Single-User<br>Toilet Room | 1 | | Toilet<br>Compartment | Accessible<br>Compartment | | Door has noncompliant hardware | - | Provide hardware that can be operable with one hand and not require tight grasping, pinching, or twisting of the wrist on both sides of the accessible compartment door. | 2 | 91<br><br>182 | \$182<br><br>182 |

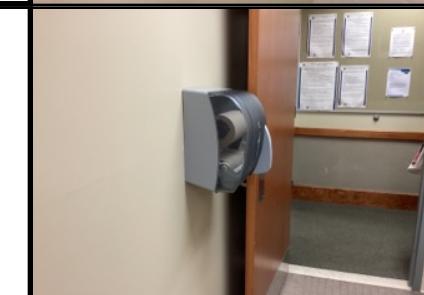
| ID | Location | Floor | Room | Element | Type | Photo | Issues | Current Measure | Recommendations | Quantity | Price | Cost Estimation |
|---|---|---|---|---|---|--|---|---|---|---|---|---|
| 15 | Men's Single-User Toilet Room | 1 | | Dispensers | | | Dispenser acts as a protruding object | 9" | Relocate dispenser out of the circulation path or provide a cane-detectable barrier under the dispenser located 27" max. above the finished floor. | 1 | 500 | \$500 |

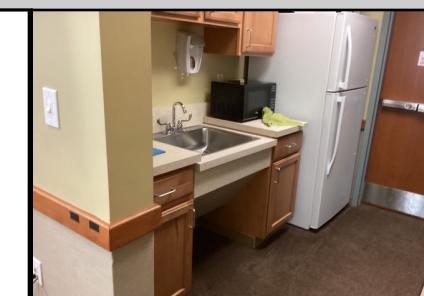
| ID | Location | Floor | Room | Element | Type | Photo | Issues | Current Measure | Recommendations | Quantity | Price | Cost Estimation |
|---|---|---|---|---|---|--|---|---|---|---|---|---|
| 16 | Meeting/Training Room | 1 | | Sink | N/A | | Toe and knee clearances not provided | 26" | Ensure there is a 27" min. knee clearance positioned for a forward approach. | 1 | 2192 | \$2192 |

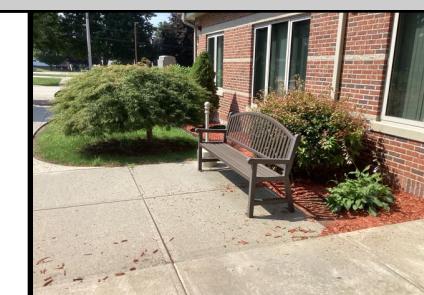
| ID | Location | Floor | Room | Element | Type | Photo | Issues | Current Measure | Recommendations | Quantity | Price | Cost Estimation |
|---|---|---|---|---|---|--|---|---|---|---|---|---|
| 17 | By Main Entrance | Ext. | | ench | N/A | | | | Recommend moving bench forward to allow for shoulder alignment between a person in a wheelchair or similar mobility positioned at the end of the bench and someone seated on the bench. | 2 | Labor | Labor |

- Recommend switching the location of the car and van accessible parking spaces so the curb ramp will be on the right side of most wheelchair vans if the driver parks with the front of the van facing the curb ramp and the police station.
- Recommend moving at least one of the exterior benches slightly forward to provide a 36" by 48" min. stable, firm and slip-resistant area at the end of the bench extending 8" beyond the back support so that a person using a wheelchair or other mobility device is able to sit alongside someone seated on the bench with their shoulders aligned.

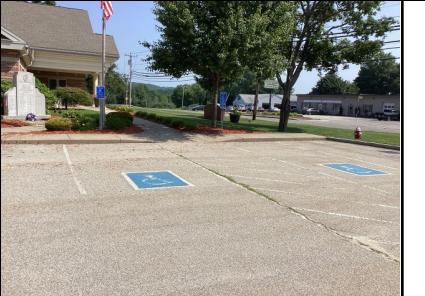
| ID | Location | Floor | Room | Element | Type | Photo | Issues | Current Measure | Recommendations | Quantity | Price | Cost Estimation |
|---|---|---|---|---|---|--|---|---|--|---|---|---|
| 18 | Parking | Ext. | | Parking Spaces | N/A | | | | Recommend switching the location of the car and van accessible parking space so the curb ramp will be on the right side of most wheelchair vans if the driver parks with the front of the van facing the curb ramp and the police station. | 1 | - | - |

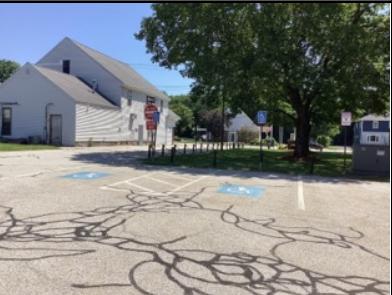
| ID | Location | Floor | Room | Element | Type | Photo | Issues | Current Measure | Recommendations | Quantity | Price | Cost Estimation |
|---|--|---|---|---|---|--|---|---|--|---|---|---|
| 1 | Parking | Ext. | | Off-Street Parking Lot or Garage | N/A | | Total # of parking<br>Total # of designated car accessible parking spaces<br>Total # of designated van accessible spaces | 40<br>2<br>- | Provide at least one van accessible parking space with a marked access aisle each 96" wide min. Include an identification sign with the international Symbol of Accessibility (ISA) mounted 60" min. above the ground measured to the bottom of the sign. Add the designation "Van Accessible" to the sign located at the van accessible parking space. Recommend locating the van space near the accessible entrance. | 1 | 1850 | \$1850 |

Note: IHCD recommends locating the van accessible parking space as close as possible to the ramp that leads to the accessible entrance.

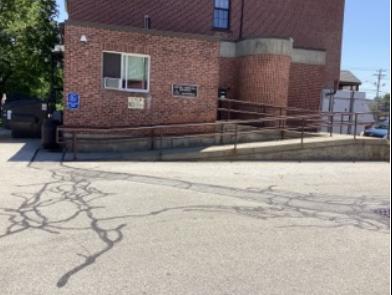
| ID | Location | Floor | Room | Element | Type | Photo | Issues | Current Measure | Recommendations | Quantity | Price | Cost Estimation |
|---|--|---|---|---|---|--|---|---|--|---|---|---|
| 2 | Exterior Ramp on West Side of Building | Ext. | | Exterior Ramp | N/A | | Ramp < 48" wide<br>Running slope > 1:12 (8.33%)<br>Handrails < 34" or > 38" above ramp surface<br>Edge protection < 4" high | 44"<br>9%<br>32"<br>- | When the ramp is renovated or replaced, widen ramp so that the clear width is 48" min./Further study will be needed to determine whether it is technically feasible to bring this ramp into full compliance. Reduce running slope to be no steeper than 1:12 (8.33%). (One portion of the ramp had a 9.00% running slope.) Alter so the handrails are 34"- 38" high above the ground. Provide edge protection. | 1 | - | - |

Accessibility issues with the exterior ramp include the ramp being narrower than allowed, lack of edge protection on the ramp, some areas of the ramp have a slightly excessive running slope, portions of the ramp surface are not in operable working condition, and the railings at the top of the ramp have extensions that do not fully extend 12" over the level portion of the ramp landing. Accessibility issues with the interior ramp include railings that do not fully extend 12" over the top and bottom ramp runs or that return to a wall, guard, or the landing surface.

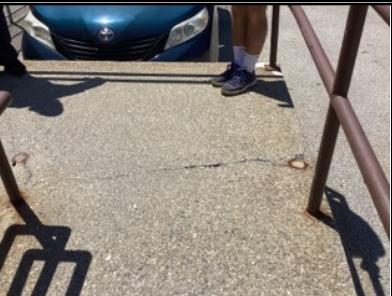
| ID | Location | Floor | Room | Element | Type | Photo | Issues | Current Measure | Recommendations | Quantity | Price | Cost Estimation |
|---|--|---|---|---|---|--|---|---|--|---|---|---|
| 3 | Exterior Ramp on West Side of Building | Ext. | | Exterior Ramp | N/A | | Not maintained in operable working condition | - | Ensure the ramp is maintained in operable working condition. (Repair minor instances of deteriorated concrete.) | 1 | - | - |

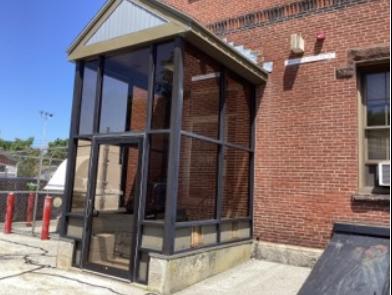
| ID | Location | Floor | Room | Element | Type | Photo | Issues | Current Measure | Recommendations | Quantity | Price | Cost Estimation |
|---|--|---|---|---|---|--|---|---|--|---|---|---|
| 4 | South Side Entrance | Ext. | | Entrance | Secondary Entrance | | Directional sign to accessible entrance not provided | - | Provide a directional sign indicating the location of the nearest accessible entrance. | 1 | 450 | \$450 |

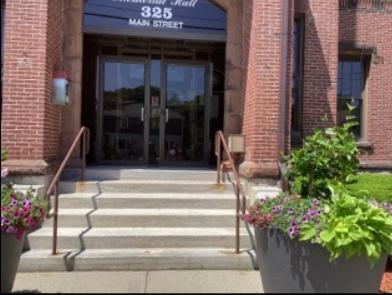
| ID | Location | Floor | Room | Element | Type | Photo | Issues | Current Measure | Recommendations | Quantity | Price | Cost Estimation |
|---|---|---|---|---|---|--|--|---|---|---|---|---|
| 5 | Main Street<br>East Side<br>Entrance | Ext. | | Entrance | Secondary<br>Entrance | | Directional sign to accessible entrance not provided | - | Provide a directional sign indicating the location of the nearest accessible entrance. | 1 | 450 | \$450 |

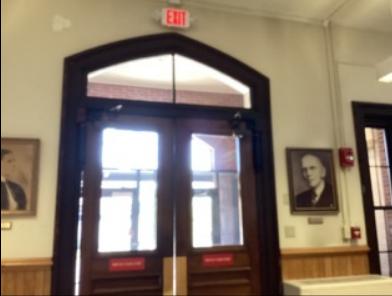
| ID | Location | Floor | Room | Element | Type | Photo | Issues | Current Measure | Recommendations | Quantity | Price | Cost Estimation |
|---|---|---|---|---|---|--|--|---|---|---|---|---|
| 6 | Main Street<br>East Side<br>Egress | 1 | | Means of<br>Egress | N/A | | Tactile exit sign not provided<br>Directional sign to accessible emergency exit not provided | -<br>- | Ensure that a tactile exit sign with raised characters and braille is provided at the exit door. Mount the sign between 48"- 60" above the finished floor located on the latch side of the door.<br>Provide a directional sign indicating the location of the nearest accessible emergency exit. | 2 | 250 | \$500 |

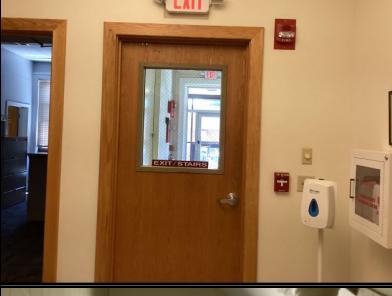
| ID | Location | Floor | Room | Element | Type | Photo | Issues | Current Measure | Recommendations | Quantity | Price | Cost Estimation |
|---|---|---|---|---|---|--|--|---|---|---|---|---|
| 7 | To South<br>Egress | 1 | | Means of<br>Egress | N/A | | Tactile exit sign not provided | - | Ensure that a tactile exit sign with raised characters and braille is provided at the exit door. Mount the sign between 48"- 60" above the finished floor located on the latch side of the door. | 1 | 250 | \$250 |

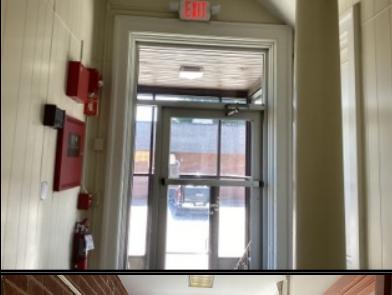
| ID | Location | Floor | Room | Element | Type | Photo | Issues | Current Measure | Recommendations | Quantity | Price | Cost Estimation |
|---|---|---|---|---|---|--|--|---|---|---|---|---|
| 8 | To South<br>Egress | 1 | | Means of<br>Egress | N/A | | Tactile exit sign not provided<br>Directional sign to accessible emergency exit not provided | -<br>- | Ensure that a tactile exit sign with raised characters and braille is provided at the exit door. Mount the sign between 48"- 60" above the finished floor located on the latch side of the door.<br>Provide a directional sign indicating the location of the nearest accessible emergency exit. | 2 | 250 | \$500 |

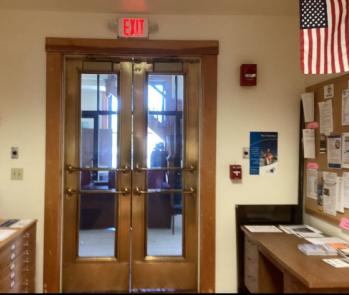
| ID | Location | Floor | Room | Element | Type | Photo | Issues | Current Measure | Recommendations | Quantity | Price | Cost Estimation |
|---|--|---|---|---|---|--|---|---|--|---|---|---|
| 10 | East Egress | 2 | | Means of Egress | N/A | | Tactile exit sign not provided | - | Ensure that a tactile exit sign with raised characters and braille is provided at the exit door. Mount the sign between 48"- 60" above the finished floor located on the latch side of the door. | 1 | 250 | \$250 |

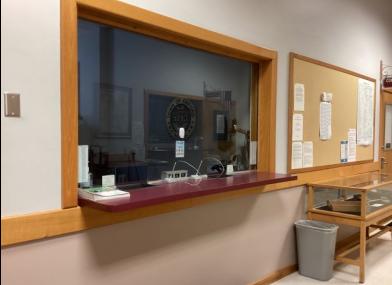
| ID | Location | Floor | Room | Element | Type | Photo | Issues | Current Measure | Recommendations | Quantity | Price | Cost Estimation |
|---|--|---|---|---|---|--|---|---|--|---|---|---|
| 11 | Treasurer Collector | 1 | | Interior Access Route | N/A | | Obstructed by protruding objects | 12" | Provide a cane-detectable barrier 27" max. above the finished floor under the ends of the counter. (Issue applies to 3 service counters on this floor.) | 3 | 398 | \$1194 |

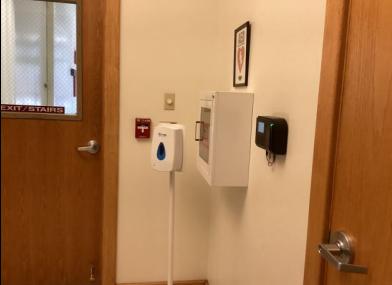
| ID | Location | Floor | Room | Element | Type | Photo | Issues | Current Measure | Recommendations | Quantity | Price | Cost Estimation |
|---|--|---|---|---|---|--|---|---|--|---|---|---|
| 12 | By Town Manager Clerk | 1 | | Interior Access Route | Defibrillator | | Obstructed by protruding objects | 7" | Relocate defibrillator out of the circulation path or provide a cane-detectable barrier under the defibrillator mounted 27" max. above the finished floor. | 1 | 398 | \$398 |

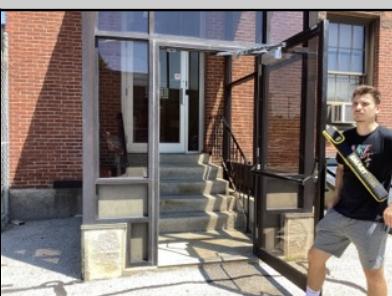
| ID | Location | Floor | Room | Element | Type | Photo | Issues | Current Measure | Recommendations | Quantity | Price | Cost Estimation |
|---|--|---|---|---|---|--|---|---|--|---|---|---|
| 13 | South Side Entrance | Ext. | | Doors, Doorways, & Gates | Secondary Entrance | | Threshold > 1/2" high | 2.25" | Alter the threshold to be 1/2" high max. | 1 | 1000 | \$1000 |

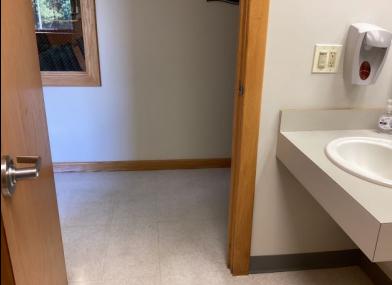
| ID | Location | Floor | Room | Element | Type | Photo | Issues | Current Measure | Recommendations | Quantity | Price | Cost Estimation |
|---|--|---|---|---|---|--|---|---|--|---|---|---|
| 14 | Women's and Men's Single-User Toilet Rooms | 2 | | Doors, Doorways, & Gates | Toilet Room | | Maneuvering clearance(s) not provided | 7" | Provide an automatic door opener. | 2 | 6000 | \$12000 |

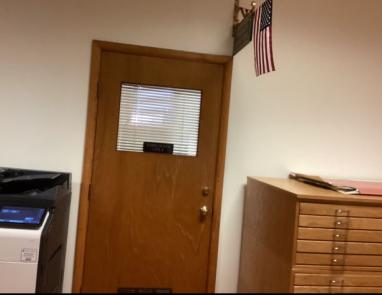
| ID | Location | Floor | Room | Element | Type | Photo | Issues | Current Measure | Recommendations | Quantity | Price | Cost Estimation |
|---|--|---|---|---|---|--|--|---|---|---|---|---|
| 15 | Finance Director | 2 | | Doors, Doorways, & Gates | Office | | Maneuvering clearance(s) not provided<br>Hardware not compliant | 9.5"<br>- | Relocate the cabinet to provide 18" min. pull side maneuvering clearance at the door or provide an automatic door opener.<br>Provide hardware that can be operable with one hand and not require tight grasping, pinching, or twisting of the wrist. | 1 | Labor 750<br><br><b>750</b> | \$750 |

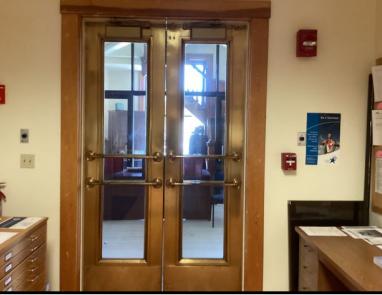
| ID | Location | Floor | Room | Element | Type | Photo | Issues | Current Measure | Recommendations | Quantity | Price | Cost Estimation |
|---|--|---|---|---|---|--|--|---|---|---|---|---|
| 16 | East Egress | 2 | | Doors, Doorways, & Gates | Circulation | | If double-leaf door, neither compliant<br>Door requires > 5 lbs. of force to open | 24"<br>12 lbs. | Ensure that at least one of the active leaves is at least 32" min. wide or provide an automatic door opener that will open both doors when activated. Adjust closers so doors do not require more than 5 pounds of force to open. | 1 | 6000<br><br><b>6000</b> | \$6000 |

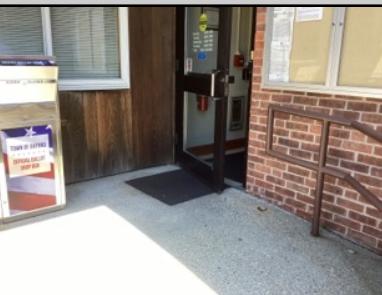
| ID | Location | Floor | Room | Element | Type | Photo | Issues | Current Measure | Recommendations | Quantity | Price | Cost Estimation |
|---|--|---|---|---|---|--|--|---|---|---|---|---|
| 17 | Exterior Ramp on West Side of Building | Ext. | | Ramps | Exterior | | Handrails do not extend 12" past top & bottom | - | Alter handrails to extend horizontally above the flat portion of the ramp landing for 12" min. beyond the top and bottom of ramp runs. (While this handrail has rail extensions, part of the rail extension is over the part of the ramp that is sloped.) | 1 | - | - |

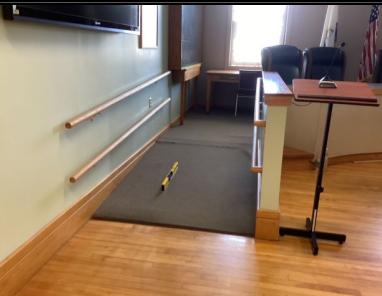
| ID | Location | Floor | Room | Element | Type | Photo | Issues | Current Measure | Recommendations | Quantity | Price | Cost Estimation |
|---|--|---|---|---|---|--|--|---|---|---|---|---|
| 18 | Meeting Room | 2 | | Ramps | Interior | | Handrails do not extend 12" past top & bottom | - | Alter handrails to extend horizontally above the landing for 12" min. beyond the top and bottom of ramp runs. Extensions shall return to a wall, guard, or the landing surface, or shall be continuous to the handrail of an adjacent ramp run. | 1 | - | - |

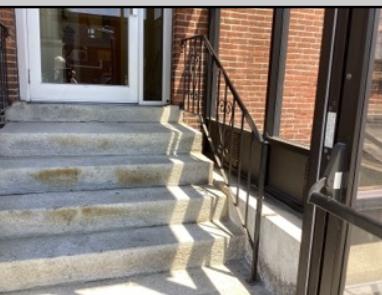
| ID | Location | Floor | Room | Element | Type | Photo | Issues | Current Measure | Recommendations | Quantity | Price | Cost Estimation |
|---|--|---|---|---|---|--|--|---|---|---|---|---|
| 19 | South Side Entrance | Ext. | | Stairways | Secondary Entrance | | Handrails do not extend 12" from stairs<br>Handrails not continuous where required<br>Handrails extensions not compliant | -<br>-<br>- | Bottom: Ensure that the handrail extends at least 12" plus the width of one tread beyond the bottom riser.<br>Provide continuous handrails. | 1 | - | - |

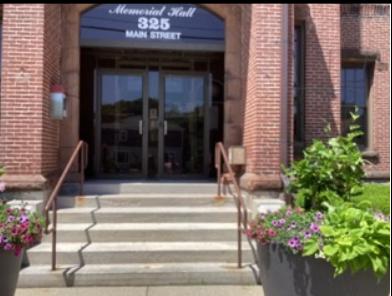
| ID | Location | Floor | Room | Element | Type | Photo | Issues | Current Measure | Recommendations | Quantity | Price | Cost Estimation |
|---|--|---|---|---|---|--|---|---|---|---|---|---|
| 20 | Main Street East Side Entrance | Ext. | | Stairways | Secondary Entrance | | Handrails do not extend 12" from stairs | - | Top: Ensure handrails extend horizontally above the landing for 12" min. beginning above the first riser nosing. Bottom: Ensure that the handrail extends at least 12" plus the width of one tread beyond the bottom riser. | 1 | - | - |

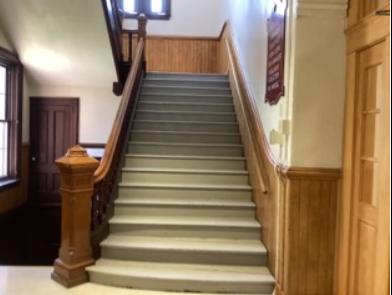
| ID | Location | Floor | Room | Element | Type | Photo | Issues | Current Measure | Recommendations | Quantity | Price | Cost Estimation |
|---|--|---|---|---|---|--|---|---|---|---|---|---|
| 21 | Main Staircase | 1 | | Stairways | Interior | | Handrails do not extend 12" from stairs<br>Handrails have noncompliant cross section<br>Handrails not continuous where required | -<br>-<br>- | Top: Ensure handrails extend horizontally above the landing for 12" min. beginning above the first riser nosing. Bottom: Ensure that the handrail extends at least 12" plus the width of one tread beyond the bottom riser. Provide handrails with 1 1/4" - 2" circular cross sections. Provide continuous handrails. | 1 | Labor | Labor |

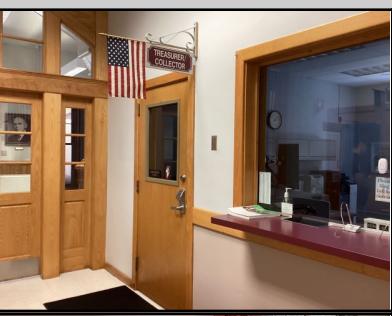
| ID | Location | Floor | Room | Element | Type | Photo | Issues | Current Measure | Recommendations | Quantity | Price | Cost Estimation |
|---|--|---|---|---|---|--|---|---|---|---|---|---|
| 22 | Treasurer Collector | 1 | | Signage | Designation | | Raised characters not provided on sign<br>Braille not provided on sign<br>Sign not located on the latch side of the door | -<br>-<br>- | Provide text with raised characters duplicated in braille on the sign.<br>Provide braille on the sign.<br>Locate the sign at permanent rooms alongside the door on the latch side.<br>(Issue applies to blade signs in seven locations.) | 7 | Labor 250 | \$1750<br><br><b>1750</b> |

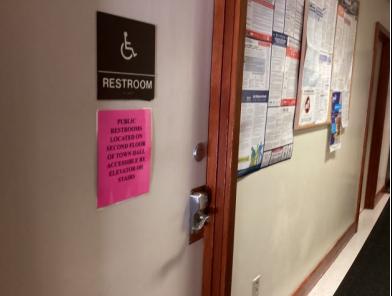
| ID | Location | Floor | Room | Element | Type | Photo | Issues | Current Measure | Recommendations | Quantity | Price | Cost Estimation |
|---|--|---|---|---|---|--|---|---|---|---|---|---|
| 23 | Employee Only Toilet Room on First Floor | 1 | | Signage | Designation | | Sign not located on the latch side of the door<br>Directional sign to access. toilet not provided | -<br>- | Locate the sign at permanent rooms alongside the door on the latch side.<br>Install a sign indicating the location of the nearest accessible toilet room. | 1 | Labor 250 | \$250<br><br><b>250</b> |

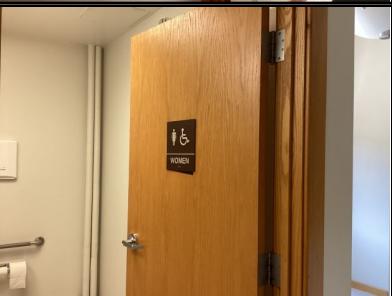
| ID | Location | Floor | Room | Element | Type | Photo | Issues | Current Measure | Recommendations | Quantity | Price | Cost Estimation |
|---|--|---|---|---|---|--|---|---|---|---|---|---|
| 24 | Women's and Men's Single-User Toilet Rooms | 2 | | Signage | Designation | | Sign not located on the latch side of the door | - | Locate the sign at permanent rooms alongside the door on the latch side. | 2 | Labor | Labor |

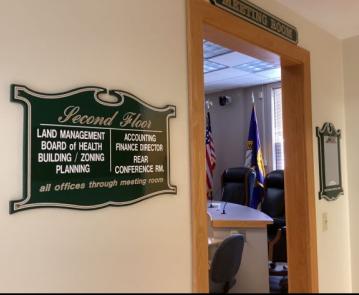
| ID | Location | Floor | Room | Element | Type | Photo | Issues | Current Measure | Recommendations | Quantity | Price | Cost Estimation |
|---|---|---|---|---|---|--|--|---|--|---|---|---|
| 25 | Meeting Room | 2 | | Signage | Designation | | Raised characters not provided on sign<br>Braille not provided on sign<br>Signage not located on an accessible route | -<br>-<br>- | Provide text with raised characters duplicated in braille on the sign.<br>Relocate sign to an accessible route./Provide an accessible route to the sign.<br><br>Note: This recommendation is in reference to the designation sign presently above the entryway that reads, "Meeting Room". | 1 | 250 | \$250 |

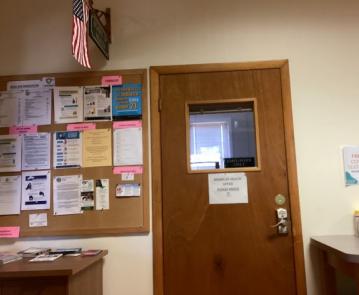
| ID | Location | Floor | Room | Element | Type | Photo | Issues | Current Measure | Recommendations | Quantity | Price | Cost Estimation |
|---|---|---|---|---|---|--|--|---|--|---|---|---|
| 26 | Board of Health | 2 | | Signage | Designation | | Raised characters not provided on sign<br>Braille not provided on sign<br>Sign not located on the latch side of the door | -<br>-<br>- | Provide text with raised characters duplicated in braille on the sign.<br>Provide braille on the sign.<br>Locate the sign at permanent rooms alongside the door on the latch side. When an accessible designation sign is installed, ensure there is 18" x 18" clear floor space at the sign. In this case, the furniture on the latch side of the door would need to be repositioned. | 4 | 250 | \$1000 |

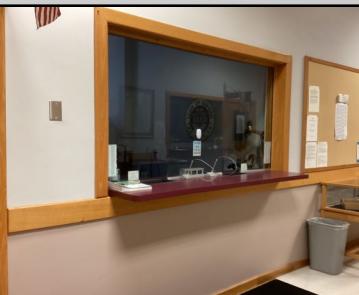
| ID | Location | Floor | Room | Element | Type | Photo | Issues | Current Measure | Recommendations | Quantity | Price | Cost Estimation |
|---|---|---|---|---|---|--|--|---|--|---|---|---|
| 27 | Treasurer Collector | 1 | | Service Counter | N/A | | Counter > 36" high | 42" | Provide a counter that is 36" max. above the ground or finished floor.<br><br>Note: Issue applies to three service counters not including the service counter in the town manager's office. | 3 | 1144 | \$3432 |

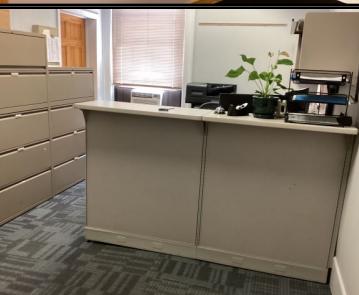
| ID | Location | Floor | Room | Element | Type | Photo | Issues | Current Measure | Recommendations | Quantity | Price | Cost Estimation |
|---|---|---|---|---|---|--|--|---|--|---|---|---|
| 28 | Town Manager | 1 | | Service Counter | N/A | | Counter > 36" high | 43.5" | Provide a counter that is 36" max. above the ground or finished floor. | 1 | 1144 | \$1144 |

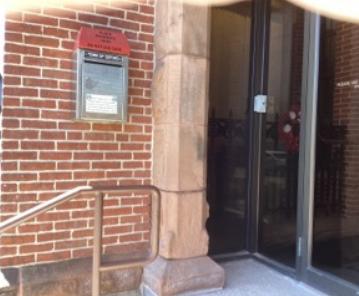
| ID | Location | Floor | Room | Element | Type | Photo | Issues | Current Measure | Recommendations | Quantity | Price | Cost Estimation |
|---|---|---|---|---|---|--|--|---|--|---|---|---|
| 29 | Main Street East Side Entrance | Ext. | | Operable Parts / Reach Range | Other | | Element not on an accessible route<br>Reach < 15" or > 48"(forward/side approach) | - 61" | Ensure drop-off box is located on an accessible route.<br>Relocate drop-off box to an accessible location and locate it so that controls are between 15"- 48" above the finished floor or ground. | 1 | - | - |

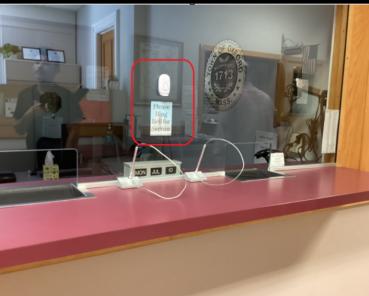
| ID | Location | Floor | Room | Element | Type | Photo | Issues | Current Measure | Recommendations | Quantity | Price | Cost Estimation |
|---|---|---|---|---|---|--|---|---|---|---|---|---|
| 30 | Treasurer<br>Collector Bell | 1 | | Operable<br>Parts /<br>Reach<br>Range | Bell | | Side reach > 54" | 58" | Relocate bell so that controls are between 15" - 48" above the finished floor. | 1 | Labor | Labor |

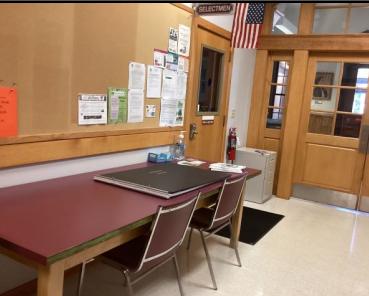
| ID | Location | Floor | Room | Element | Type | Photo | Issues | Current Measure | Recommendations | Quantity | Price | Cost Estimation |
|---|---|---|---|---|---|--|---|---|---|---|---|---|
| 31 | By<br>Selectmen's<br>Office | 1 | | Dining or<br>Work<br>Surfaces | Work<br>Surface | | At least one or 5% accessible tables not provided<br>Knee or toe clearance not provided | 23"<br>- | Ensure that at least one dining or work surface is accessible.<br>Provide at least one dining or work surface with 27" min. high knee and toe clearance. For children, provide at least one dining or work surface with 24" min. high knee and toe clearance. | 1 | 455 | \$455 |

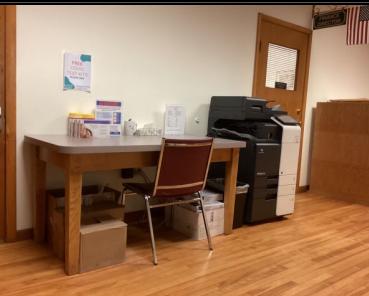
| ID | Location | Floor | Room | Element | Type | Photo | Issues | Current Measure | Recommendations | Quantity | Price | Cost Estimation |
|---|---|---|---|---|---|--|---|---|---|---|---|---|
| 32 | Finance<br>Director | 2 | | Dining or<br>Work<br>Surfaces | Work<br>Surface | | At least one or 5% accessible tables not provided<br>Knee or toe clearance not provided | -<br>25" | Ensure that at least one work surface is accessible.<br>Provide at least one work surface with 27" min. high knee and toe clearance. For children, provide at least one dining or work surface with 24" min. high knee and toe clearance. | 1 | 455 | \$455 |

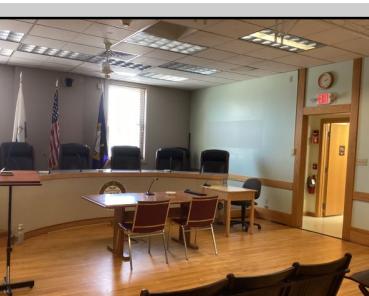
| ID | Location | Floor | Room | Element | Type | Photo | Issues | Current Measure | Recommendations | Quantity | Price | Cost Estimation |
|---|---|---|---|---|---|--|---|---|---|---|---|---|
| 33 | Meeting<br>Room | 2 | | Assembly<br>Area | N/A | | Assistive listening devices not provided | - | If audible communication is integral to the use of the space, provide an assistive listening system. | 1 | 1578 | \$1578 |

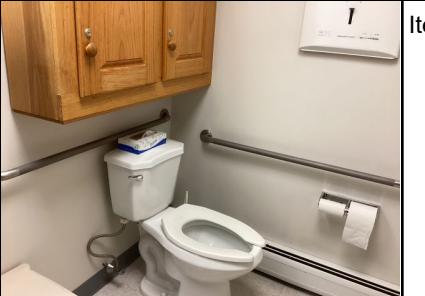
| ID | Location | Floor | Room | Element | Type | Photo | Issues | Current Measure | Recommendations | Quantity | Price | Cost Estimation |
|---|---|---|---|---|---|--|---|---|--|---|---|---|
| 34 | Women's and Men's Single-User Toilet Room | 2 | | Single-User Toilet | N/A | | Item mounted over grab bar (MAAB) | -<br>- | Relocate cabinet so that it is not mounted over the grab bar. Ensure that when the cabinet is relocated that it does not interfere with the required clear floor space at the toilet.<br>Note: There may not be sufficient space for the cabinet to remain in the toilet room. | 2 | 500 | \$1000<br><b>1000</b> |

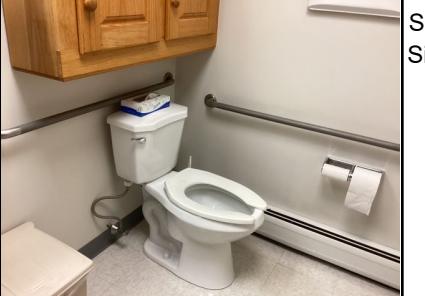
| ID | Location | Floor | Room | Element | Type | Photo | Issues | Current Measure | Recommendations | Quantity | Price | Cost Estimation |
|---|---|---|---|---|---|--|---|---|--|---|---|---|
| 35 | Women's and Men's Single-User Toilet Room | 2 | | Single-User Toilet | N/A | | Side grab bar < 54" from back wall<br>Side or rear grab bar < 33" or > 36" high | 52"<br>30" | Provide a side wall grab bar that is 42" long min. located 12" max. from the rear wall (54" from the back wall total).<br>Mount grab bars 33"- 36" above the finished floor. | 2 | 750 | \$1500<br><b>1500</b> |

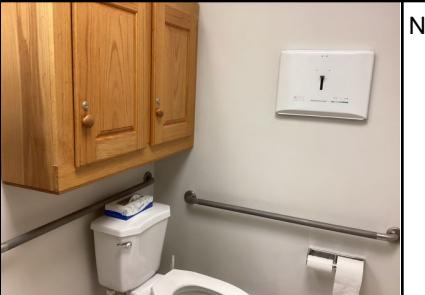
| ID | Location | Floor | Room | Element | Type | Photo | Issues | Current Measure | Recommendations | Quantity | Price | Cost Estimation |
|---|---|---|---|---|---|--|---|---|--|---|---|---|
| 36 | Women's and Men's Single-User Toilet Room | 2 | | Dispensers | Toilet Seat Cover and Cabinet | | Noncompliant operable part | - | Provide a toilet seat cover dispenser that can be operable with one hand and not require tight grasping, pinching, or twisting of the wrist. | 2 | 500 | \$1000<br><b>1000</b> |

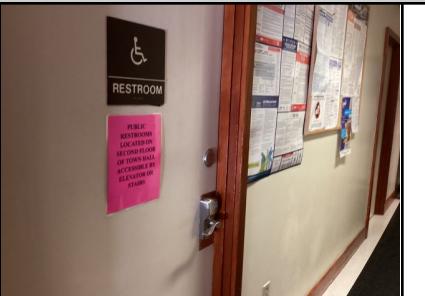
| ID | Location | Floor | Room | Element | Type | Photo | Issues | Current Measure | Recommendations | Quantity | Price | Cost Estimation |
|---|---|---|---|---|---|--|---|---|--|---|---|---|
| 37 | Employee Only Toilet Room on First Floor | 1 | | Sign | Informational | | | | Recommend adding the words, "Employee Only" to the accessible sign at this toilet room, so a low vision or blind visitor won't be waiting at a locked door for a toilet room they won't have access to. | 1 | - | - |

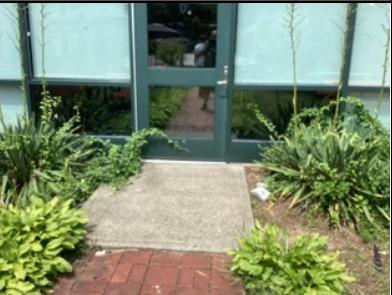
| ID | Location | Floor | Room | Element | Type | Photo | Issues | Current Measure | Recommendations | Quantity | Price | Cost Estimation |
|---|---|---|---|---|---|--|---|---|---|---|---|---|
| 1 | Media Center Courtyard Door 6 | 1 | B6 | Exterior Access Route | Walkway | | Level changes > 1/4" | 1" | Alter change in level to be 1/4" high max. | 1 | - | - |

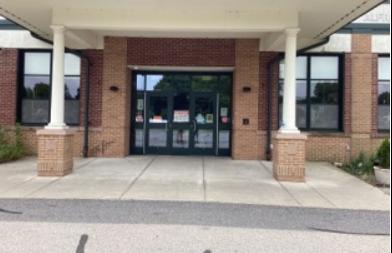
| ID | Location | Floor | Room | Element | Type | Photo | Issues | Current Measure | Recommendations | Quantity | Price | Cost Estimation |
|---|---|---|---|---|---|--|---|---|---|---|---|---|
| 4 | Main Entrance | Ext. | | Exterior Access Route | Exterior | | Level changes > 1/4" | .75" | Alter change in level to be 1/4" high max. | 1 | - | - |
