Town of Oxford

# ADA Self-Evaluation and Transition Plan

July 2024

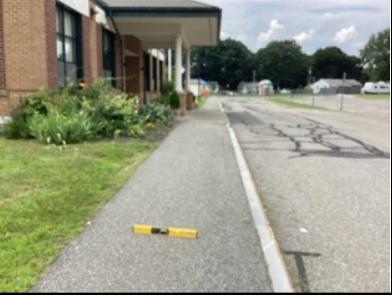
| ID | Location | Floor | Room | Element | Type | Photo | Issues | Current Measure | Recommendations | Quantity | Price | Cost Estimation |
|---|---|---|---|---|---|--|---|---|---|---|---|---|
| 5 | By Main Entrance | Ext. | | Exterior Access Route | Walkway | | Cross slope > 1:50 (2.00%) | 3.7% | Reduce cross slope to be no steeper than 1:50 (2.00%). | 1 | - | - |

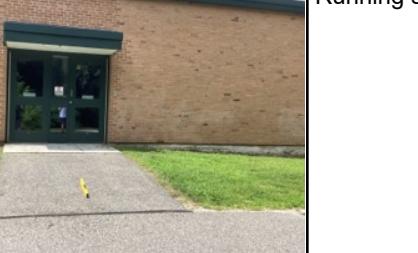
| ID | Location | Floor | Room | Element | Type | Photo | Issues | Current Measure | Recommendations | Quantity | Price | Cost Estimation |
|---|---|---|---|---|---|---|---|---|--|---|---|---|
| 6 | Door 2 East Side | Ext. | | Exterior Access Route | Walkway | | Running slope > 1:20 (5.00%) | 13.% | Reduce running slope to be no steeper than 1:20 (5.00%). or 8.33% (1:12) if treated as a ramp. | 1 | - | - |

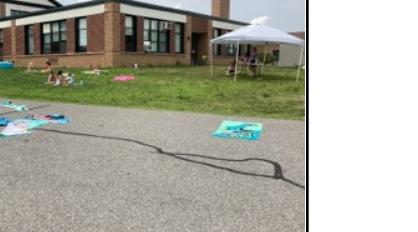
| ID | Location | Floor | Room | Element | Type | Photo | Issues | Current Measure | Recommendations | Quantity | Price | Cost Estimation |
|---|---|---|---|---|---|---|---|---|--|---|---|---|
| 8 | By Playground | Ext. | | Exterior Access Route | Exterior | | Accessible route not provided | - | If used by children or members of the public, ensure a stable, firm and slip resistant accessible route is provided to small above ground pool and tent. | 1 | - | - |

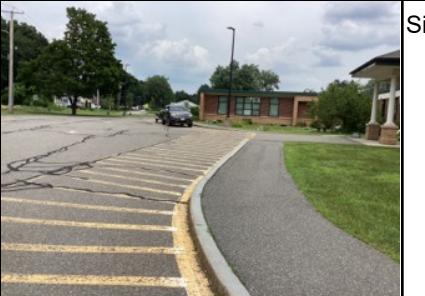
| ID | Location | Floor | Room | Element | Type | Photo | Issues | Current Measure | Recommendations | Quantity | Price | Cost Estimation |
|---|---|---|---|---|---|--|--|---|--|---|---|---|
| 11 | Student Drop-off | Ext. | | Passenger Loading Zones | | | Sign with ISA not provided (MAAB) | - | Provide a sign that includes the International Symbol of Accessibility (ISA) at the head of the passenger loading zone. Locate the sign so that the bottom is 60" min. above the ground and the top is 96" max. above the ground. | 1 | 500 | \$500 |

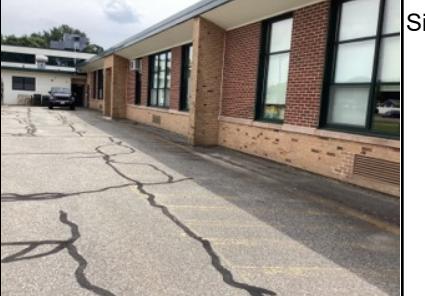
| ID | Location | Floor | Room | Element | Type | Photo | Issues | Current Measure | Recommendations | Quantity | Price | Cost Estimation |
|---|---|---|---|---|---|--|--|---|--|---|---|---|
| 12 | Student Pickup by Playground | Ext. | | Passenger Loading Zones | N/A | | Sign with ISA not provided (MAAB) | - | Provide a sign that includes the International Symbol of Accessibility (ISA) at the head of the loading zone. Locate the sign so that the bottom is 60" min. above the ground and the top is 96" max. above the ground. Re-stripe faded loading zone access aisle. | 1 | 500 | \$500 |

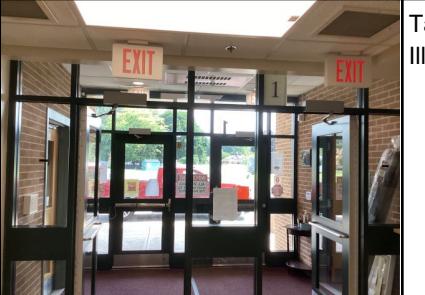
| ID | Location | Floor | Room | Element | Type | Photo | Issues | Current Measure | Recommendations | Quantity | Price | Cost Estimation |
|---|---|---|---|---|---|--|--|---|--|---|---|---|
| 13 | Main Entrance Egress | 1 | | Means of Egress | N/A | | Tactile exit sign not provided<br>Illuminated ISA symbol not provided (MAAB) | -<br>- | Ensure that a tactile exit sign with raised characters and braille is provided at the exit door. Mount the sign between 48"- 60" above the finished floor located on the latch side of the door.<br>Provide an illuminated sign with the International Symbol of Accessibility (ISA)./When the illuminated exit sign is repaired or replaced, provide an illuminated sign with the International | 1 | 250<br>200 | \$450 |

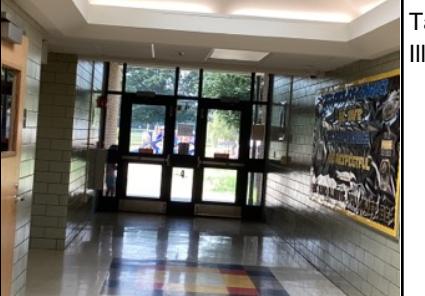
| ID | Location | Floor | Room | Element | Type | Photo | Issues | Current Measure | Recommendations | Quantity | Price | Cost Estimation |
|---|---|---|---|---|---|--|--|---|--|---|---|---|
| 14 | South Egress to Playground Door 4 | 1 | | Means of Egress | N/A | | Tactile exit sign not provided<br>Illuminated ISA symbol not provided (MAAB) | -<br>- | Ensure that a tactile exit sign with raised characters and braille is provided at the exit door. Mount the sign between 48"- 60" above the finished floor located on the latch side of the door.<br>Provide an illuminated sign with the International Symbol of Accessibility (ISA)./When the illuminated exit sign is repaired or replaced, provide an illuminated sign with the International | 1 | 250<br>200 | \$450 |

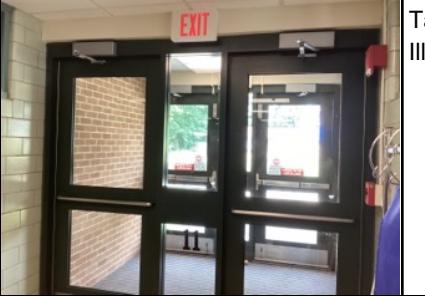
| ID | Location | Floor | Room | Element | Type | Photo | Issues | Current Measure | Recommendations | Quantity | Price | Cost Estimation |
|---|---|---|---|---|---|--|--|---|--|---|---|---|
| 15 | West Egress Door 12 | 1 | | Means of Egress | | | Tactile exit sign not provided<br>Illuminated ISA symbol not provided (MAAB) | -<br>- | Ensure that a tactile exit sign with raised characters and braille is provided at the exit When the illuminated exit sign is repaired or replaced, provide an illuminated sign with the International Symbol of Accessibility (ISA). | 1 | 250<br>200 | \$450 |

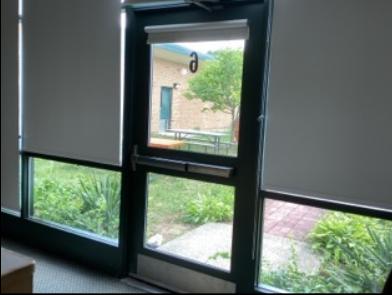
| ID | Location | Floor | Room | Element | Type | Photo | Issues | Current Measure | Recommendations | Quantity | Price | Cost Estimation |
|---|---|---|---|---|---|--|--|---|---|---|---|---|
| 16 | Media Center<br>Door 6 Exit to<br>Enclosed<br>Courtyard | 1 | B6 | Means of<br>Egress | N/A | | Tactile exit sign not provided | - | Ensure that a tactile exit sign with raised characters and braille is provided at the exit door. Mount the sign between 48"- 60" above the finished floor located on the latch side of the door. | 1 | 250 | \$250 |

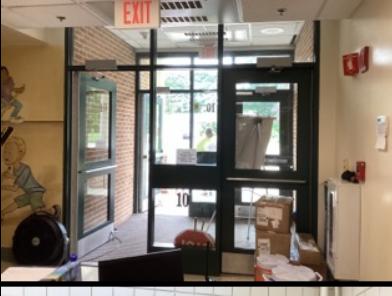
| ID | Location | Floor | Room | Element | Type | Photo | Issues | Current Measure | Recommendations | Quantity | Price | Cost Estimation |
|---|---|---|---|---|---|--|--|---|---|---|---|---|
| 17 | Door 10 | 1 | B6 | Means of<br>Egress | N/A | | Tactile exit sign not provided<br>Illuminated ISA symbol not provided (MAAB) | -<br>- | Ensure that a tactile exit sign with raised characters and braille is provided at the exit door. Mount the sign between 48"- 60" above the finished floor located on the latch side of the door.<br>When the illuminated exit sign is repaired or replaced, provide an illuminated sign with the International Symbol of Accessibility (ISA). | 1 | 250<br>200 | \$450 |

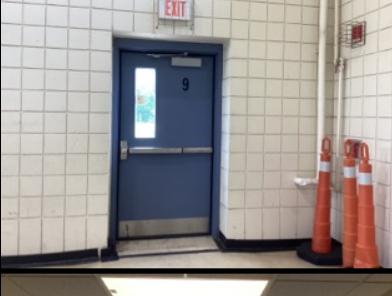
| ID | Location | Floor | Room | Element | Type | Photo | Issues | Current Measure | Recommendations | Quantity | Price | Cost Estimation |
|---|---|---|---|---|---|--|--|---|---|---|---|---|
| 18 | Gymnasium<br>Doors 9 and<br>8 | 1 | B6 | Means of<br>Egress | N/A | | Tactile exit sign not provided<br>Illuminated ISA symbol not provided (MAAB) | -<br>- | Ensure that a tactile exit sign with raised characters and braille is provided at the exit door. Mount the sign between 48"- 60" above the finished floor located on the latch side of the door.<br>When the illuminated exit sign is repaired or replaced, provide an illuminated sign with the International Symbol of Accessibility (ISA). | 2 | 250<br>200 | \$900 |

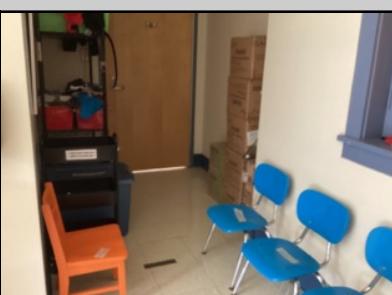
| ID | Location | Floor | Room | Element | Type | Photo | Issues | Current Measure | Recommendations | Quantity | Price | Cost Estimation |
|---|---|---|---|---|---|--|--|---|---|---|---|---|
| 20 | Nurse's<br>Office<br>Second<br>Room | 1 | | Interior<br>Access<br>Route | N/A | | Route < 36" wide | 21" | Ensure that a clear width of 36" min. is maintained at the accessible route. (Relocate one chair.) | 1 | Labor | Labor |

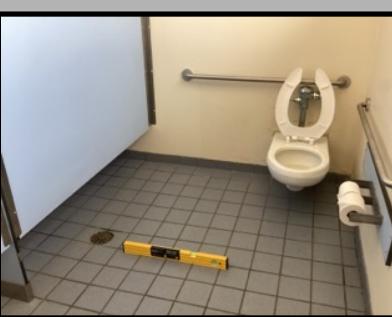
| ID | Location | Floor | Room | Element | Type | Photo | Issues | Current Measure | Recommendations | Quantity | Price | Cost Estimation |
|---|--|---|---|---|---|--|---|---|---|---|---|---|
| 21 | Boys' Multi-User Toilet Room | 1 | | Interior Access Route | N/A | | Cross slope > 1:50 (2.00%) | 4.5% | Reduce cross slope to be no steeper than 1:50 (2.00%)./Further study will be needed to determine whether it is technically feasible to bring the route into full compliance with the ADA Standards. | 1 | - | - |

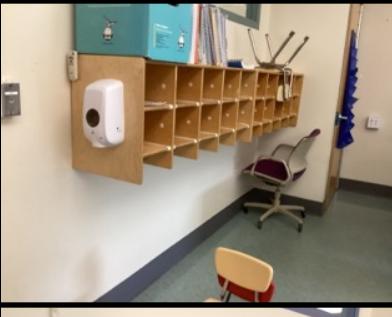
| ID | Location | Floor | Room | Element | Type | Photo | Issues | Current Measure | Recommendations | Quantity | Price | Cost Estimation |
|---|--|---|---|---|---|--|---|---|---|---|---|---|
| 22 | Kindergarten Classroom | 1 | | Interior Access Route | | | Obstructed by protruding objects | 35" | Relocate storage cabinet out of the accessible route or provide a cane-detectable barrier 27" max. above the finished floor below the cabinet. | 1 | 398 | \$398 |

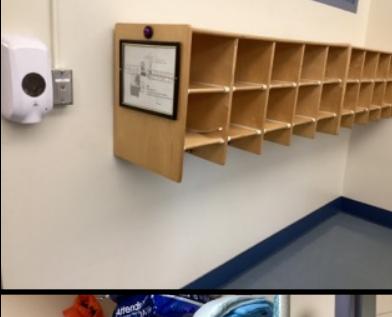
| ID | Location | Floor | Room | Element | Type | Photo | Issues | Current Measure | Recommendations | Quantity | Price | Cost Estimation |
|---|--|---|---|---|---|--|---|---|---|---|---|---|
| 23 | Grade 2 Classroom | 1 | B6 | Interior Access Route | | | Obstructed by protruding objects | 36.75" | Relocate storage out of the accessible route or provide a cane-detectable barrier 27" max. above the finished floor below the storage. | 1 | 398 | \$398 |

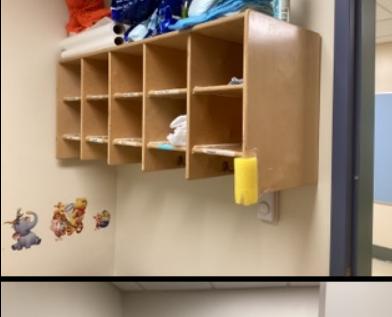
| ID | Location | Floor | Room | Element | Type | Photo | Issues | Current Measure | Recommendations | Quantity | Price | Cost Estimation |
|---|--|---|---|---|---|--|---|---|---|---|---|---|
| 24 | All-Gender Single-User Toilet Room Near Media Center | 1 | B6 | Interior Access Route | | | Obstructed by protruding objects<br>Maneuvering clearance(s) not provided | 50" | Relocate storage out of the accessible route or provide a cane-detectable barrier 27" max. above the finished floor below the storage. | 1 | 398 | \$398 |

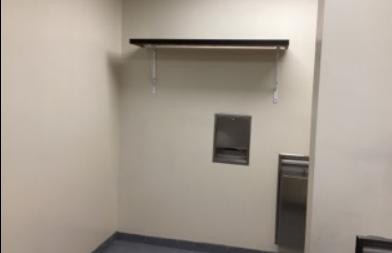
| ID | Location | Floor | Room | Element | Type | Photo | Issues | Current Measure | Recommendations | Quantity | Price | Cost Estimation |
|---|--|---|---|---|---|--|---|---|---|---|---|---|
| 25 | Boys' Multi-User Toilet Room by Gymnasium | 1 | B6 | Interior Access Route | | | Obstructed by protruding objects | 70" | Provide a cane-detectable barrier 27" max. above the ground below the shelf. | 1 | 398 | \$398 |

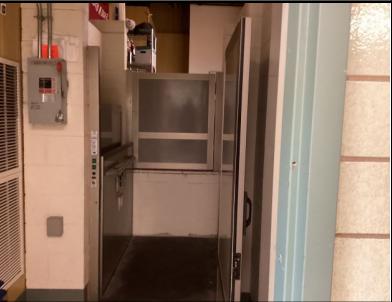
| ID | Location | Floor | Room | Element | Type | Photo | Issues | Current Measure | Recommendations | Quantity | Price | Cost Estimation |
|---|---|---|---|---|---|--|---|---|---|---|---|---|
| 27 | Lift to Stage in Cafetorium | 1 | | Doors, Doorways, & Gates | | | Door requires > 5 lbs. of force to open | - | Adjust closers so doors do not require more than 5 pounds of force to open. | 1 | Labor | Labor |

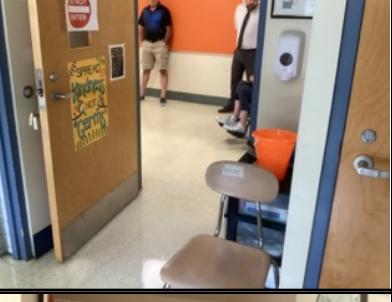
| ID | Location | Floor | Room | Element | Type | Photo | Issues | Current Measure | Recommendations | Quantity | Price | Cost Estimation |
|---|---|---|---|---|---|--|---|---|---|---|---|---|
| 28 | Nurse's Office | 1 | | Doors, Doorways, & Gates | Office | | Maneuvering clearance(s) not provided | 1" | Relocate chair and stored items to provide 18" min. pull-side maneuvering clearance. | 1 | Labor | Labor |

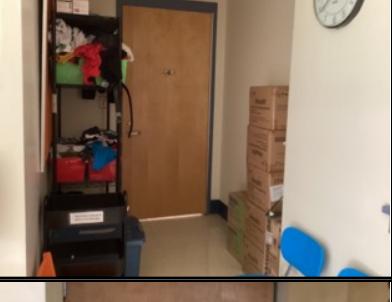
| ID | Location | Floor | Room | Element | Type | Photo | Issues | Current Measure | Recommendations | Quantity | Price | Cost Estimation |
|---|---|---|---|---|---|--|---|---|---|---|---|---|
| 29 | Nurse's Office Second Room | 1 | | Doors, Doorways, & Gates | | | Maneuvering clearance(s) not provided | 1" | Relocate shelving and stored items to provide 18" min. pull-side maneuvering clearance. | 1 | Labor | Labor |

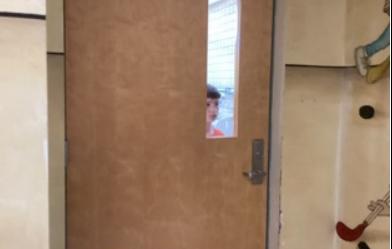
| ID | Location | Floor | Room | Element | Type | Photo | Issues | Current Measure | Recommendations | Quantity | Price | Cost Estimation |
|---|---|---|---|---|---|--|---|---|---|---|---|---|
| 30 | Gymnasium | 1 | B6 | Doors, Doorways, & Gates | N/A | | Maneuvering clearance(s) not provided | 16.5" | Provide an automatic door opener to provide 18" min. pull side maneuvering clearance at the door. | 1 | 6000 | \$6000 |

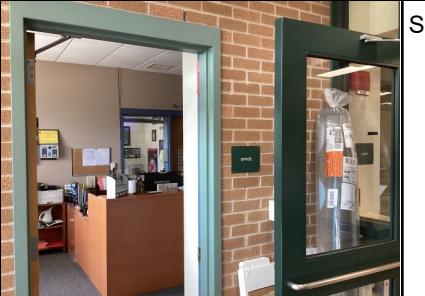
| ID | Location | Floor | Room | Element | Type | Photo | Issues | Current Measure | Recommendations | Quantity | Price | Cost Estimation |
|---|---|---|---|---|---|--|--|---|---|---|---|---|
| 31 | Office | 1 | | Signage | Designation | | Signage lacks 18" by 18" clear floor space | - | Remove stored items below sign. Ensure door swing does not interfere with clear floor space at sign. | 1 | Labor | Labor |

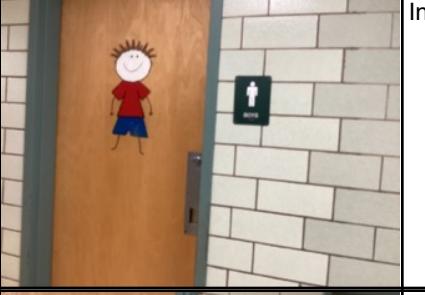
| ID | Location | Floor | Room | Element | Type | Photo | Issues | Current Measure | Recommendations | Quantity | Price | Cost Estimation |
|---|---|---|---|---|---|--|--|---|---|---|---|---|
| 32 | Boys' Multi-User Toilet Room | 1 | | Signage | Designation | | International Symbol of Acc. not provided | - | Replace the sign with a sign containing the International Symbol of Accessibility (ISA).<br><b>Note:</b> Adding a sign with the International Symbol of Accessibility (ISA) at accessible toilet rooms that do not have an ISA sign is not required if every toilet room in the school is accessible. | 1 | 250 | \$250 |

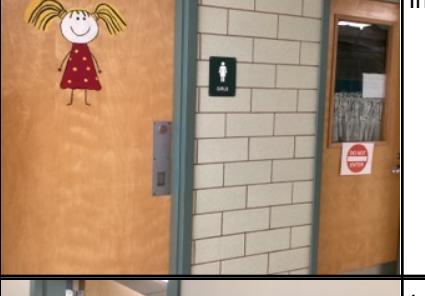
| ID | Location | Floor | Room | Element | Type | Photo | Issues | Current Measure | Recommendations | Quantity | Price | Cost Estimation |
|---|---|---|---|---|---|--|--|---|---|---|---|---|
| 33 | Girls' Multi-User Toilet Room | 1 | | Signage | Designation | | International Symbol of Acc. not provided | - | Replace the sign with a sign containing the International Symbol of Accessibility (ISA).<br><b>Note:</b> Adding a sign with the International Symbol of Accessibility (ISA) at accessible toilet rooms that do not have an ISA sign is not required if every toilet room in the school is accessible. | 1 | 250 | \$250 |

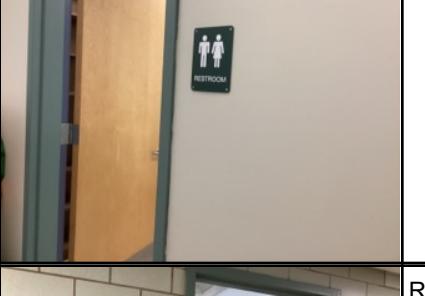
| ID | Location | Floor | Room | Element | Type | Photo | Issues | Current Measure | Recommendations | Quantity | Price | Cost Estimation |
|---|---|---|---|---|---|--|--|---|---|---|---|---|
| 34 | Kindergarten Multi-User Children's | 1 | | Signage | Designation | | International Symbol of Acc. not compliant | - | Provide a sign with the required International Symbol of Accessibility (ISA).<br><b>Note:</b> Adding a sign with the International Symbol of Accessibility (ISA) at accessible toilet rooms that do not have an ISA sign is not required if every toilet room in the school is accessible. | 1 | 250 | \$250 |

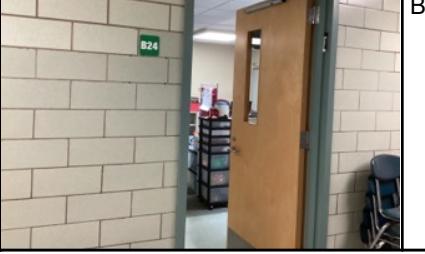
| ID | Location | Floor | Room | Element | Type | Photo | Issues | Current Measure | Recommendations | Quantity | Price | Cost Estimation |
|---|---|---|---|---|---|--|--|---|---|---|---|---|
| 35 | First Grade | 1 | B24 | Signage | Designation | | Raised characters not provided on sign<br>Braille not provided on sign | -<br>- | Provide text with raised characters duplicated in braille on the sign. | 1 | 250 | \$250 |

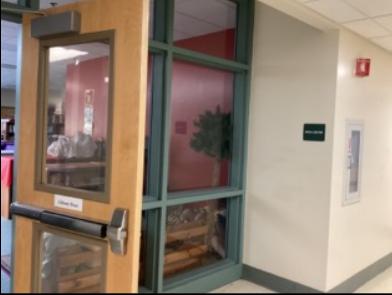
| ID | Location | Floor | Room | Element | Type | Photo | Issues | Current Measure | Recommendations | Quantity | Price | Cost Estimation |
|---|---|---|---|---|---|--|--|---|---|---|---|---|
| 36 | Media Center | 1 | B6 | Signage | Designation | | Sign not located on the latch side of the door | - | Locate the sign at permanent rooms alongside the door on the latch side. (Relocate sign to glass closer to the door latch.) | 1 | Labor | Labor |

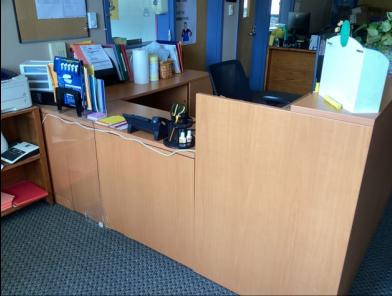
| ID | Location | Floor | Room | Element | Type | Photo | Issues | Current Measure | Recommendations | Quantity | Price | Cost Estimation |
|---|---|---|---|---|---|--|--|---|---|---|---|---|
| 38 | Office | 1 | | Service Counter | N/A | | Counter > 36" high | - | Remove stored items from the lower accessible portion of the service counter. | 1 | Labor | Labor |

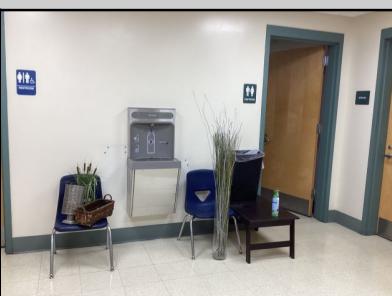
| ID | Location | Floor | Room | Element | Type | Photo | Issues | Current Measure | Recommendations | Quantity | Price | Cost Estimation |
|---|---|---|---|---|---|--|--|---|---|---|---|---|
| 39 | By Toilet Room | 1 | | Operable Parts / Reach Range | Bottle Filler | | Clear floor space is not provided<br>Not compliant | -<br>- | Relocate chairs and stored items to provide a 30" min. by 48" min. clear floor space and to allow for a parallel approach to the bottle filler. | 1 | Labor | Labor |

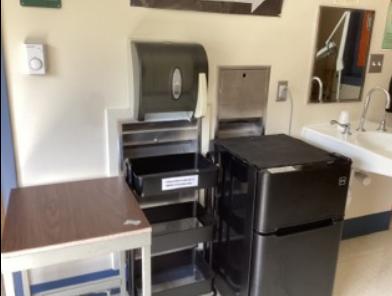
| ID | Location | Floor | Room | Element | Type | Photo | Issues | Current Measure | Recommendations | Quantity | Price | Cost Estimation |
|---|---|---|---|---|---|--|--|---|---|---|---|---|
| 40 | Outside Nurse's Office All-Gender Single-User Toilet Room | 1 | | Operable Parts / Reach Range | Equipment | | Clear floor space is not provided | - | Relocate stored items to provide a 30" min. by 48" min. clear floor space at paper towel dispenser. | 1 | Labor | Labor |

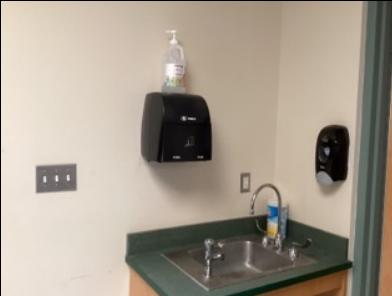
| ID | Location | Floor | Room | Element | Type | Photo | Issues | Current Measure | Recommendations | Quantity | Price | Cost Estimation |
|---|--|---|---|---|---|--|--|---|--|---|---|---|
| 41 | First Grade | 1 | B24 | Children's Reach Ranges | Paper Towel Dispenser | | Reach < 18" or > 40" (Ages 5 - 8) | 50" | Relocate so the operable part of the paper towel dispenser so it is between 18" and 40" above the finished floor. | 1 | 500 | 500 |

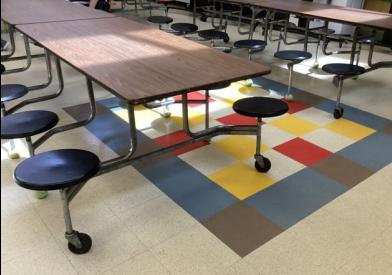
| ID | Location | Floor | Room | Element | Type | Photo | Issues | Current Measure | Recommendations | Quantity | Price | Cost Estimation |
|---|--|---|---|---|---|--|--|---|--|---|---|---|
| 42 | Cafetorium | 1 | | Dining or Work Surfaces | Dining Surface | | Knee clearance less than 19" deep | 14" | Provide at least one dining or work surface with knee clearance that is 19" deep min. | 1 | 1430 | \$1430 |

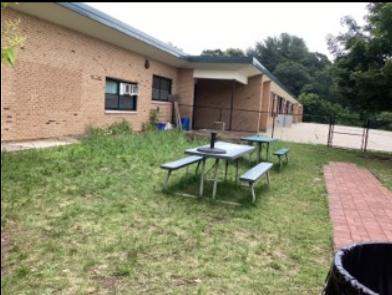
| ID | Location | Floor | Room | Element | Type | Photo | Issues | Current Measure | Recommendations | Quantity | Price | Cost Estimation |
|---|--|---|---|---|---|--|--|---|--|---|---|---|
| 43 | Media Center Courtyard | 1 | B6 | Dining or Work Surfaces | Dining Surface | | Not on a accessible route<br>Knee or toe clearance not provided<br>Knee clearance less than 19" deep | -<br>-<br>12" | Ensure dining or work surfaces are located on an accessible route.<br>Provide at least one dining or work surface with 27" min. high knee and toe clearance. For children, provide at least one dining or work surface with 24" min. high knee and toe clearance.<br>Provide at least one dining or work surface with knee clearance that is 19" deep min. | 1 | 1400 | \$1400 |

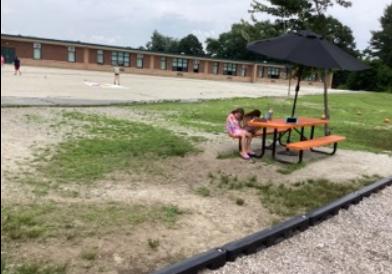
| ID | Location | Floor | Room | Element | Type | Photo | Issues | Current Measure | Recommendations | Quantity | Price | Cost Estimation |
|---|--|---|---|---|---|--|--|---|--|---|---|---|
| 44 | Playground 2 South Side | Ext. | | Dining or Work Surfaces | Dining Surface | | Not on a accessible route<br>At least one or 5% accessible tables not provided | 2<br>- | Ensure at least one picnic table in this area is located on an accessible route.<br>Ensure that at least one picnic table in this area is accessible. | 1 | 1400 | \$1400 |

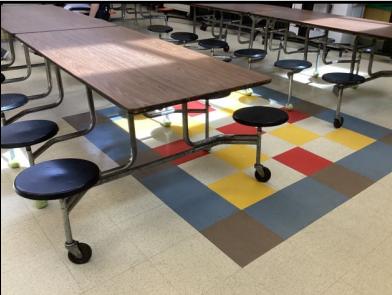
| ID | Location | Floor | Room | Element | Type | Photo | Issues | Current Measure | Recommendations | Quantity | Price | Cost Estimation |
|---|--|---|---|---|---|--|--|---|--|---|---|---|
| 45 | Cafetorium, Gym or Individual Classrooms | 1 | | Assembly Area | N/A | | Assistive listening devices not provided | - | If audible communication is integral to the use of the space, provide an assistive listening system. | 1 | 1430 | \$1430 |

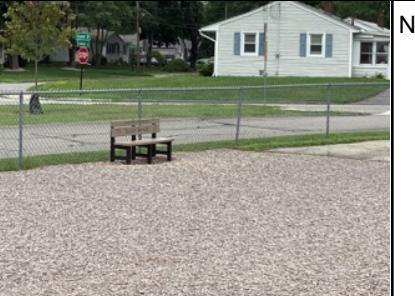
| ID | Location | Floor | Room | Element | Type | Photo | Issues | Current Measure | Recommendations | Quantity | Price | Cost Estimation |
|---|---|---|---|---|---|--|---|---|---|---|---|---|
| 46 | Playground | Ext. | | Exterior Benches | N/A | | No accessible route to one bench in area | - | Relocate one bench to an accessible route or provide an accessible route to one bench in this area.<br><b>Note:</b> The Massachusetts Architectural Access Board (MAAB) does not consider engineered wood fiber (EWF) to comply with its regulation requiring an accessible route to each play component and around the playground. | 1 | - | - |

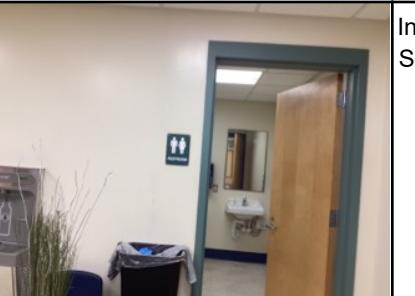
| ID | Location | Floor | Room | Element | Type | Photo | Issues | Current Measure | Recommendations | Quantity | Price | Cost Estimation |
|---|---|---|---|---|---|--|---|---|---|---|---|---|
| 47 | Second Single-User All-Gender Toilet Room by Cafeteria | 1 | | Overall Access | Toilet Room | | International Symbol of Acc. not provided<br>Signage lacks 18" by 18" clear floor space | - | Provide a sign with the International Symbol of Accessibility (ISA).<br><b>Note:</b> Adding a sign with the International Symbol of Accessibility (ISA) at accessible toilet rooms that do not have an ISA sign is not required if every toilet room in the school is accessible. | 1 | 250 Labor | \$250 |

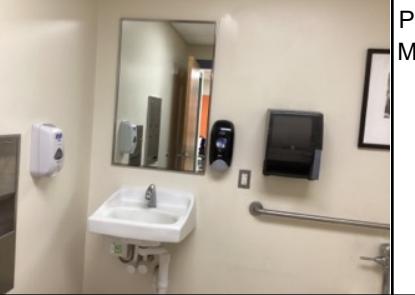
| ID | Location | Floor | Room | Element | Type | Photo | Issues | Current Measure | Recommendations | Quantity | Price | Cost Estimation |
|---|---|---|---|---|---|--|---|---|---|---|---|---|
| 48 | One of Two Single-User All-Gender Toilet Rooms by Cafeteria | 1 | | Lavatory | N/A | | Plumbing underneath is exposed<br>Mirror above lavatory w/reflective surface > 40" | - 42" | Insulate or otherwise configure pipes to prevent contact for at least one lavatory.<br>Lower mirror so that the bottom surface is at 40" max. above the finished floor. | 1 | 150 333 | \$483 |

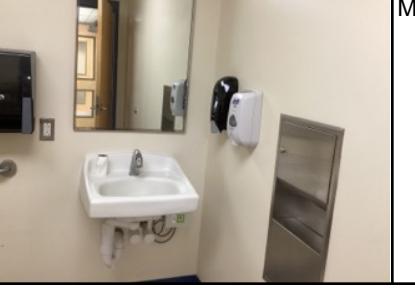
| ID | Location | Floor | Room | Element | Type | Photo | Issues | Current Measure | Recommendations | Quantity | Price | Cost Estimation |
|---|---|---|---|---|---|--|---|---|---|---|---|---|
| 49 | Second Single-User All-Gender Toilet Room by Cafeteria | 1 | | Lavatory | N/A | | Mirror above lavatory w/reflective surface > 40" | 42" | Lower mirror so that the bottom surface is at 40" max. above the finished floor. | 1 | 333 | \$333 |

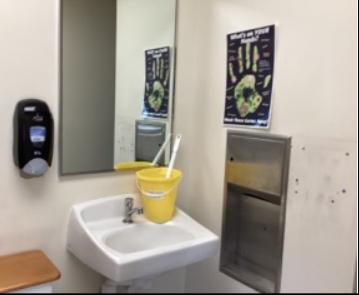
| ID | Location | Floor | Room | Element | Type | Photo | Issues | Current Measure | Recommendations | Quantity | Price | Cost Estimation |
|---|--|---|---|---|---|--|--|---|--|---|---|---|
| 50 | Nurse's Office Single-User All-Gender Toilet Room | 1 | | Lavatory | N/A | | Mirror above lavatory w/reflective surface > 40" | 42" | Lower mirror so that the bottom surface is at 40" max. above the finished floor. | 1 | 333 | \$333 |

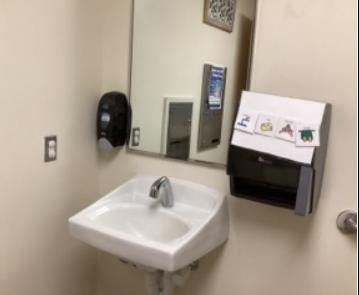
| ID | Location | Floor | Room | Element | Type | Photo | Issues | Current Measure | Recommendations | Quantity | Price | Cost Estimation |
|---|--|---|---|---|---|--|--|---|--|---|---|---|
| 51 | All-Gender Single-User Toilet Room Near Media Center | 1 | B6 | Lavatory | 453 | | Mirror above lavatory w/reflective surface > 40" | 42" | Lower mirror so that the bottom surface is at 40" max. above the finished floor. | 1 | 333 | \$333 |

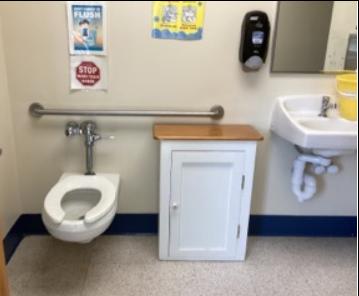
| ID | Location | Floor | Room | Element | Type | Photo | Issues | Current Measure | Recommendations | Quantity | Price | Cost Estimation |
|---|--|---|---|---|---|--|--|---|--|---|---|---|
| 52 | Nurse's Office Single-User All-Gender Toilet Room | 1 | | Single-User Toilet | N/A | | Clearance at toilet < 60" clear width | - | Relocate cabinet to ensure that there is 60" wide min. clear floor space at the toilet. | 1 | Labor | Labor |

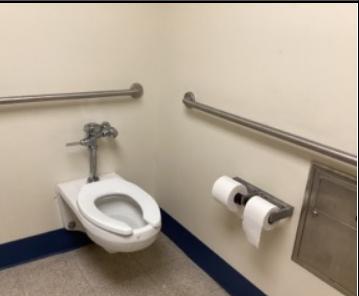
| ID | Location | Floor | Room | Element | Type | Photo | Issues | Current Measure | Recommendations | Quantity | Price | Cost Estimation |
|---|--|---|---|---|---|--|--|---|--|---|---|---|
| 53 | All-Gender Single-User Toilet Room Near Media Center | 1 | B6 | Single-User Toilet | N/A | | Side or rear grab bar < 33" or > 36" high | 37" | Mount grab bars 33"- 36" above the finished floor. | 1 | 333 | \$333 |

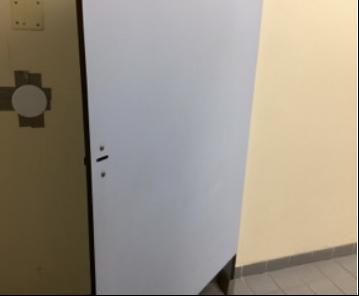
| ID | Location | Floor | Room | Element | Type | Photo | Issues | Current Measure | Recommendations | Quantity | Price | Cost Estimation |
|---|--|---|---|---|---|--|--|---|--|---|---|---|
| 54 | Boys' Multi-User Toilet Room by Gymnasium | 1 | B6 | Toilet Compartment | Accessible Compartment | | Door has noncompliant hardware<br>Door has malfunctioning self-closing hinge | -<br>- | Provide hardware that can be operable with one hand and not require tight grasping, pinching, or twisting of the wrist.<br>Repair hinge. | 1 | 750 | \$750 |

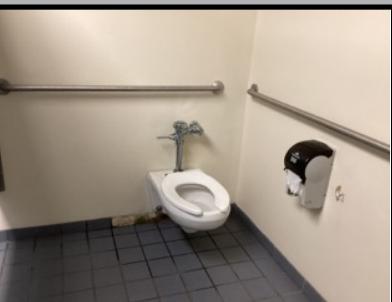
| ID | Location | Floor | Room | Element | Type | Photo | Issues | Current Measure | Recommendations | Quantity | Price | Cost Estimation |
|---|--|---|---|---|---|---|--|---|---|---|---|---|
| 55 | Boys' Multi-User Toilet Room by Gymnasium | 1 | B6 | Toilet Compartment | Accessible Compartment | | Toilet seat <17" or > 19" high<br>Side or rear grab bar < 33" or >36" high<br>Centerline < or > 18" (MAAB) | 16.5"<br>37"<br>19" | Install a toilet with a seat height 17"- 19" above the finished floor.<br>Locate grab bars between 33"- 36" above the finished floor.<br>Relocate toilet so the centerline is 18" from the side wall. | 1 | 3676<br>333<br><br><b>4009</b> | \$4009 |

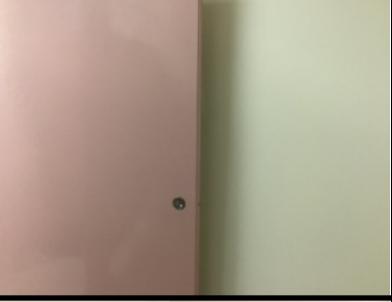
| ID | Location | Floor | Room | Element | Type | Photo | Issues | Current Measure | Recommendations | Quantity | Price | Cost Estimation |
|---|--|---|---|---|---|---|--|---|---|---|---|---|
| 56 | Girls' Multi-User Toilet Room by Gymnasium | 1 | B6 | Toilet Compartment | Accessible Compartment | | Door has noncompliant hardware<br>Door has malfunctioning self-closing hinge | -<br>- | Provide hardware that can be operable with one hand and not require tight grasping, pinching, or twisting of the wrist.<br>Repair hinge. | 1 | 91<br><br><b>91</b> | \$91 |

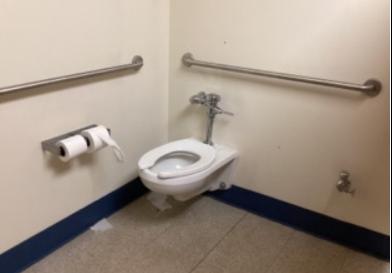
| ID | Location | Floor | Room | Element | Type | Photo | Issues | Current Measure | Recommendations | Quantity | Price | Cost Estimation |
|---|--|---|---|---|---|---|--|---|---|---|---|---|
| 57 | Girls' Multi-User Toilet Room by Gymnasium | 1 | B6 | Toilet Compartment | | | Centerline < or > 18" (MAAB) | 16" | Relocate toilet so the centerline is 18" from the side wall. | 1 | 3676<br><br><b>3676</b> | \$3676 |

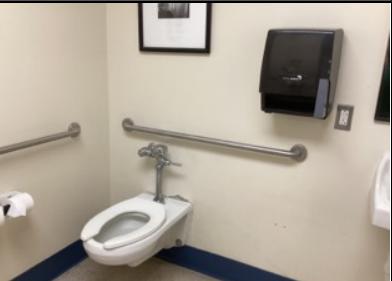
| 59 | Second Single-User All-Gender Toilet Room by Cafeteria | 1 | | Dispensers | Paper Towel Dispenser | | Noncompliant operable part | - | Ensure paper towel dispenser is not located above the grab bar. | 1 | 500<br><br><b>500</b> | \$500 |

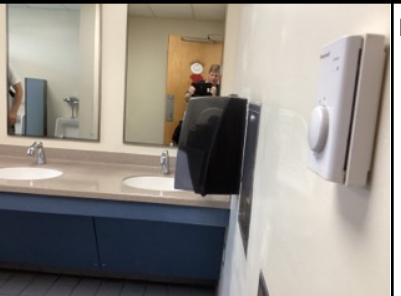
| ID | Location | Floor | Room | Element | Type | Photo | Issues | Current Measure | Recommendations | Quantity | Price | Cost Estimation |
|---|---|---|---|---|---|--|--|---|---|---|---|---|
| 60 | Boys' Multi-User Toilet Room | 1 | | Dispensers | Paper Towel Dispenser | | Dispenser acts as a protruding object | 10" | Relocate dispenser out of the circulation path or provide a cane-detectable barrier 27" max. above the finished floor below the paper towel dispenser. | 1 | 398 | \$398 |

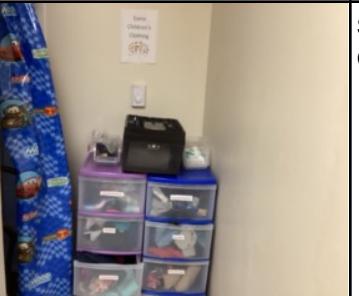
| ID | Location | Floor | Room | Element | Type | Photo | Issues | Current Measure | Recommendations | Quantity | Price | Cost Estimation |
|---|---|---|---|---|---|--|--|---|---|---|---|---|
| 61 | Nurse's Office Shower | 1 | | Shower Compartment | Transfer Type | | Shower not on an accessible route<br>Clear space at transfer shower < 48" x 36" | - 35" | Provide a 48" x 36" clear floor space for a transfer shower. (Relocate stored items.) | 1 | Labor | Labor |

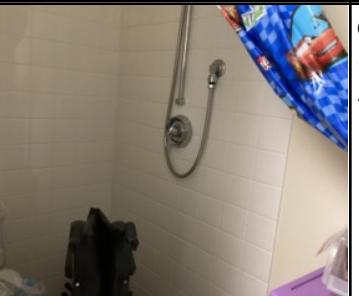
| ID | Location | Floor | Room | Element | Type | Photo | Issues | Current Measure | Recommendations | Quantity | Price | Cost Estimation |
|---|---|---|---|---|---|--|--|---|---|---|---|---|
| 62 | Nurse's Office Shower | 1 | | Shower Compartment | Transfer Type | | Grab bars not provided<br>Seat not provided (transfer compartment)<br>Accessible shower not provided | 34" - - - | Provide compliant grab bars depending on shower type.<br>Provide a folding seat.<br>Provide at least one accessible shower. | 1 | 7894 | \$7894 |

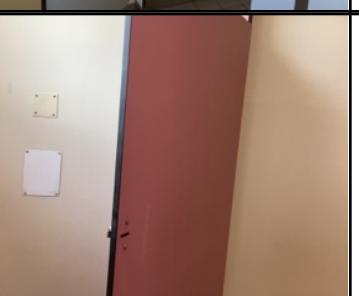
| ID | Location | Floor | Room | Element | Type | Photo | Issues | Current Measure | Recommendations | Quantity | Price | Cost Estimation |
|---|---|---|---|---|---|--|--|---|---|---|---|---|
| 64 | Girls' Multi-User Toilet Room | 1 | | Toilet Compartment (Children) | Accessible Compartment | | Door with malfunctioning self-closing hinge<br>Door pull not provided | - - | Repair self-closing hinge.<br>Provide a door pull on each side of the door between 34" to 48" above the finished floor that does not require tight grasping, pinching or twisting of the wrist. | 1 | Labor 91 | \$91 |

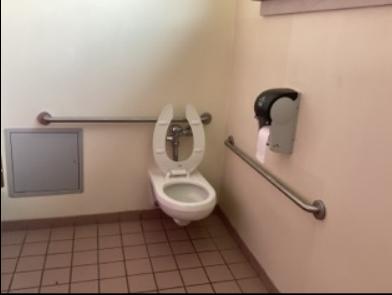
| ID | Location | Floor | Room | Element | Type | Photo | Issues | Current Measure | Recommendations | Quantity | Price | Cost Estimation |
|---|--|---|---|---|---|--|--|---|---|---|---|---|
| 65 | Girls' Multi-User Toilet Room | 1 | | Toilet Compartment (Children) | Accessible Compartment | | Side or rear grab bar < 25" or > 27" high (Ages 9 - 12)<br>Noncompliant toilet paper dispenser | 31" - | Relocate rear grab bar to 25"- 27" above the finished floor.<br>Relocate toilet paper dispenser so that it is between 14"- 19" above the finished floor and between 7"- 9" in front of the toilet. Ensure dispensers and other devices are not mounted above grab bars./Replace dispenser as it does not allow continuous paper flow. | 1 | 333<br>500<br><br><b>833</b> | \$833 |

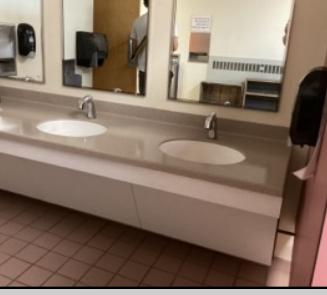
| ID | Location | Floor | Room | Element | Type | Photo | Issues | Current Measure | Recommendations | Quantity | Price | Cost Estimation |
|---|--|---|---|---|---|--|--|---|---|---|---|---|
| 66 | Boys' and Girls' Multi-User Toilet Rooms | 1 | | Lavatory (Children) | N/A | | Mirror above lavatory w/reflective surface > 31" | 36" | Lower mirror so that the bottom surface is at 31" above the finished floor. | 2 | 333<br><br><b>666</b> | \$666 |

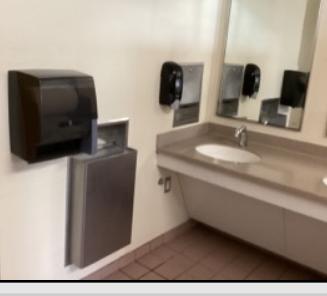
| ID | Location | Floor | Room | Element | Type | Photo | Issues | Current Measure | Recommendations | Quantity | Price | Cost Estimation |
|---|--|---|---|---|---|--|--|---|---|---|---|---|
| 67 | Girls' Multi-User Toilet Room | 1 | | Dispensers (Children) | Paper Towel Dispenser | | Dispenser acts as a protruding object | - | Relocate paper towel dispenser out of the circulation path or provide a cane-detectable barrier 27" max. above the ground under the paper towel dispenser. | 1 | 398<br><br><b>398</b> | \$398 |

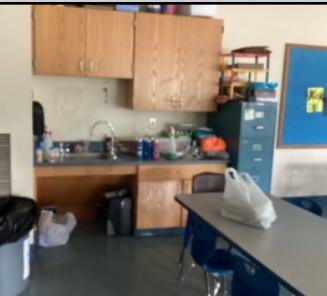
| ID | Location | Floor | Room | Element | Type | Photo | Issues | Current Measure | Recommendations | Quantity | Price | Cost Estimation |
|---|--|---|---|---|---|--|--|---|---|---|---|---|
| 68 | Art | 1 | C24 | Sink | | | Clear floor space not provided at sink | - | Provide a 30" by 48" clear floor space positioned for a forward approach. (Move stored items under the sink.) | 1 | Labor | Labor |

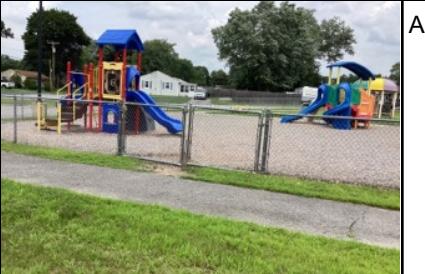
| ID | Location | Floor | Room | Element | Type | Photo | Issues | Current Measure | Recommendations | Quantity | Price | Cost Estimation |
|---|---|---|---|---|---|--|--|---|---|---|---|---|
| 69 | Playground | Ext. | | Play Areas | N/A | | Accessible route not provided to playground | - | Install a stable, firm and slip resistant accessible route to the playground entry. | 1 | Labor | Labor |

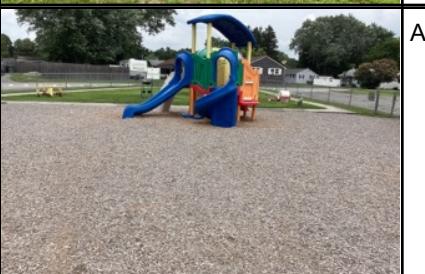
| ID | Location | Floor | Room | Element | Type | Photo | Issues | Current Measure | Recommendations | Quantity | Price | Cost Estimation |
|---|---|---|---|---|---|--|--|---|---|---|---|---|
| 70 | Playground | Ext. | | Play Areas | N/A | | Accessible route not provided to play components | - | Provide a compliant impact-attenuating surface to and around the play components.<br><b>Note:</b> The Massachusetts Architectural Access Board (MAAB) does not consider engineered wood fiber (EWF) to comply with its regulation requiring an accessible route to each play component and around the playground. | 1 | - | - |

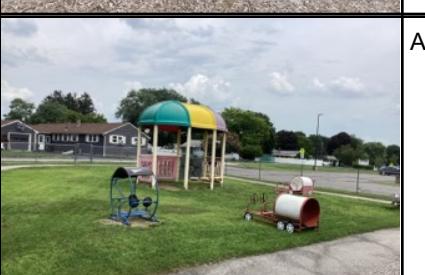
| ID | Location | Floor | Room | Element | Type | Photo | Issues | Current Measure | Recommendations | Quantity | Price | Cost Estimation |
|---|---|---|---|---|---|--|--|---|---|---|---|---|
| 71 | Playground | Ext. | | Play Areas | N/A | | Accessible route not provided to play components | - | Provide a compliant impact-attenuating surface to and around the play components.<br><b>Note:</b> The Massachusetts Architectural Access Board (MAAB) does not consider engineered wood fiber (EWF) to comply with its regulation requiring an accessible route to each play component and around the playground. | 1 | - | - |

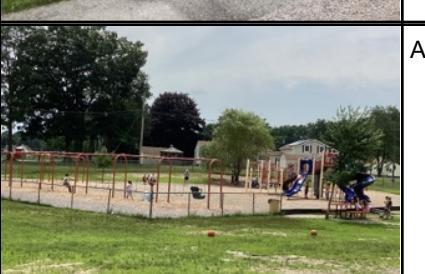
| ID | Location | Floor | Room | Element | Type | Photo | Issues | Current Measure | Recommendations | Quantity | Price | Cost Estimation |
|---|---|---|---|---|---|--|--|---|---|---|---|---|
| 72 | Playground 2 South Side | Ext. | | Play Areas | N/A | | Accessible route not provided to play components | - | Provide a compliant impact-attenuating surface to and around the play components.<br><b>Note:</b> The Massachusetts Architectural Access Board (MAAB) does not consider engineered wood fiber (EWF) to comply with its regulation requiring an accessible route to each play component and around the playground. | 1 | - | - |

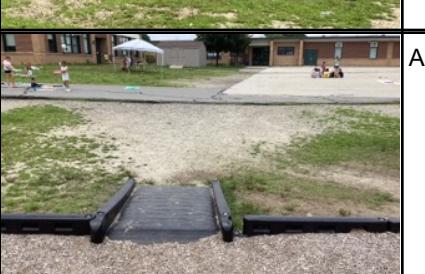
| ID | Location | Floor | Room | Element | Type | Photo | Issues | Current Measure | Recommendations | Quantity | Price | Cost Estimation |
|---|---|---|---|---|---|--|--|---|---|---|---|---|
| 73 | Playground 2 South Side | Ext. | | Play Areas | N/A | | Accessible route not provided to playground | 2" | Install a stable, firm and slip resistant accessible route to and around the playground. | 1 | - | - |

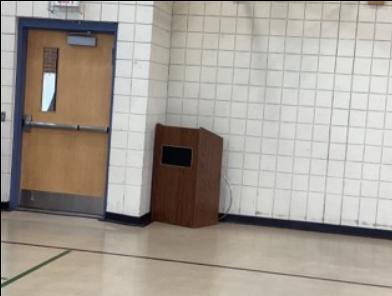
| ID | Location | Floor | Room | Element | Type | Photo | Issues | Current Measure | Recommendations | Quantity | Price | Cost Estimation |
|---|---|---|---|---|---|--|---|---|--|---|---|---|
| 74 | Gymnasium | 1 | B6 | Podium | N/A | | | | Recommend providing an adjustable height podium with knee and toe clearance positioned for a forward approach. | 1 | - | - |

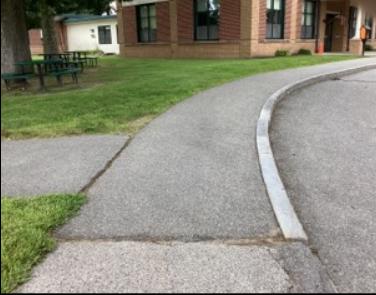
| ID | Location | Floor | Room | Element | Type | Photo | Issues | Current Measure | Recommendations | Quantity | Price | Cost Estimation |
|---|---|---|---|---|---|--|---|---|--|---|---|---|
| 6 | By Front Entrance | Ext. | | Exterior Access Route | Walkway | | Surface openings > 1/2" | 2" | Repair so that openings are 1/2" max. | 1 | - | - |

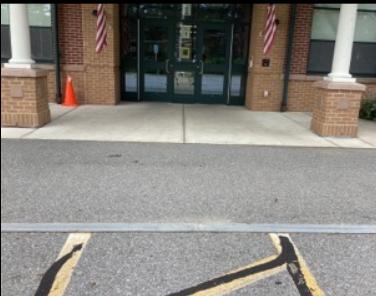
| ID | Location | Floor | Room | Element | Type | Photo | Issues | Current Measure | Recommendations | Quantity | Price | Cost Estimation |
|---|---|---|---|---|---|--|---|---|--|---|---|---|
| 7 | Door 1 Main Entrance | Ext. | | Exterior Access Route | Exterior | | Level changes > 1/4" | .75" | Alter change in level to be 1/4" high max. | 1 | - | - |

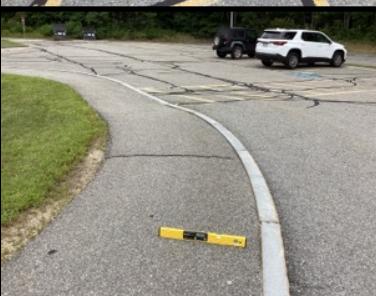
| ID | Location | Floor | Room | Element | Type | Photo | Issues | Current Measure | Recommendations | Quantity | Price | Cost Estimation |
|---|---|---|---|---|---|--|---|---|--|---|---|---|
| 8 | By Door 11 | Ext. | | Exterior Access Route | Walkway | | Surface openings > 1/2"<br>Cross slope > 1:50 (2.00%) | 1"<br>3.11% | Repair so that openings are 1/2" max.<br>Reduce cross slope to be no steeper than 1:50 (2.00%). | 1 | - | - |

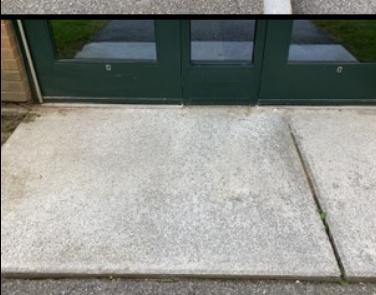
| ID | Location | Floor | Room | Element | Type | Photo | Issues | Current Measure | Recommendations | Quantity | Price | Cost Estimation |
|---|---|---|---|---|---|--|---|---|--|---|---|---|
| 9 | Door 10 | Ext. | | Exterior Access Route | Exterior | | Surface openings > 1/2" | 1" | Repair so that openings are 1/2" max. and the long opening dimension is perpendicular to the dominant direction of travel. | 1 | Labor | Labor |

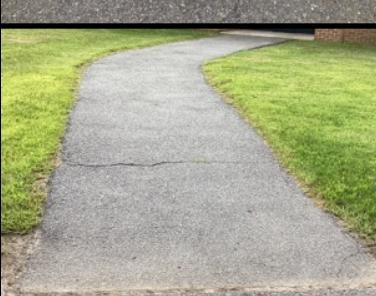
| ID | Location | Floor | Room | Element | Type | Photo | Issues | Current Measure | Recommendations | Quantity | Price | Cost Estimation |
|---|---|---|---|---|---|--|---|---|--|---|---|---|
| 10 | Door 6 | Ext. | | Exterior Access Route | Walkway | | Level changes > 1/4" | 1" | Alter change in level to be 1/4" high max. | 1 | Labor | Labor |

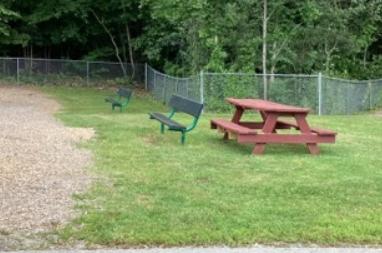
| ID | Location | Floor | Room | Element | Type | Photo | Issues | Current Measure | Recommendations | Quantity | Price | Cost Estimation |
|---|---|---|---|---|---|--|---|---|--|---|---|---|
| 11 | Playground | Ext. | | Exterior Access Route | Exterior | | Accessible route not provided | - | Ensure an accessible route is provided. | 1 | Labor | Labor |

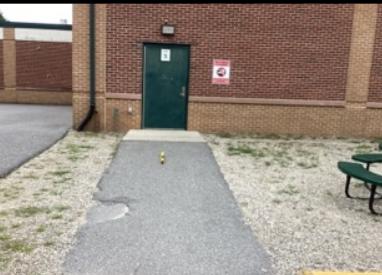
| ID | Location | Floor | Room | Element | Type | Photo | Issues | Current Measure | Recommendations | Quantity | Price | Cost Estimation |
|---|---|---|---|---|---|--|---|---|--|---|---|---|
| 12 | Egress Door 5 by Playground | Ext. | | Exterior Access Route | Exterior | | Surface openings > 1/2"<br>Running slope > 1:20 (5.00%) | 5"<br>8.1% | Replace or reposition so that openings are 1/2" max. and the long opening dimension is perpendicular to the dominant direction of travel. Reduce running slope to be no steeper than 1:20 (5.00%). | 1 | Labor | Labor |

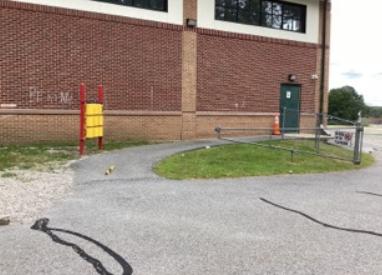
| ID | Location | Floor | Room | Element | Type | Photo | Issues | Current Measure | Recommendations | Quantity | Price | Cost Estimation |
|---|---|---|---|---|---|--|---|---|--|---|---|---|
| 13 | Door 4 | Ext. | | Exterior Access Route | Exterior | | Running slope > 1:20 (5.00%) | 7% | Reduce running slope to be no steeper than 1:20 (5.00%). | 1 | Labor | Labor |

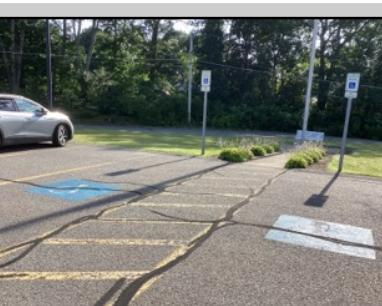
| ID | Location | Floor | Room | Element | Type | Photo | Issues | Current Measure | Recommendations | Quantity | Price | Cost Estimation |
|---|---|---|---|---|---|--|---|---|--|---|---|---|
| 15 | By Front Entrance | Ext. | | Off-Street Parking Lot or Garage | Visitor | | Total # of designated van accessible spaces<br>Access aisle not compliant<br>Access aisle < 96" wide at van space | 2<br>-<br>60" | Provide a marked access aisle that is at least 96" wide at the van accessible space. (Re-stripe.) | 1 | 300 | \$300 |

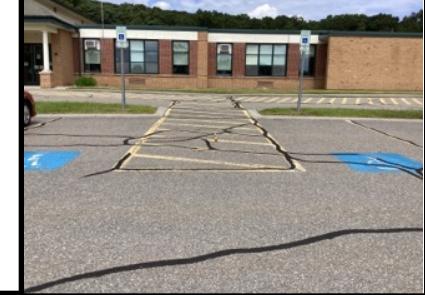
| ID | Location | Floor | Room | Element | Type | Photo | Issues | Current Measure | Recommendations | Quantity | Price | Cost Estimation |
|---|---|---|---|---|---|--|--|---|---|---|---|---|
| 16 | Back Entrance Parking | Ext. | | Off-Street Parking Lot or Garage | Visitor | | Total # of designated van accessible spaces<br>Running or cross slope at access aisle > 1:50 (2.00%) | 2<br>3.2% | Reduce running or cross slope to be no steeper than 1:50 (2.00%). | 1 | - | - |

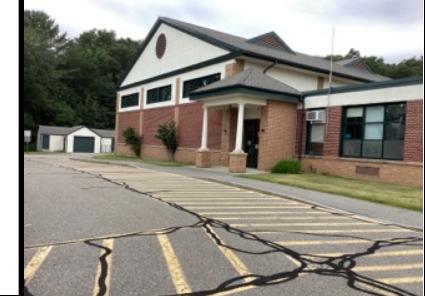
| ID | Location | Floor | Room | Element | Type | Photo | Issues | Current Measure | Recommendations | Quantity | Price | Cost Estimation |
|---|---|---|---|---|---|--|--|---|---|---|---|---|
| 17 | Pasenger Loadg Zone by Door 3 | | | Passenger Loading Zones | N/A | | Sign with ISA not provided (MAAB) | - | Provide a sign that includes the International Symbol of Accessibility (ISA) at the head of the space. Locate the sign so that the bottom is 60" min. above the ground and the top is 96" max. above the ground. | 1 | Labor | Labor |

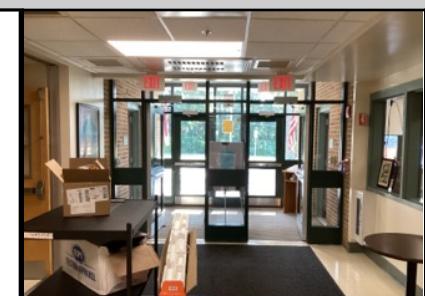
| ID | Location | Floor | Room | Element | Type | Photo | Issues | Current Measure | Recommendations | Quantity | Price | Cost Estimation |
|---|---|---|---|---|---|--|--|---|---|---|---|---|
| 18 | Front Egress | 1 | | Means of Egress | N/A | | Tactile exit sign not provided<br>Illuminated ISA symbol not provided (MAAB) | -<br>- | Ensure that a tactile exit sign with raised characters and braille is provided at the exit door. Mount the sign between 48"- 60" above the finished floor located on the latch side of the door.<br>When the illuminated exit sign is repaired or replaced, provide an illuminated sign with the International Symbol of Accessibility (ISA). | 1 | 250<br>200<br><br><b>450</b> | \$450 |

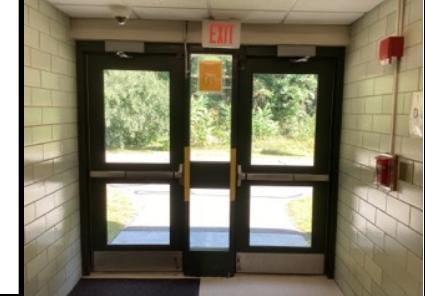
| ID | Location | Floor | Room | Element | Type | Photo | Issues | Current Measure | Recommendations | Quantity | Price | Cost Estimation |
|---|---|---|---|---|---|--|--|---|---|---|---|---|
| 19 | Door 1 Egress | 1 | | Means of Egress | N/A | | Tactile exit sign not provided<br>Illuminated ISA symbol not provided (MAAB) | -<br>- | Ensure that a tactile exit sign with raised characters and braille is provided at the exit door. Mount the sign between 48"- 60" above the finished floor located on the latch side of the door.<br>When the illuminated exit sign is repaired or replaced, provide an illuminated sign with the International Symbol of Accessibility (ISA). | 1 | 250<br>200<br><br><b>450</b> | \$450 |

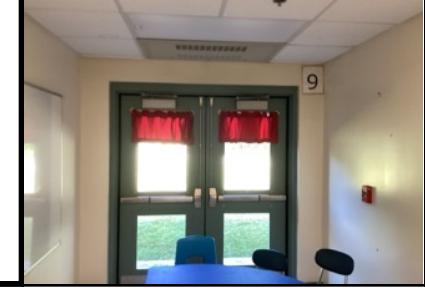
| ID | Location | Floor | Room | Element | Type | Photo | Issues | Current Measure | Recommendations | Quantity | Price | Cost Estimation |
|---|---|---|---|---|---|--|--|---|---|---|---|---|
| 20 | Door 9 Egress | 1 | D23 | Means of Egress | N/A | | Tactile exit sign not provided<br>Directional sign to accessible emergency exit not provided | -<br>- | Ensure that a tactile exit sign with raised characters and braille is provided at the exit door. Mount the sign between 48"- 60" above the finished floor located on the latch side of the door.<br>Provide a directional sign indicating the location of the nearest accessible emergency exit. | 2 | 250<br><br><b>500</b> | \$500 |

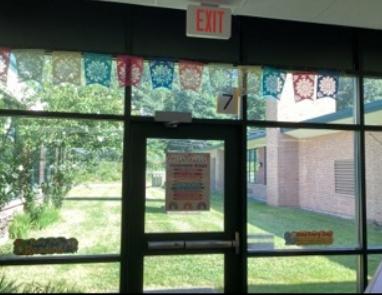
| ID | Location | Floor | Room | Element | Type | Photo | Issues | Current Measure | Recommendations | Quantity | Price | Cost Estimation |
|---|---|---|---|---|---|--|--|---|---|---|---|---|
| 21 | Media Center Door 7 | 1 | | Means of Egress | N/A | | Tactile exit sign not provided<br>Directional sign to accessible emergency exit not provided | -<br>- | Ensure that a tactile exit sign with raised characters and braille is provided at the exit door. Mount the sign between 48"- 60" above the finished floor located on the latch side of the door.<br>Provide a directional sign indicating the location of the nearest accessible emergency exit. | 2 | 250<br><br><b>500</b> | \$500 |

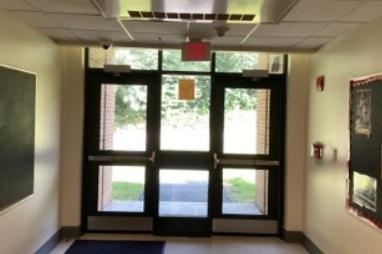
| ID | Location | Floor | Room | Element | Type | Photo | Issues | Current Measure | Recommendations | Quantity | Price | Cost Estimation |
|---|---|---|---|---|---|--|--|---|---|---|---|---|
| 22 | Door 6 | 1 | | Means of Egress | N/A | | Tactile exit sign not provided<br>Illuminated ISA symbol not provided (MAAB) | -<br>- | Ensure that a tactile exit sign with raised characters and braille is provided at the exit door. Mount the sign between 48"- 60" above the finished floor located on the latch side of the door.<br>When the illuminated exit sign is repaired or replaced, provide an illuminated sign with the International Symbol of Accessibility (ISA). | 1 | 250<br>200<br><br><b>450</b> | \$450 |

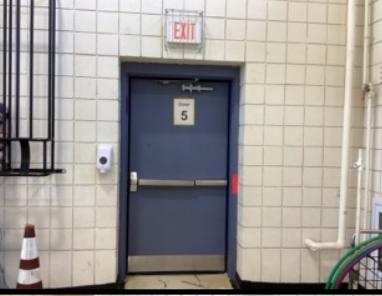
| ID | Location | Floor | Room | Element | Type | Photo | Issues | Current Measure | Recommendations | Quantity | Price | Cost Estimation |
|---|---|---|---|---|---|--|--|---|---|---|---|---|
| 23 | Gym Door 5 | 1 | | Means of Egress | N/A | | Tactile exit sign not provided<br>Illuminated ISA symbol not provided (MAAB) | -<br>- | Ensure that a tactile exit sign with raised characters and braille is provided at the exit door. Mount the sign between 48"- 60" above the finished floor located on the latch side of the door.<br>When the illuminated exit sign is repaired or replaced, provide an illuminated sign with the International Symbol of Accessibility (ISA). | 1 | 250<br>200<br><br><b>450</b> | \$450 |

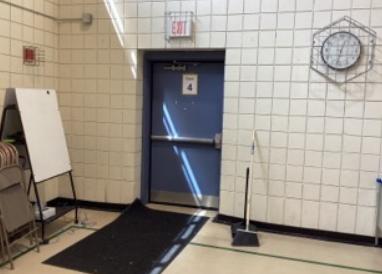
| ID | Location | Floor | Room | Element | Type | Photo | Issues | Current Measure | Recommendations | Quantity | Price | Cost Estimation |
|---|---|---|---|---|---|--|--|---|---|---|---|---|
| 24 | Gym Door 4 | 1 | | Means of Egress | N/A | | Tactile exit sign not provided<br>Illuminated ISA symbol not provided (MAAB) | -<br>- | Ensure that a tactile exit sign with raised characters and braille is provided at the exit door. Mount the sign between 48"- 60" above the finished floor located on the latch side of the door.<br>When the illuminated exit sign is repaired or replaced, provide an illuminated sign with the International Symbol of Accessibility (ISA). | 1 | 250<br>200<br><br><b>450</b> | \$450 |

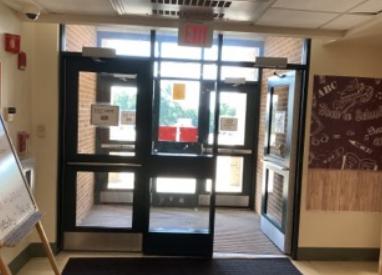
| ID | Location | Floor | Room | Element | Type | Photo | Issues | Current Measure | Recommendations | Quantity | Price | Cost Estimation |
|---|---|---|---|---|---|--|--|---|---|---|---|---|
| 25 | Door 3 | 1 | | Means of Egress | N/A | | Tactile exit sign not provided<br>Illuminated ISA symbol not provided (MAAB) | -<br>- | Ensure that a tactile exit sign with raised characters and braille is provided at the exit door. Mount the sign between 48"- 60" above the finished floor located on the latch side of the door.<br>When the illuminated exit sign is repaired or replaced, provide an illuminated sign with the International Symbol of Accessibility (ISA). | 1 | 250<br>200<br><br><b>450</b> | \$450 |

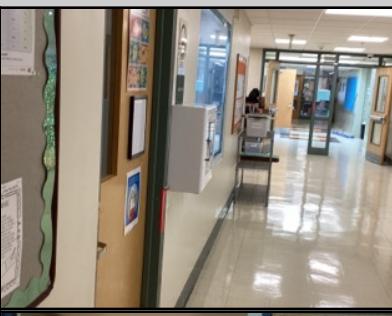
| ID | Location | Floor | Room | Element | Type | Photo | Issues | Current Measure | Recommendations | Quantity | Price | Cost Estimation |
|---|---|---|---|---|---|--|--|---|---|---|---|---|
| 27 | By Nurse's Office | 1 | | Interior Access Route | N/A | | Obstructed by protruding objects | 7.75" | Relocate defibrillator out of the accessible route or provide a cane-detectable barrier 27" max. above the ground under the defibrillator. | 1 | 398<br><br><b>398</b> | \$398 |

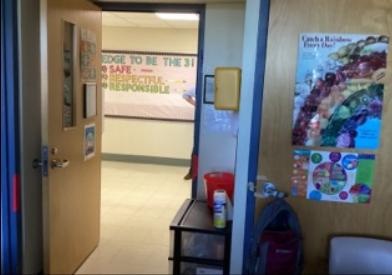
| ID | Location | Floor | Room | Element | Type | Photo | Issues | Current Measure | Recommendations | Quantity | Price | Cost Estimation |
|---|---|---|---|---|---|--|--|---|---|---|---|---|
| 28 | Nurse's Office | 1 | | Interior Access Route | N/A | | Obstructed by protruding objects | 6" | Relocate wall hung object out of the accessible route or provide a cane-detectable barrier 27" max. above the ground under the wall hung object. | 1 | 398<br><br><b>398</b> | \$398 |

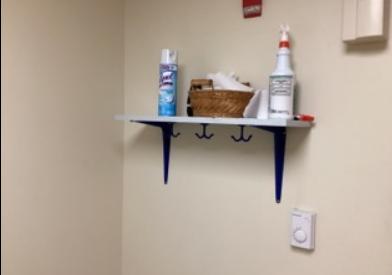
| ID | Location | Floor | Room | Element | Type | Photo | Issues | Current Measure | Recommendations | Quantity | Price | Cost Estimation |
|---|---|---|---|---|---|--|--|---|---|---|---|---|
| 29 | Women's Single-User Toilet Room | 1 | | Interior Access Route | N/A | | Obstructed by protruding objects | 9" | Relocate shelf out of the accessible route or provide a cane-detachable barrier 27" max. above the ground under the shelf. | 1 | 398<br><br><b>398</b> | \$398 |
