Town of Oxford

# ADA Self-Evaluation and Transition Plan

July 2024

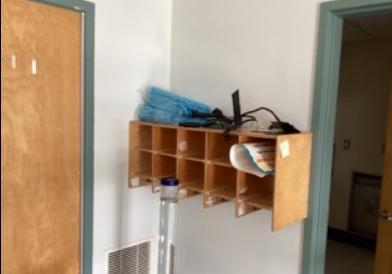
| ID | Location | Floor | Room | Element | Type | Photo | Issues | Current Measure | Recommendations | Quantity | Price | Cost Estimation |
|---|---|---|---|---|---|--|--|---|---|---|---|---|
| 30 | ILC | 1 | D20 | Interior Access Route | N/A | | Obstructed by protruding objects | 15" | Provide a cane-detectable barrier 27" max. above the finished floor under the shelf. | 1 | 398<br><br><b>398</b> | \$398 |

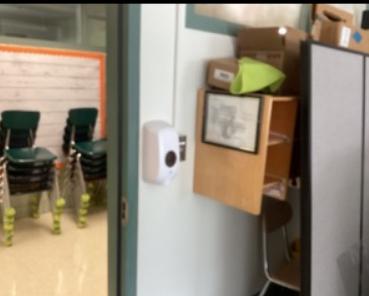
| ID | Location | Floor | Room | Element | Type | Photo | Issues | Current Measure | Recommendations | Quantity | Price | Cost Estimation |
|---|---|---|---|---|---|--|---|---|---|---|---|---|
| 31 | ILC | 1 | D20 | Interior Access Route | N/A | | Obstructed by protruding objects | 15" | Provide a cane-detectable barrier 27" max. above the finished floor under the shelf or relocate the shelf out of the accessible route. | 1 | 398 | \$398 |

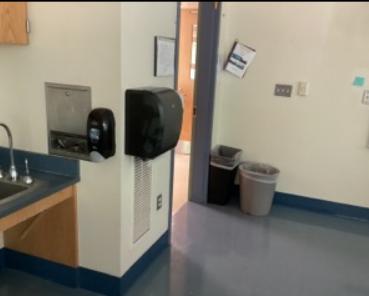
| ID | Location | Floor | Room | Element | Type | Photo | Issues | Current Measure | Recommendations | Quantity | Price | Cost Estimation |
|---|---|---|---|---|---|--|---|---|---|---|---|---|
| 32 | English | 1 | C19 | Interior Access Route | N/A | | Obstructed by protruding objects | 9" | Relocate object out of the accessible route or provide a cane-detectable barrier 27" max. above the finished floor. | 1 | 398 | \$398 |

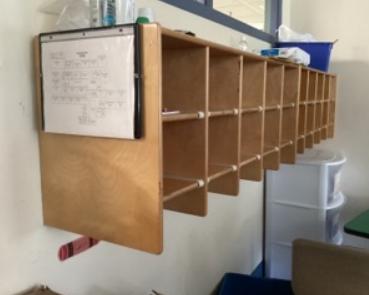
| ID | Location | Floor | Room | Element | Type | Photo | Issues | Current Measure | Recommendations | Quantity | Price | Cost Estimation |
|---|---|---|---|---|---|--|---|---|---|---|---|---|
| 33 | ESL | 1 | B1 | Interior Access Route | N/A | | Obstructed by protruding objects | 15" | Provide a cane-detectable barrier under the shelf. | 1 | 398 | \$398 |

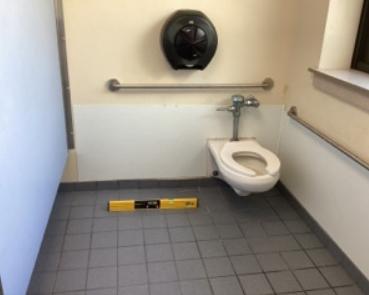
| ID | Location | Floor | Room | Element | Type | Photo | Issues | Current Measure | Recommendations | Quantity | Price | Cost Estimation |
|---|---|---|---|---|---|--|---|---|---|---|---|---|
| 34 | Boys' Multi-User Toilet Room | 1 | B1 | Interior Access Route | N/A | | Cross slope > 1:50 (2.00%) | 3.2" | Reduce cross slope to be no steeper than 1:50 (2.00%) in all directions by the toilet./Further study will be needed to determine whether it is technically feasible to bring the floor into full compliance with the ADA Standards. | 1 | - | - |

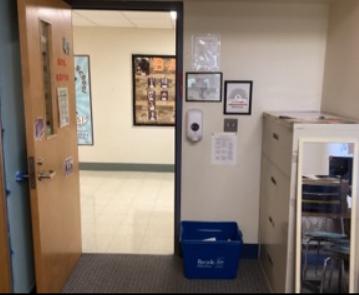
| ID | Location | Floor | Room | Element | Type | Photo | Issues | Current Measure | Recommendations | Quantity | Price | Cost Estimation |
|---|---|---|---|---|---|--|---|---|---|---|---|---|
| 36 | Guidance | 1 | | Doors, Doorways, & Gates | Office | | Maneuvering clearance(s) not provided | - | Relocate recycle bin to provide 18" min. pull side maneuvering clearance at the door. | 1 | Labor | Labor |

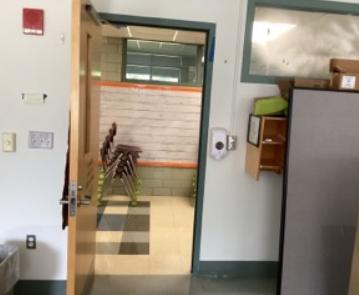
| ID | Location | Floor | Room | Element | Type | Photo | Issues | Current Measure | Recommendations | Quantity | Price | Cost Estimation |
|---|---|---|---|---|---|--|---|---|---|---|---|---|
| 37 | ILC | 1 | | Doors, Doorways, & Gates | Office | | Maneuvering clearance(s) not provided | 15.75" | Relocate shelf to provide 18" min. pull side maneuvering clearance at the door. | 1 | 459 | \$459 |

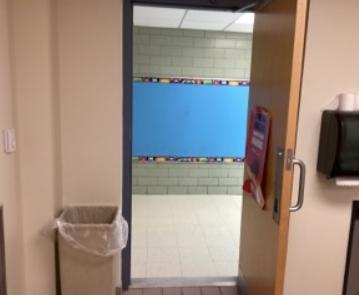
| ID | Location | Floor | Room | Element | Type | Photo | Issues | Current Measure | Recommendations | Quantity | Price | Cost Estimation |
|---|---|---|---|---|---|--|---|---|---|---|---|---|
| 38 | Girls' Multi-User Toilet Room | 1 | | Doors, Doorways, & Gates | Toilet Room | | Maneuvering clearance(s) not provided | - | Relocate trash container to provide 18" min. pull side maneuvering clearance at the door. | 1 | Labor | Labor |

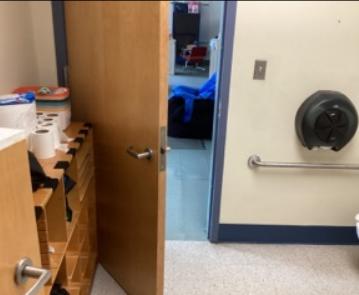
| ID | Location | Floor | Room | Element | Type | Photo | Issues | Current Measure | Recommendations | Quantity | Price | Cost Estimation |
|---|---|---|---|---|---|--|---|---|---|---|---|---|
| 39 | ILC Single-User Toilet Room | 1 | D20 | Doors, Doorways, & Gates | Toilet Room | | Clear width at door < 32" | 27" | Relocate furniture so that there is 32" min. clear width at the door. | 1 | Labor | Labor |

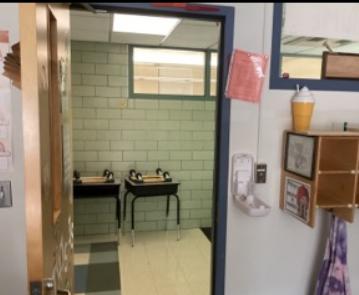
| ID | Location | Floor | Room | Element | Type | Photo | Issues | Current Measure | Recommendations | Quantity | Price | Cost Estimation |
|---|---|---|---|---|---|--|---|---|---|---|---|---|
| 40 | ILC 2 | 1 | D22 | Doors, Doorways, & Gates | Classroom | | Obstructed by protruding objects<br>Maneuvering clearance(s) not provided | 16" | Provide a cane-detectable barrier 27" max. above the finished floor under the shelf.<br>Relocate shelf to provide 18" min. pull side maneuvering clearance at the door. | 1 | 500 | \$500 |

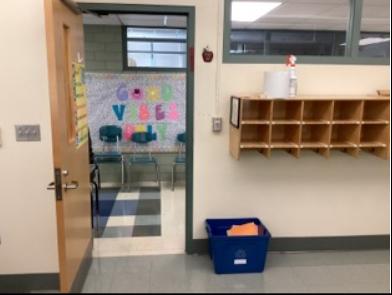
| ID | Location | Floor | Room | Element | Type | Photo | Issues | Current Measure | Recommendations | Quantity | Price | Cost Estimation |
|---|---|---|---|---|---|--|---|---|--|---|---|---|
| 41 | 5th Grade Math and Science | 1 | D23 | Doors, Doorways, & Gates | Classroom | | Obstructed by protruding objects<br>Maneuvering clearance(s) not provided | 15" | Provide a cane-detectable barrier 27" max. above the finished floor under the shelf. Relocate shelf to provide 18" min. pull side maneuvering clearance at the door. | 1 | 500 | \$500 |

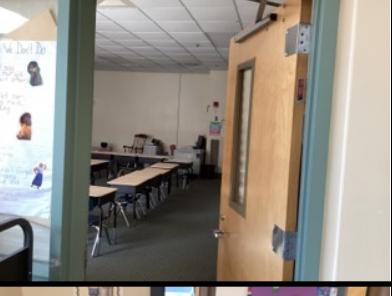
| ID | Location | Floor | Room | Element | Type | Photo | Issues | Current Measure | Recommendations | Quantity | Price | Cost Estimation |
|---|---|---|---|---|---|--|---|---|--|---|---|---|
| 42 | Computer Room | 1 | C16 | Doors, Doorways, & Gates | Classroom | | Door requires > 5 lbs. of force to open | 11 lbs. | Adjust closers so doors do not require more than 5 pounds of force to open. | 1 | Labor | Labor |

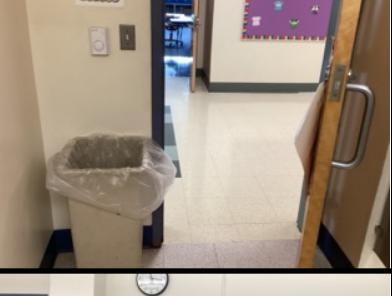
| ID | Location | Floor | Room | Element | Type | Photo | Issues | Current Measure | Recommendations | Quantity | Price | Cost Estimation |
|---|---|---|---|---|---|--|---|---|--|---|---|---|
| 43 | Men's Single-User Toilet Room With Urinal | 1 | B2 | Doors, Doorways, & Gates | Toilet Room | | Maneuvering clearance(s) not provided | - | Remove trash container to provide 18" min. pull side maneuvering clearance at the door. | 1 | Labor | Labor |

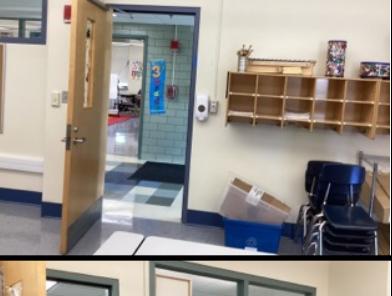
| ID | Location | Floor | Room | Element | Type | Photo | Issues | Current Measure | Recommendations | Quantity | Price | Cost Estimation |
|---|---|---|---|---|---|--|---|---|--|---|---|---|
| 44 | Music | 1 | B8 | Doors, Doorways, & Gates | Classroom | | Obstructed by protruding objects<br>Maneuvering clearance(s) not provided | 16" | Provide a cane-detectable barrier 27" max. above the finished floor under the shelf. Relocate shelf to provide 18" min. pull side maneuvering clearance at the door. | 1 | 500 | \$500 |

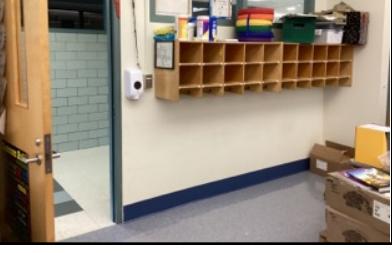
| ID | Location | Floor | Room | Element | Type | Photo | Issues | Current Measure | Recommendations | Quantity | Price | Cost Estimation |
|---|---|---|---|---|---|--|---|---|--|---|---|---|
| 45 | Third Grade | 1 | | Doors, Doorways, & Gates | Classroom | | Obstructed by protruding objects<br>Maneuvering clearance(s) not provided | 15" | Provide a cane-detectable barrier 27" max. above the finished floor under the shelf. Relocate shelf to provide 18" min. pull side maneuvering clearance at the door. | 1 | 500 | \$500 |

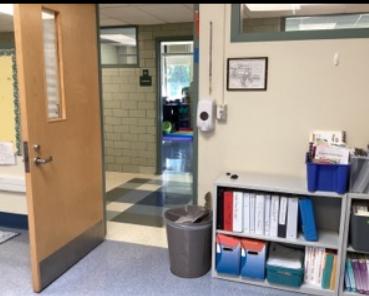
| ID | Location | Floor | Room | Element | Type | Photo | Issues | Current Measure | Recommendations | Quantity | Price | Cost Estimation |
|---|---|---|---|---|---|--|--|---|--|---|---|---|
| 46 | Title 1 | 1 | B6 | Doors, Doorways, & Gates | Classroom | | Maneuvering clearance(s) not provided | 10.5" | Relocate trash container and bookshelf to provide 18" min. pull side maneuvering clearance at the door. | 1 | Labor | Labor |

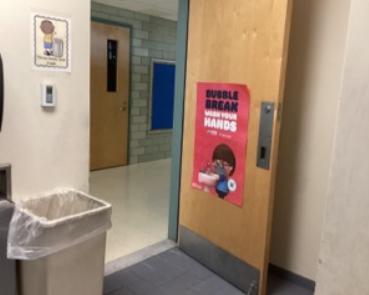
| ID | Location | Floor | Room | Element | Type | Photo | Issues | Current Measure | Recommendations | Quantity | Price | Cost Estimation |
|---|---|---|---|---|---|--|--|---|--|---|---|---|
| 47 | Boys' Multi-User Toilet Room | 1 | B1 | Doors, Doorways, & Gates | Toilet Room | | Maneuvering clearance(s) not provided | - | Relocate trash container and bookshelf to provide 18" min. pull side maneuvering clearance at the door. | 1 | Labor | Labor |

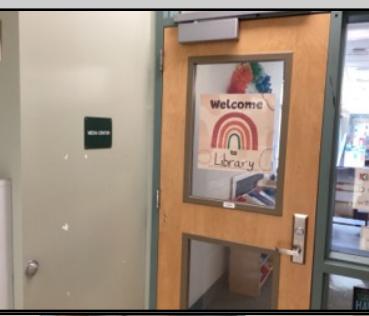
| ID | Location | Floor | Room | Element | Type | Photo | Issues | Current Measure | Recommendations | Quantity | Price | Cost Estimation |
|---|---|---|---|---|---|--|--|---|--|---|---|---|
| 48 | Media Center | 1 | D23 | Signage | Designation | | Sign not located on the latch side of the door | - | Locate the sign at permanent rooms alongside the door on the latch side. | 1 | Labor | Labor |

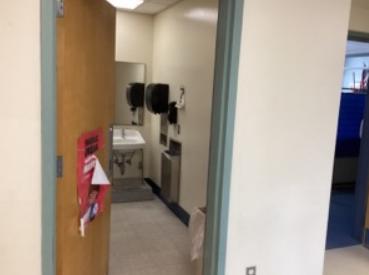
| ID | Location | Floor | Room | Element | Type | Photo | Issues | Current Measure | Recommendations | Quantity | Price | Cost Estimation |
|---|---|---|---|---|---|--|--|---|--|---|---|---|
| 49 | Men's Single-User Toilet Room With Urinal | 1 | B2 | Signage | Designation | | Signage is not provided<br>International Symbol of Acc. not provided | -<br>- | Locate compliant signage with raised characters and braille alongside the door on the latch side. Provide a sign containing the International Symbol of Accessibility (ISA). | 1<br><br><b>250</b> | 250<br><br><b>250</b> | \$250 |

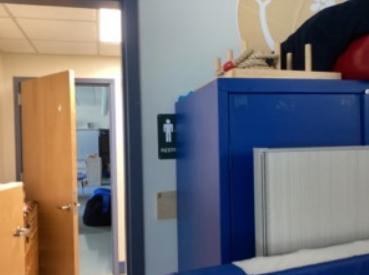
| ID | Location | Floor | Room | Element | Type | Photo | Issues | Current Measure | Recommendations | Quantity | Price | Cost Estimation |
|---|---|---|---|---|---|--|--|---|--|---|---|---|
| 50 | ILC Single-User Toilet Room | 1 | D23 | Signage | Designation | | Signage lacks 18" by 18" clear floor space | - | Relocate cabinets to provide a clear floor space of 18" min. by 18" min. at the sign. | 1 | Labor | Labor |

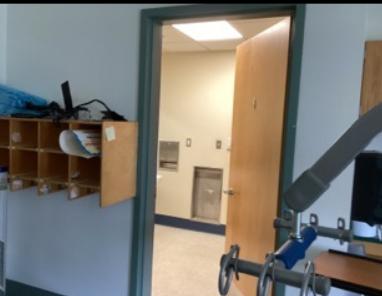
| ID | Location | Floor | Room | Element | Type | Photo | Issues | Current Measure | Recommendations | Quantity | Price | Cost Estimation |
|---|---|---|---|---|---|--|---|---|--|---|---|---|
| 51 | ILC Single-User Toilet Room Door 3 | 1 | D23 | Signage | Designation | | Signage is not provided<br>International Symbol of Acc. not provided | -<br>- | Locate compliant signage with raised characters and braille alongside the door on the latch side. Replace the sign with a sign containing the International Symbol of Accessibility (ISA). | 1 | 250 | \$250 |

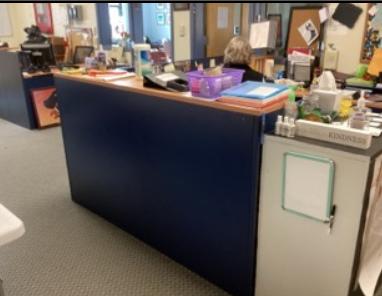
| ID | Location | Floor | Room | Element | Type | Photo | Issues | Current Measure | Recommendations | Quantity | Price | Cost Estimation |
|---|---|---|---|---|---|--|---|---|--|---|---|---|
| 52 | Main Office | 1 | | Service Counter | N/A | | Counter > 36" high | 41" | Provide a counter that is 36" max. above the ground or finished floor. | 1 | 1144 | \$1144 |

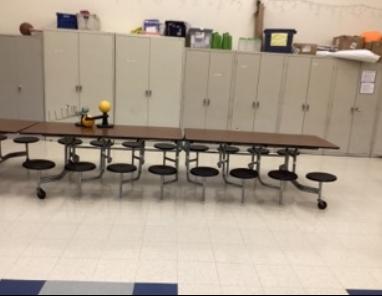
| ID | Location | Floor | Room | Element | Type | Photo | Issues | Current Measure | Recommendations | Quantity | Price | Cost Estimation |
|---|---|---|---|---|---|--|---|---|--|---|---|---|
| 53 | Cafeteria | 1 | | Dining or Work Surfaces | Dining Surface | | At least one or 5% accessible tables not provided<br>Knee clearance less than 19" deep | -<br>16" | Ensure that at least one dining surface is accessible.<br>Provide at least one dining surface with knee clearance that is 19" deep min. | 1 | 1430 | \$1430 |

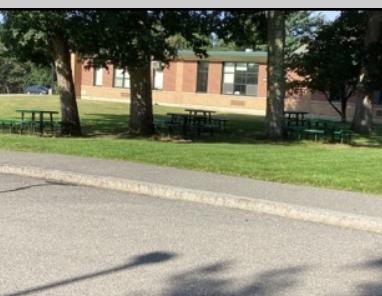
| ID | Location | Floor | Room | Element | Type | Photo | Issues | Current Measure | Recommendations | Quantity | Price | Cost Estimation |
|---|---|---|---|---|---|--|---|---|--|---|---|---|
| 54 | By Front Entrance | Ext. | | Picnic Tables | N/A | | At least 5% accessible spaces not provided<br>Toe or knee clearance at tables not provided<br>Knee clearance less than 19" deep | -<br>- | Ensure that at least 5% (minimum one) of picnic tables in each area where picnic tables are provided are accessible and located on an accessible route. | 1 | 1400 | \$1400 |

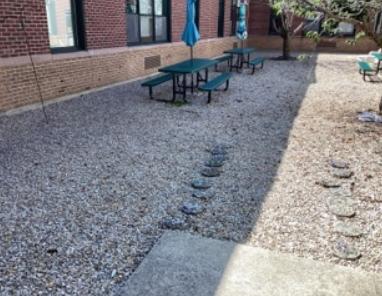
| ID | Location | Floor | Room | Element | Type | Photo | Issues | Current Measure | Recommendations | Quantity | Price | Cost Estimation |
|---|---|---|---|---|---|--|---|---|--|---|---|---|
| 55 | Media Center Courtyard | 1 | | Picnic Tables | N/A | | At least 5% accessible spaces not provided<br>Knee clearance less than 19" deep | -<br>- | Ensure that at least 5% (minimum one) of picnic tables are accessible.<br>Provide at least one picnic table with knee clearance that is 19" deep min. | 1 | 1400 | \$1400 |

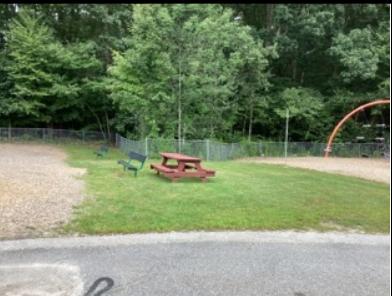
| ID | Location | Floor | Room | Element | Type | Photo | Issues | Current Measure | Recommendations | Quantity | Price | Cost Estimation |
|---|---|---|---|---|---|--|--|---|---|---|---|---|
| 56 | Playground | Ext. | | Picnic Tables | N/A | | At least 5% accessible spaces not provided<br>Knee clearance less than 19" deep | -<br>- | Ensure that at least 5% (minimum one) of picnic tables are accessible.<br>Provide at least one picnic table with knee clearance that is 19" deep min. | 1 | Labor | Labor |

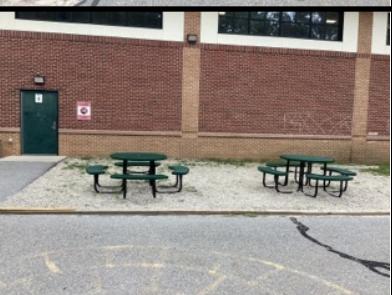
| ID | Location | Floor | Room | Element | Type | Photo | Issues | Current Measure | Recommendations | Quantity | Price | Cost Estimation |
|---|---|---|---|---|---|--|--|---|---|---|---|---|
| 57 | By Door 5 | Ext. | | Picnic Tables | N/A | | At least 5% accessible spaces not provided<br>Knee clearance less than 19" deep | -<br>- | Ensure that at least 5% (minimum one) of picnic tables are accessible.<br>Provide at least one picnic table with knee clearance that is 19" deep min. | 1 | Labor | Labor |

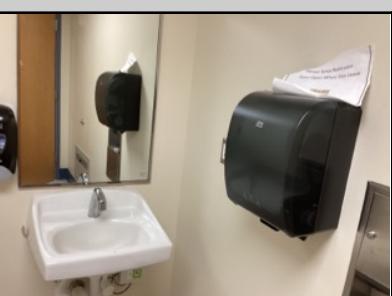
| ID | Location | Floor | Room | Element | Type | Photo | Issues | Current Measure | Recommendations | Quantity | Price | Cost Estimation |
|---|---|---|---|---|---|--|--|---|---|---|---|---|
| 58 | All-Gender Single-User Toilet Room | 1 | | Lavatory | N/A | | Clear floor space not provided at lavatory | - | Provide at least one lavatory with a 30" min. by 48" min. clear floor space positioned for a forward approach. (Relocate paper towel dispenser.) | 1 | 500 | \$500 |

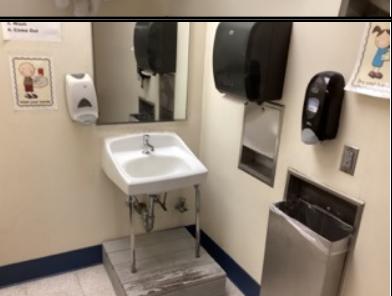
| ID | Location | Floor | Room | Element | Type | Photo | Issues | Current Measure | Recommendations | Quantity | Price | Cost Estimation |
|---|---|---|---|---|---|--|--|---|---|---|---|---|
| 59 | Men's Single-User Toilet Room With Urinal | 1 | B2 | Lavatory | N/A | | Clear floor space not provided at lavatory<br>Toe or knee clearances not provided<br>Plumbing underneath is exposed | -<br>-<br>- | Provide at least one lavatory with a 30" min. by 48" min. clear floor space positioned for a forward approach.<br>Provide at least one lavatory with knee and toe clearance positioned for a forward approach.<br>Insulate or otherwise configure pipes to prevent contact for at least one lavatory. | 1 | 2192<br>150<br><br><b>2342</b> | \$2342 |

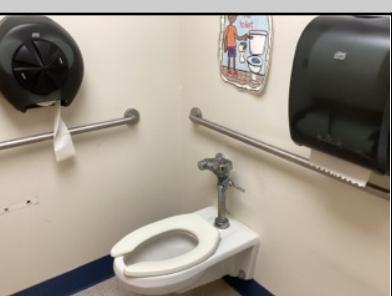
| ID | Location | Floor | Room | Element | Type | Photo | Issues | Current Measure | Recommendations | Quantity | Price | Cost Estimation |
|---|---|---|---|---|---|--|--|---|---|---|---|---|
| 60 | Nurse's Office Single-User Toilet Room | 1 | | Single-User Toilet | N/A | | Centerline < or > 18" (MAAB)<br>Side or rear grab bar < 33" or > 36" high<br>Toilet paper dispenser is not compliant | 19.25"<br>37"<br>- | Relocate toilet so that the centerline is 18" from the side wall.<br>Mount grab bars 33"- 36" above the finished floor.<br>Relocate toilet paper so that it is 24" min. high, located under the grab bar, and between 7" and 9" from the front of the toilet. | 1 | 3676<br>306<br>500<br><br><b>4482</b> | \$4482 |

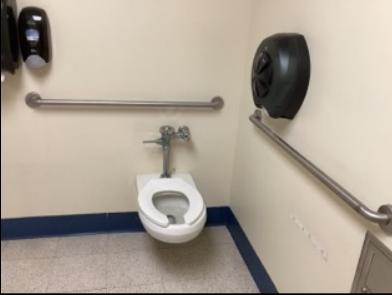
| ID | Location | Floor | Room | Element | Type | Photo | Issues | Current Measure | Recommendations | Quantity | Price | Cost Estimation |
|---|---|---|---|---|---|--|---|---|--|---|---|---|
| 61 | Women's Single-User Toilet Room | 1 | | Single-User Toilet | N/A | | Toilet paper dispenser is not compliant | - | Relocate toilet paper so that it is 24" min. high, located under the grab bar, and between 7" and 9" from the front of the toilet. | 1 | 333 | \$333 |

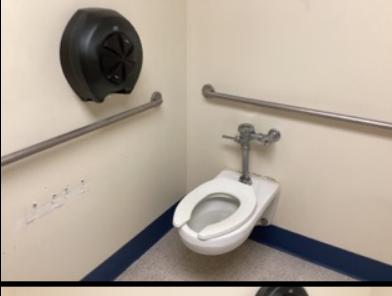
| ID | Location | Floor | Room | Element | Type | Photo | Issues | Current Measure | Recommendations | Quantity | Price | Cost Estimation |
|---|---|---|---|---|---|--|---|---|--|---|---|---|
| 62 | All-Gender Single-User Toilet Room | 1 | | Single-User Toilet | N/A | | Flush control not on open side<br>Toilet paper dispenser is not compliant | -<br>- | Relocate the flush control to the open side.<br>Relocate toilet paper so that it is 24" min. high, located under the grab bar, and between 7" and 9" from the front of the toilet./Replace dispenser as it does not allow continuous paper flow. | 1 | 486<br>333 | \$819 |

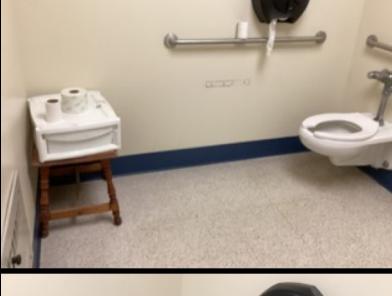
| ID | Location | Floor | Room | Element | Type | Photo | Issues | Current Measure | Recommendations | Quantity | Price | Cost Estimation |
|---|---|---|---|---|---|--|---|---|--|---|---|---|
| 63 | All-Gender Single-User Toilet Room | 1 | C1 | Single-User Toilet | N/A | | Clearance at toilet < 72" clear depth (MAAB)<br>Toilet paper dispenser is not compliant | 69"<br>- | Relocate furniture and stored items to ensure that there is 72" deep min. clear floor space at the toilet.<br>Relocate toilet paper so that it is 24" min. high, located under the grab bar, and between 7" and 9" from the front of the toilet./Replace dispenser as it does not allow continuous paper flow. | 1 | 333 | \$333 |

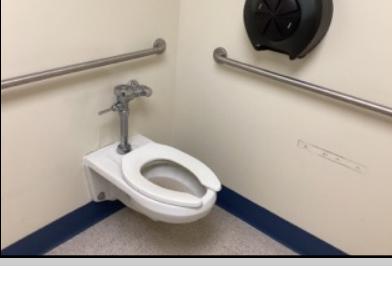
| ID | Location | Floor | Room | Element | Type | Photo | Issues | Current Measure | Recommendations | Quantity | Price | Cost Estimation |
|---|---|---|---|---|---|--|---|---|--|---|---|---|
| 64 | All-Gender Single-User Toilet Room | 1 | C1 - 2 | Single-User Toilet | N/A | | Flush control not on open side<br>Toilet paper dispenser is not compliant | - | Relocate the flush control to the open side.<br>Relocate toilet paper so that it is 24" min. high, located under the grab bar, and between 7" and 9" from the front of the toilet./Replace dispenser as it does not allow continuous paper flow. | 1 | 486<br>333 | \$819 |

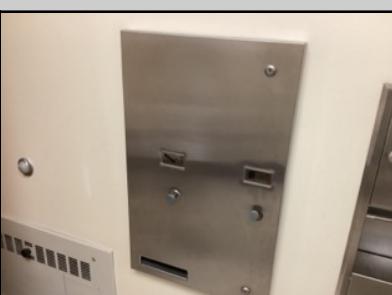
| ID | Location | Floor | Room | Element | Type | Photo | Issues | Current Measure | Recommendations | Quantity | Price | Cost Estimation |
|---|---|---|---|---|---|--|---|---|--|---|---|---|
| 65 | Women's Single-User Toilet Room | 1 | | Dispensers | Tampon Dispenser | | Noncompliant operable part | - | Provide a sanitary napkin dispenser that can be operable with one hand and not require tight grasping, pinching, or twisting of the wrist. | 1 | 1300 | \$1300 |

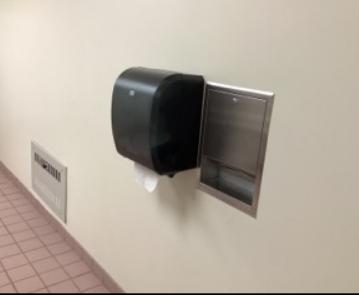
| ID | Location | Floor | Room | Element | Type | Photo | Issues | Current Measure | Recommendations | Quantity | Price | Cost Estimation |
|---|--|---|---|---|---|--|--|---|---|---|---|---|
| 66 | Girls' Multi-User Toilet Room | 1 | | Dispensers | Paper Towel Dispenser | | Dispenser acts as a protruding object | 9" | Relocate dispenser out of the circulation path or provide a cane-detectable barrier under the dispenser 27" max. above the finished floor. | 2 | 398 | \$796 |

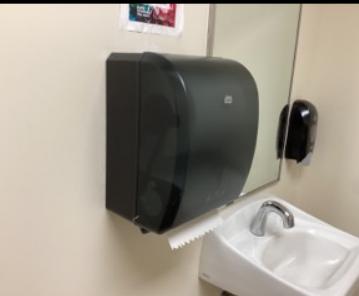
| ID | Location | Floor | Room | Element | Type | Photo | Issues | Current Measure | Recommendations | Quantity | Price | Cost Estimation |
|---|--|---|---|---|---|--|--|---|---|---|---|---|
| 67 | All-Gender Single-User Toilet Room | 1 | C1 | Dispensers | Paper Towel Dispenser | | Dispenser acts as a protruding object | 9" | Relocate paper towel dispenser out of the circulation path. | 1 | 333 | \$333 |

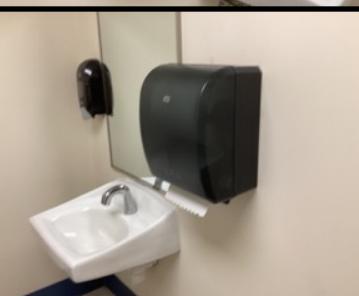
| ID | Location | Floor | Room | Element | Type | Photo | Issues | Current Measure | Recommendations | Quantity | Price | Cost Estimation |
|---|--|---|---|---|---|--|--|---|---|---|---|---|
| 68 | All-Gender Single-User Toilet Room | 1 | C1 - 2 | Dispensers | Paper Towel Dispenser | | Dispenser acts as a protruding object | 9" | Relocate dispenser out of the circulation path. | 1 | 333 | \$333 |

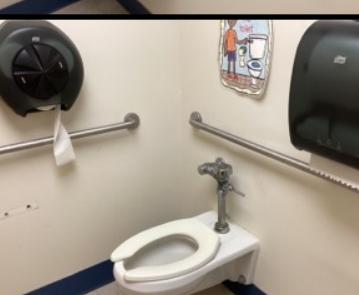
| ID | Location | Floor | Room | Element | Type | Photo | Issues | Current Measure | Recommendations | Quantity | Price | Cost Estimation |
|---|--|---|---|---|---|--|--|---|---|---|---|---|
| 69 | Nurse's Office Single-User Toilet Room | 1 | | Dispensers | Paper Towel Dispenser | | Noncompliant operable part | - | Relocate paper towel dispenser so that it is not located above the grab bar. | 1 | 500 | \$500 |

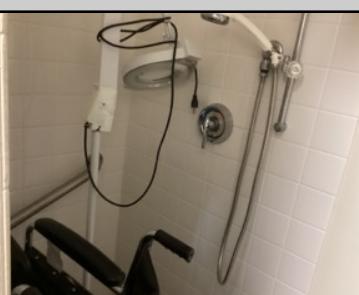
| ID | Location | Floor | Room | Element | Type | Photo | Issues | Current Measure | Recommendations | Quantity | Price | Cost Estimation |
|---|--|---|---|---|---|--|--|---|---|---|---|---|
| 70 | Nurse's Office | 1 | | Shower Compartment | Transfer Type | | Size of shower compartment not compliant<br>Grab bars are not 33"-36" high<br>Accessible shower not provided | -<br>-<br>- | Provide a transfer shower that is 36" by 36".<br>Locate grab bars between 33"- 36" above the finished floor.<br>Provide at least one compliant accessible shower. | 1 | 7894 | \$7894 |

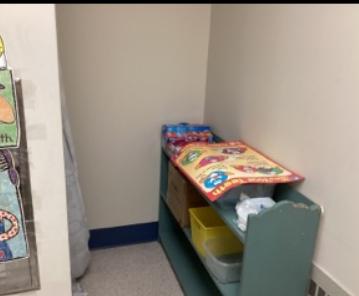
| ID | Location | Floor | Room | Element | Type | Photo | Issues | Current Measure | Recommendations | Quantity | Price | Cost Estimation |
|---|--|---|---|---|---|--|---|---|--|---|--|---|
| 71 | Nurse's Office Shower | 1 | | Shower Compartment | Transfer Type | | Clear space at transfer shower < 48" x 36" | 24" | Provide a 48" x 36" clear floor space for a transfer shower. (Relocate furniture.) | 1 | Labor | Labor |

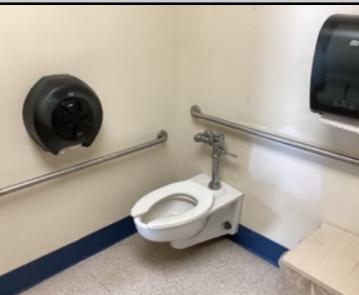
| ID | Location | Floor | Room | Element | Type | Photo | Issues | Current Measure | Recommendations | Quantity | Price | Cost Estimation |
|---|--|---|---|---|---|--|---|---|--|---|--|---|
| 72 | ILC Single-User Toilet Room | 1 | D20 | Single-User Toilet (Children) | N/A | | Centerline < 15" or > 18" (4 - 6)<br>Side or rear grab bar < 25" or > 27" high (4 - 6)<br>Noncompliant toilet paper and paper towel dispensers | 16.25"<br>32.5"<br>-<br>18.5"<br>33"<br>- | Relocate toilet so that the centerline is between 15" and 18" from the side wall.<br>Locate grab bar between 25"- 27" above the floor.<br>Relocate the toilet paper and paper towel dispensers so that they are not mounted above grab bars. | 1 | 3676<br>256<br>1000<br><br><b>4932</b> | \$4932 |

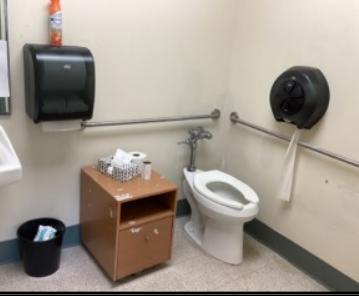
| ID | Location | Floor | Room | Element | Type | Photo | Issues | Current Measure | Recommendations | Quantity | Price | Cost Estimation |
|---|--|---|---|---|---|--|---|---|--|---|--|---|
| 73 | Grade 5 Single-User Toilet Room | 1 | C18 | Single-User Toilet (Children) | N/A | | Clearance at toilet < 60" clear wide<br>Toilet seat < 15" or > 17" high (4 - 6)<br>Side or rear grab bar < 25" or > 27" high (4 - 6)<br>Noncompliant toilet paper dispenser | -<br>18.5"<br>33"<br>- | Relocate furniture and trash container to provide a clear floor space that is 60" wide min.<br>Install a toilet with a seat between 15"- 17" high above the finished floor.<br>Locate grab bar between 25"- 27" above the floor.<br>Relocate toilet paper dispenser so that it is not mounted above grab bars. | 1 | Labor<br>2816<br>333<br>500<br><br><b>3649</b> | \$3649 |

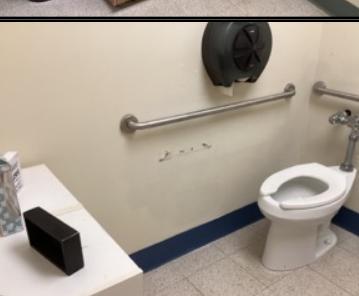
| ID | Location | Floor | Room | Element | Type | Photo | Issues | Current Measure | Recommendations | Quantity | Price | Cost Estimation |
|---|--|---|---|---|---|--|---|---|--|---|--|---|
| 74 | All-Gender Single-User Toilet Room English | 1 | C19 | Single-User Toilet (Children) | All Gender | | Clearance at toilet < 72" clear deep<br>Noncompliant toilet paper dispenser | 66"<br>-<br>18.25"<br>16"<br>34" | Relocate furniture and stored items to provide a clear floor space that is 72" deep min.<br>Relocate toilet paper dispenser so that it is between 14"- 19" above the floor and between 7"- 9" in front of the toilet. Ensure dispensers and other devices are not mounted above grab bars./Replace dispenser as it does not allow continuous paper flow. | 1 | 500<br><br><b>500</b> | \$500 |

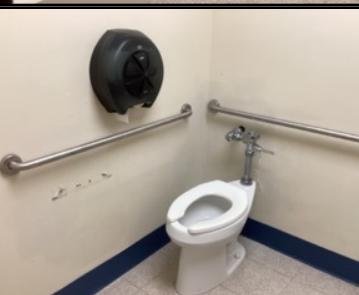
| ID | Location | Floor | Room | Element | Type | Photo | Issues | Current Measure | Recommendations | Quantity | Price | Cost Estimation |
|---|--|---|---|---|---|--|---|---|--|---|--|---|
| 75 | All-Gender Single-User Toilet Room English | 1 | C19 | Single-User Toilet (Children) | All Gender | | Toilet seat < 15" or > 17" high (4 - 6)<br>Centerline < 15" or > 18" (4 - 6)<br>Side or rear grab bar < 25" or > 27" high (4 - 6) | 18.25"<br>16"<br>34" | Install a toilet with a seat between 15"- 17" high above the finished floor.<br>Relocate toilet so that the centerline is between 15" and 18" from the side wall.<br>Locate grab bar between 25"- 27" above the floor. | 1 | 3676<br>333<br><br><b>4009</b> | \$4009 |

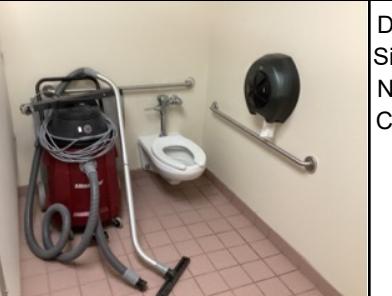
| ID | Location | Floor | Room | Element | Type | Photo | Issues | Current Measure | Recommendations | Quantity | Price | Cost Estimation |
|---|---|---|---|---|---|--|--|---|--|---|---|---|
| 76 | Girls' Multi-User Toilet Room | 1 | | Toilet Compartment (Children) | Accessible Compartment | | Door with malfunctioning self-closing hinge<br>Side or rear grab bar < 25" or > 27" high (Ages 9 - 12)<br>Noncompliant toilet paper dispenser<br>Clearance at toilet < 60" clear width | -<br>31"<br>-<br>58" | Repair self-closing hinge.<br>Relocate grab bar to 25"- 27" above the finished floor.<br>Relocate toilet paper dispenser so that it is not mounted above grab bars.<br>Provide a wheelchair accessible compartment that is 60" wide min. and 72" deep min.<br>(Relocate vacuum cleaner.) | 1 | Labor 333<br>500<br><br><b>833</b> | \$833 |

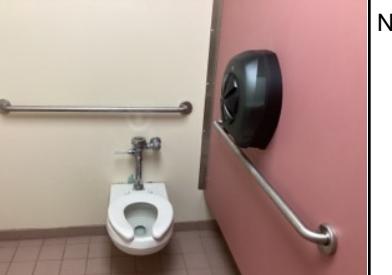
| ID | Location | Floor | Room | Element | Type | Photo | Issues | Current Measure | Recommendations | Quantity | Price | Cost Estimation |
|---|---|---|---|---|---|--|--|---|--|---|---|---|
| 77 | Girls' Multi-User Toilet Room | 1 | G2 | Toilet Compartment (Children) | Accessible Compartment | | Noncompliant toilet paper dispenser | - | Relocate toilet paper dispenser so that it is between 14"- 19" above the finished floor and between 7"- 9" in front of the toilet. Ensure dispensers and other devices are not mounted above grab bars./Replace dispenser as it does not allow continuous paper flow. | 1 | 333<br><br><b>333</b> | \$333 |

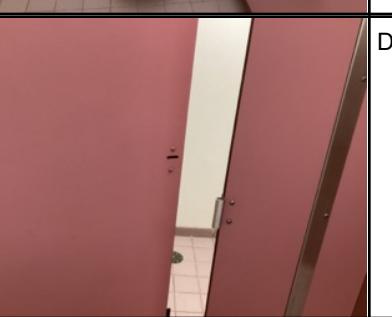
| ID | Location | Floor | Room | Element | Type | Photo | Issues | Current Measure | Recommendations | Quantity | Price | Cost Estimation |
|---|---|---|---|---|---|--|--|---|--|---|---|---|
| 78 | Girls' Multi-User Toilet Room | 1 | G2 | Toilet Compartment (Children) | Accessible Compartment | | Door pull not provided | - | Provide a door pull on each side of the door between 34" to 48" above the finished floor that does not require tight grasping, pinching or twisting of the wrist. | 1 | 91<br><br><b>91</b> | \$91 |

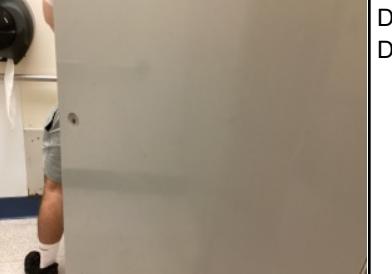
| ID | Location | Floor | Room | Element | Type | Photo | Issues | Current Measure | Recommendations | Quantity | Price | Cost Estimation |
|---|---|---|---|---|---|--|--|---|--|---|---|---|
| 79 | Men's Single-User Toilet Room With Urinal | 1 | B2 | Toilet Compartment (Children) | Accessible Compartment | | Door with malfunctioning self-closing hinge<br>Door pull not provided | -<br>+ | Repair self-closing hinge.<br>Provide a door pull on each side of the door between 34" to 48" above the finished floor that does not require tight grasping, pinching or twisting of the wrist. | 1 | Labor 91<br><br><b>91</b> | \$91 |

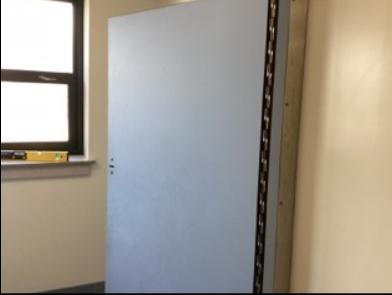
| ID | Location | Floor | Room | Element | Type | Photo | Issues | Current Measure | Recommendations | Quantity | Price | Cost Estimation |
|---|--|---|---|---|---|--|---|---|--|---|---|---|
| 81 | Boys' Multi-User Toilet Room | 1 | B1 | Toilet Compartment (Children) | Accessible Compartment | | Door with malfunctioning self-closing hinge<br>Door pull not provided | -<br>- | Repair self-closing hinge.<br>Provide a door pull on each side of the door between 34" to 48" above the finished floor that does not require tight grasping, pinching or twisting of the wrist. | 1 | Labor 91<br><br><b>91</b> | \$91 |

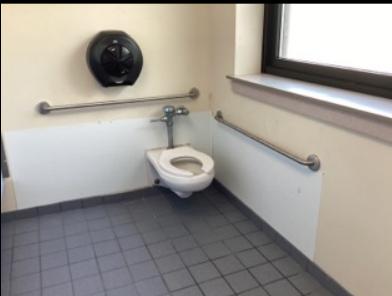
| ID | Location | Floor | Room | Element | Type | Photo | Issues | Current Measure | Recommendations | Quantity | Price | Cost Estimation |
|---|--|---|---|---|---|--|---|---|--|---|---|---|
| 82 | Boys' Multi-User Toilet Room | 1 | B1 | Toilet Compartment (Children) | Accessible Compartment | | Side or rear grab bar < 25" or > 27" high (Ages 9 - 12)<br>Noncompliant toilet paper dispenser<br>Clearance at toilet < 60" clear width | 31.5"<br>-<br>58.25" | Relocate grab bar to 25"- 27" above the finished floor.<br>Relocate toilet paper dispenser so that it is not mounted above grab bars./Replace dispenser as it does not allow continuous paper flow.<br>Provide a wheelchair accessible compartment that is 60" wide min. and 72" deep min. | 1 | 333<br>333<br>8037<br><br><b>8703</b> | \$8703 |

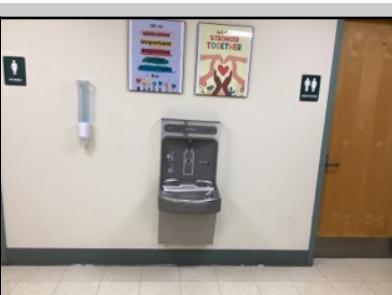
| ID | Location | Floor | Room | Element | Type | Photo | Issues | Current Measure | Recommendations | Quantity | Price | Cost Estimation |
|---|--|---|---|---|---|--|---|---|--|---|---|---|
| 84 | By All-Gender Toilet Room | 1 | | Drinking Fountains | Low | | No drinking fountain provided for standing users<br>Knee or toe clearance not provided | -<br>25" | Provide an additional drinking fountain for standing users or install a Hi-Lo drinking fountain.<br>Provide knee and toe clearance, 27" min. high at drinking fountain for seated users. | 1 | 4028<br>2636<br><br><b>6664</b> | \$6664 |

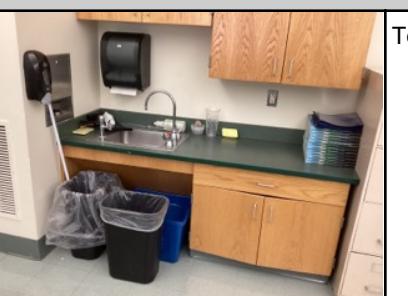
| ID | Location | Floor | Room | Element | Type | Photo | Issues | Current Measure | Recommendations | Quantity | Price | Cost Estimation |
|---|---|---|---|---|---|--|---|---|--|---|---|---|
| 85 | Fourth Grade | 1 | C13 | Sink | N/A | | Toe and knee clearances not provided | - | Ensure there is a 27" min. knee clearance positioned for a forward approach. (Relocate stored items under sink.) | 1 | Labor | Labor |

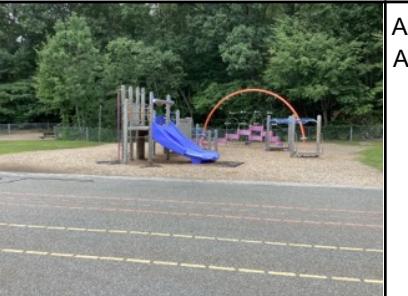
| ID | Location | Floor | Room | Element | Type | Photo | Issues | Current Measure | Recommendations | Quantity | Price | Cost Estimation |
|---|---|---|---|---|---|--|---|---|--|---|---|---|
| 86 | Playground | Ext. | | Play Areas | N/A | | Accessible route not provided around playground<br>Accessible route not provided to play components | -<br>- | Provide an accessible route around the play area.<br>Provide a compliant impact-attenuating surface to and around the play components.<br><b>Note:</b> The Massachusetts Architectural Access Board (MAAB) does not consider engineered wood fiber (EWF) to comply with its regulation requiring an accessible route to each play component and around the playground. | 1 | Labor | Labor |

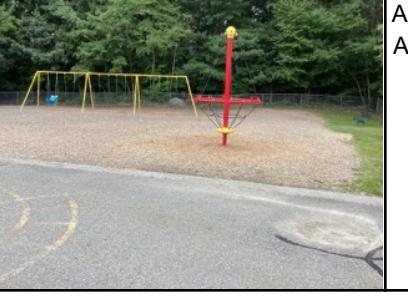
| ID | Location | Floor | Room | Element | Type | Photo | Issues | Current Measure | Recommendations | Quantity | Price | Cost Estimation |
|---|---|---|---|---|---|--|---|---|--|---|---|---|
| 87 | Playground | Ext. | | Play Areas | N/A | | Accessible route not provided around playground<br>Accessible route not provided to play components | -<br>- | Provide an accessible route around the play area.<br>Provide a compliant impact-attenuating surface to and around the play components.<br><b>Note:</b> The Massachusetts Architectural Access Board (MAAB) does not consider engineered wood fiber (EWF) to comply with its regulation requiring an accessible route to each play component and around the playground. | 1 | Labor | Labor |

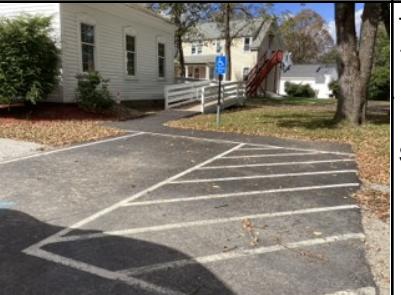
| ID | Location | Floor | Room | Element | Type | Photo | Issues | Current Measure | Recommendations | Quantity | Price | Cost Estimation |
|---|---|---|---|---|---|--|---|---|--|---|---|---|
| 1 | Parking | Ext. | | Off-Street Parking Lot or Garage | N/A | | Total # of parking<br>Total # of designated van accessible spaces<br>Running or cross slope at access aisle > 1:50 (2.00%)<br>Sign does not have the designation "Van Accessible"<br>Sign bottom < 60" above finished grade | 1<br>1<br>-<br>58"<br>- | Reduce running or cross slope to be no steeper than 1:50 (2.00%).<br>Add the designation "Van Accessible" to the sign located at the van accessible space.<br>Locate sign with the bottom of the sign 60" above the ground.<br><b>Note:</b> Cost is for a designation sign with the words, "Van Accessible". | 1 | 500 | \$500 |

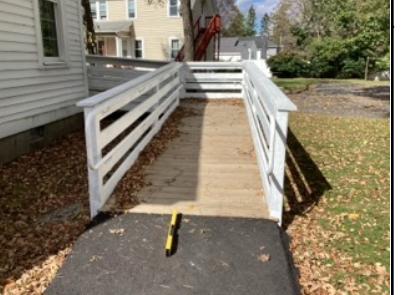
| ID | Location | Floor | Room | Element | Type | Photo | Issues | Current Measure | Recommendations | Quantity | Price | Cost Estimation |
|---|---|---|---|---|---|--|---|---|--|---|---|---|
| 2 | Ramp | Ext. | | Exterior Ramp | N/A | | Landing has a slope > 1:50 in either direction | 4.2% | Alter so that the slope in all directions is no greater than 1:50 (2.00%)./Rebuild the ramp to ensure that the slope of the landing does not exceed 1:50 (2.00%). | 1 | - | - |

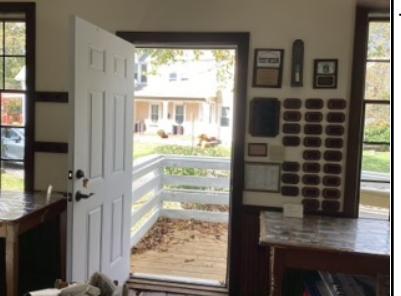
| ID | Location | Floor | Room | Element | Type | Photo | Issues | Current Measure | Recommendations | Quantity | Price | Cost Estimation |
|---|---|---|---|---|---|--|---|---|--|---|---|---|
| 3 | Main Entrance | 1 | | Means of Egress | N/A | | Tactile exit sign not provided | - | Ensure that a tactile exit sign with raised characters and braille is provided at the exit door. Mount the sign between 48"- 60" above the finished floor located on the latch side of the door. | 1 | 250 | \$250 |

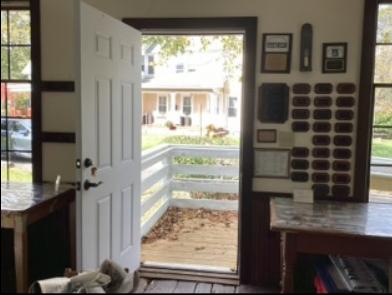
| ID | Location | Floor | Room | Element | Type | Photo | Issues | Current Measure | Recommendations | Quantity | Price | Cost Estimation |
|---|---|---|---|---|---|---|---|---|---|---|---|---|
| 5 | Main Entrance | 1 | | Doors, Doorways, & Gates | Emergency Egress | | Maneuvering clearance(s) not provided | 9" | Relocate table to provide 18" min. pull-side maneuvering clearance at the door. | 1 | Labor | Labor |

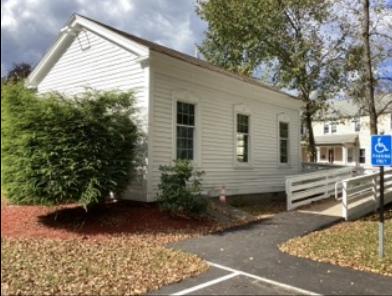
| ID | Location | Floor | Room | Element | Type | Photo | Issues | Current Measure | Recommendations | Quantity | Price | Cost Estimation |
|---|---|---|---|---|---|---|---|---|---|---|---|---|
| 6 | Old Schoolhouse | Ext. | | Photographs of Interior | N/A | | | Recommend, as space is limited at the entry to the schoolhouse, providing photographs from the inside of the schoolhouse and information about the schoolhouse at a wayside exhibit at an accessible location onsite. Recommend also duplicating the display information on an Oxford-maintained website. | 1 | Labor | Labor | |

- Recommend, due to limited space inside the schoolhouse building, providing photographs from the inside of the schoolhouse and information about the schoolhouse at a wayside exhibit at an accessible location onsite. Recommend also duplicating the wayside display information on an Oxford-maintained website.

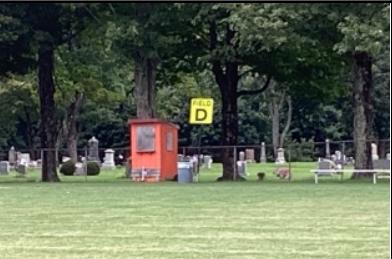
| ID | Location | Floor | Room | Element | Type | Photo | Issues | Current Measure | Recommendations | Quantity | Price | Cost Estimation |
|---|---|---|---|---|---|--|---|---|---|---|---|---|
| 1 | Field D Ticket Booth | Ext. | | Exterior Access Route | Exterior | | Accessible route not provided | - | Ensure an accessible route is provided to the service window at the ticket booth. | 1 | Labor | Labor |

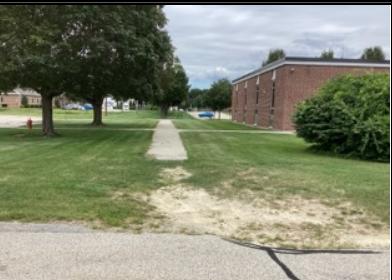
| ID | Location | Floor | Room | Element | Type | Photo | Issues | Current Measure | Recommendations | Quantity | Price | Cost Estimation |
|---|---|---|---|---|---|--|---|---|---|---|---|---|
| 2 | By Door 22 | Ext. | | Exterior Access Route | Walkway | | Accessible route not provided | - | Provide a 48" wide min. stable, firm and slip resistant accessible route to the existing walkway. | 1 | Labor | Labor |

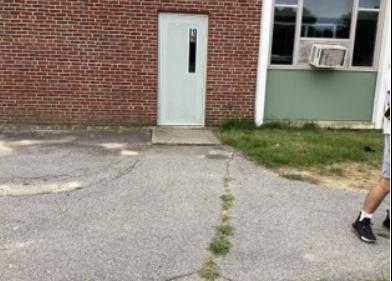
| ID | Location | Floor | Room | Element | Type | Photo | Issues | Current Measure | Recommendations | Quantity | Price | Cost Estimation |
|---|---|---|---|---|---|--|---|---|---|---|---|---|
| 3 | Door 19 | Ext. | | Exterior Access Route | Exterior | | Surface openings > 1/2"<br>Level changes > 1/4" | 3"<br>1" | Replace or reposition so that openings are 1/2" max. and the long opening dimension is perpendicular to the dominant direction of travel.<br>Alter change in level to be 1/4" high max. | 1 | Labor | Labor |

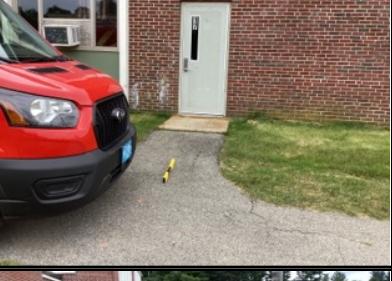
| ID | Location | Floor | Room | Element | Type | Photo | Issues | Current Measure | Recommendations | Quantity | Price | Cost Estimation |
|---|---|---|---|---|---|--|---|---|---|---|---|---|
| 4 | Door 17 | Ext. | | Exterior Access Route | Exterior | | Surface openings > 1/2"<br>Cross slope > 1:50 (2.00%)<br>Running slope > 1:20 (5.00%)<br>Level changes > 1/4" | 1"<br>4.0 %<br>11.0 %<br>1" | If this door is used by students or members of the public replace or reposition so that openings are 1/2" max. and the long opening dimension is perpendicular to the dominant direction of travel.<br>Reduce cross slope to be no steeper than 1:50 (2.00%).<br>Reduce running slope to be no steeper than 1:20 (5.00%).<br>Alter change in level to be 1/4" high max. | 1 | Labor | Labor |

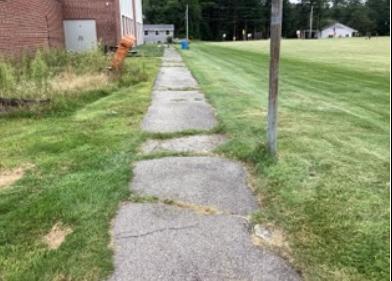
| ID | Location | Floor | Room | Element | Type | Photo | Issues | Current Measure | Recommendations | Quantity | Price | Cost Estimation |
|---|---|---|---|---|---|--|---|---|---|---|---|---|
| 5 | By Door 15 | Ext. | | Exterior Access Route | Walkway | | Cross slope > 1:50 (2.00%)<br>Route not maintained in operable working condition | 2.6"<br>- | Reduce cross slope to be no steeper than 1:50 (2.00%).<br>Ensure the accessible route is maintained in operable working condition. | 1 | Labor | Labor |

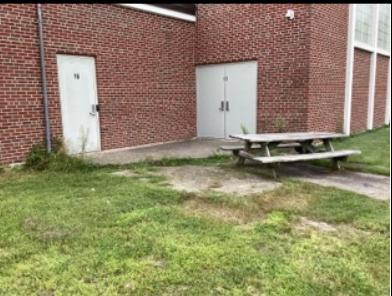
| ID | Location | Floor | Room | Element | Type | Photo | Issues | Current Measure | Recommendations | Quantity | Price | Cost Estimation |
|---|---|---|---|---|---|--|--|---|--|---|---|---|
| 6 | Doors 15 and 26 | Ext. | | Exterior Access Route | Exterior | | Accessible route not provided | - | Ensure an accessible route is provided to each door if these doors are used by students or members of the public. | 1 | Labor | Labor |

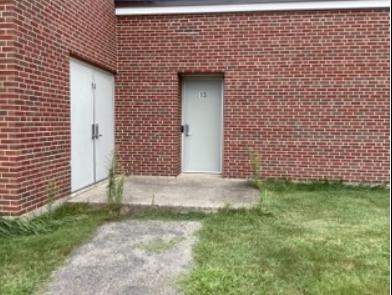
| ID | Location | Floor | Room | Element | Type | Photo | Issues | Current Measure | Recommendations | Quantity | Price | Cost Estimation |
|---|---|---|---|---|---|--|--|---|--|---|---|---|
| 7 | Doors 13 and 14 | Ext. | | Exterior Access Route | Exterior | | Accessible route not provided | - | Ensure an accessible route is provided to each door if these doors are used by students or members of the public. | 1 | Labor | Labor |

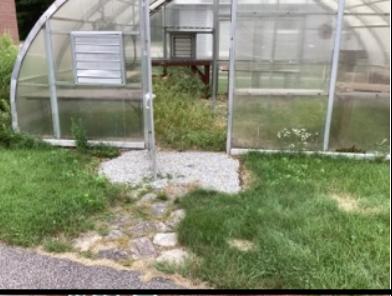
| ID | Location | Floor | Room | Element | Type | Photo | Issues | Current Measure | Recommendations | Quantity | Price | Cost Estimation |
|---|---|---|---|---|---|--|--|---|--|---|---|---|
| 8 | Greenhouse | Ext. | | Exterior Access Route | Exterior | | Accessible route not provided | - | Provide a 48" wide min. stable, firm and slip resistant accessible route to the greenhouse entry and a 36" wide min. accessible route within the greenhouse. | 1 | Labor | Labor |

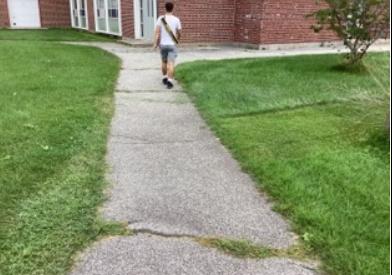
| ID | Location | Floor | Room | Element | Type | Photo | Issues | Current Measure | Recommendations | Quantity | Price | Cost Estimation |
|---|---|---|---|---|---|--|--|---|--|---|---|---|
| 9 | Towards Door 6 | Ext. | | Exterior Access Route | Walkway | | Surface openings > 1/2" | 2" | Replace or reposition so that openings are 1/2" max. and the long opening dimension is perpendicular to the dominant direction of travel. | 1 | Labor | Labor |

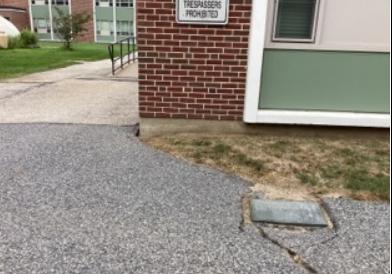
| ID | Location | Floor | Room | Element | Type | Photo | Issues | Current Measure | Recommendations | Quantity | Price | Cost Estimation |
|---|---|---|---|---|---|--|--|---|--|---|---|---|
| 10 | By Door 5 | Ext. | | Exterior Access Route | Exterior | | Route not maintained in operable working condition | - | Ensure the accessible route is maintained in operable working condition. | 1 | Labor | Labor |

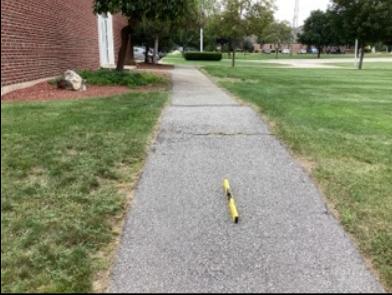
| ID | Location | Floor | Room | Element | Type | Photo | Issues | Current Measure | Recommendations | Quantity | Price | Cost Estimation |
|---|---|---|---|---|---|--|---|---|--|---|---|---|
| 11 | Towards Door 3 | Ext. | | Exterior Access Route | Walkway | | Cross slope > 1:50 (2.00%)<br>Running slope > 1:20 (5.00%) | 3%<br>16.8" | Reduce cross slope to be no steeper than 1:50 (2.00%).<br>Reduce running slope to be no steeper than 1:20 (5.00%). | 1 | Labor | Labor |

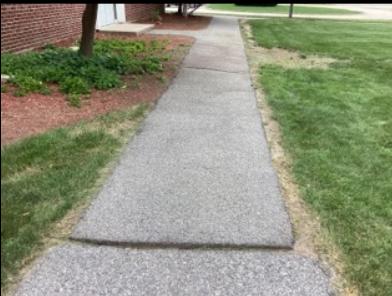
| ID | Location | Floor | Room | Element | Type | Photo | Issues | Current Measure | Recommendations | Quantity | Price | Cost Estimation |
|---|---|---|---|---|---|--|---|---|--|---|---|---|
| 12 | Towards Door 3 | Ext. | | Exterior Access Route | Walkway | | Surface is not stable, firm, and slip-resistant | 2" | Repair surface. | 2 | Labor | Labor |

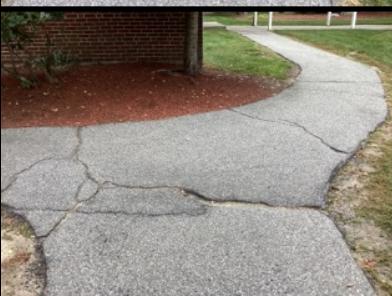
| ID | Location | Floor | Room | Element | Type | Photo | Issues | Current Measure | Recommendations | Quantity | Price | Cost Estimation |
|---|---|---|---|---|---|--|---|---|--|---|---|---|
| 13 | Towards Door 3 | Ext. | | Exterior Access Route | Walkway | | Route not maintained in operable working condition | - | Ensure the accessible route is maintained in operable working condition. | 1 | Labor | Labor |

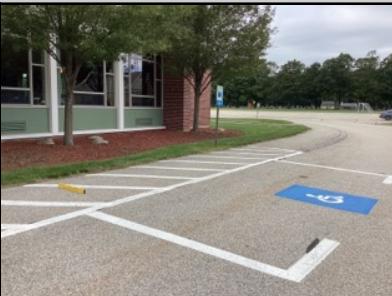
| ID | Location | Floor | Room | Element | Type | Photo | Issues | Current Measure | Recommendations | Quantity | Price | Cost Estimation |
|---|---|---|---|---|---|--|---|---|--|---|---|---|
| 14 | By Main Entrance | Ext. | | Off-Street Parking Lot or Garage | N/A | | Total # of designated van accessible spaces<br>Van space < 132" or <96" wide<br>Running or cross slope at space > 1:50 (2.00%) | 1<br>108"<br>3.5% | Provide a van accessible space that is at least 132" wide.<br>Reduce running or cross slope to be no steeper than 1:50 (2.00%). | 1 | Labor | Labor |

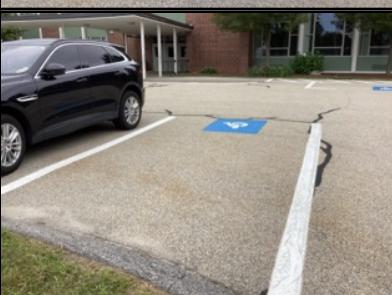
| ID | Location | Floor | Room | Element | Type | Photo | Issues | Current Measure | Recommendations | Quantity | Price | Cost Estimation |
|---|---|---|---|---|---|--|---|---|--|---|---|---|
| 15 | By Main Entrance | Ext. | | Off-Street Parking Lot or Garage | N/A | | Total # of designated car accessible parking spaces<br>Access aisle not provided<br>Sign with the International Symbol of Acc. not provided | 1<br>-<br>- | Provide a marked access aisle that is at least 60" wide.<br>Provide a sign with the International Symbol of Accessibility (ISA) with the bottom of the sign 60" min. above the ground and the top 96" max. above the ground. | 1 | Labor | Labor |

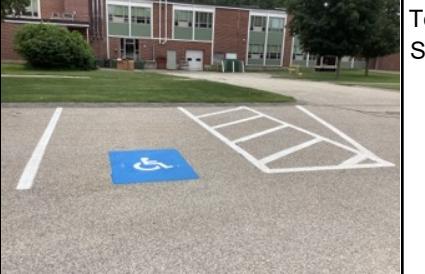
| ID | Location | Floor | Room | Element | Type | Photo | Issues | Current Measure | Recommendations | Quantity | Price | Cost Estimation |
|---|---|---|---|---|---|---|--|---|--|---|---|---|
| 16 | By Door 22 | Ext. | | Off-Street Parking Lot or Garage | N/A | | Total # of designated car accessible parking spaces<br>Sign with the International Symbol of Acc. not provided | -<br>- | Provide a sign with the International Symbol of Accessibility (ISA) with the bottom of the sign 60" min. above the ground and the top 96" max. above the ground. | 1 | Labor | Labor |

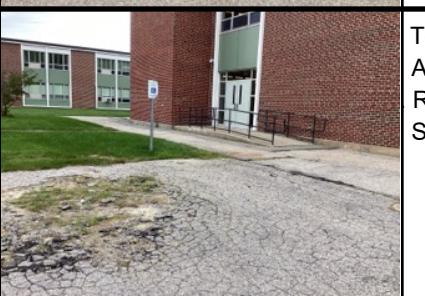
| ID | Location | Floor | Room | Element | Type | Photo | Issues | Current Measure | Recommendations | Quantity | Price | Cost Estimation |
|---|---|---|---|---|---|---|--|---|--|---|---|---|
| 18 | By Ramp at Door 5 | Ext. | | Off-Street Parking Lot or Garage | N/A | | Total # of designated van accessible spaces<br>Access aisle not provided<br>Running or cross slope at access aisle > 1:50 (2.00%)<br>Sign does not have the designation "Van Accessible" | -<br>-<br>-<br>- | Provide a marked access aisle that is at least 96" wide.<br>Reduce running or cross slope to be no steeper than 1:50 (2.00%) / repair surface.<br>Add the designation "Van Accessible" to the sign located at the van accessible space. | 1 | Labor | Labor |

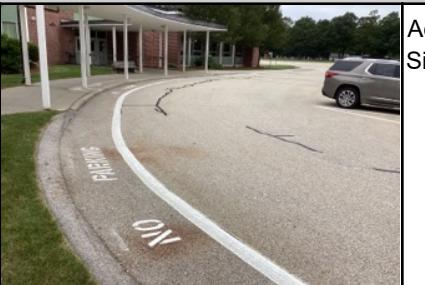
| 19 | Drop-off Area | Ext. | | Passenger Loading Zones | N/A | | Access aisle < 60" wide<br>Sign with ISA not provided (MAAB) | 36" | Provide a marked access aisle that is at least 60" wide and that extends the full length of the vehicle at the drop-off zone.<br>Provide a sign that includes the International Symbol of Accessibility (ISA) at the head of the space. Locate the sign so that the bottom is 60" min. above the ground and the top is 96" max. above the ground. | 1 | Labor | Labor |

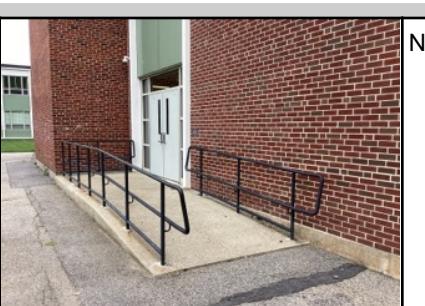
| 20 | Door 5 Ramped Rear Accessible Entrance | Ext. | | Exterior Ramp | N/A | | Not maintained in operable working condition | 1" | Ensure the ramp is maintained in operable working condition. Reduce transition at bottom of ramp to 1/4" max. | 1 | Labor | Labor |

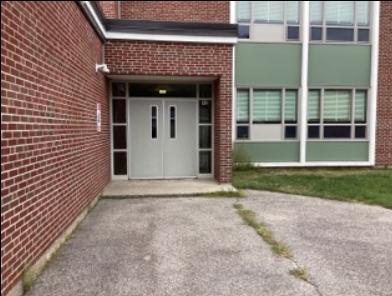
| ID | Location | Floor | Room | Element | Type | Photo | Issues | Current Measure | Recommendations | Quantity | Price | Cost Estimation |
|---|---|---|---|---|---|--|--|---|--|---|---|---|
| 21 | Door 12 | Ext. | | Entrance | N/A | | Directional sign to accessible entrance not provided | - | Provide a directional sign indicating the location of the nearest accessible entrance. | 1 | Labor | Labor |

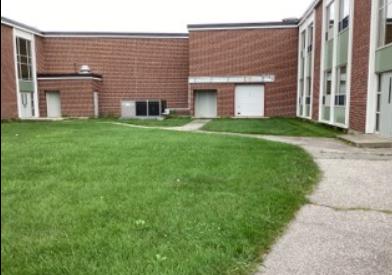
| ID | Location | Floor | Room | Element | Type | Photo | Issues | Current Measure | Recommendations | Quantity | Price | Cost Estimation |
|---|---|---|---|---|---|--|--|---|--|---|---|---|
| 22 | Egress Doors 6 Through 9 | Ext. | | Entrance | N/A | | Directional sign to accessible entrance not provided | - | Provide a directional sign indicating the location of the nearest accessible entrance. | 1 | Labor | Labor |

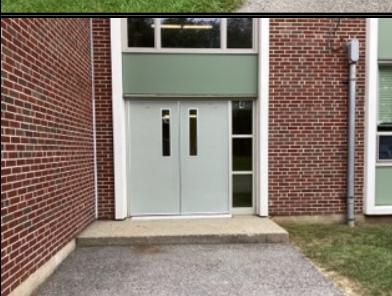
| ID | Location | Floor | Room | Element | Type | Photo | Issues | Current Measure | Recommendations | Quantity | Price | Cost Estimation |
|---|---|---|---|---|---|--|--|---|--|---|---|---|
| 23 | Door 4 | Ext. | | Entrance | N/A | | Directional sign to accessible entrance not provided | - | Provide a directional sign indicating the location of the nearest accessible entrance. | 1 | Labor | Labor |

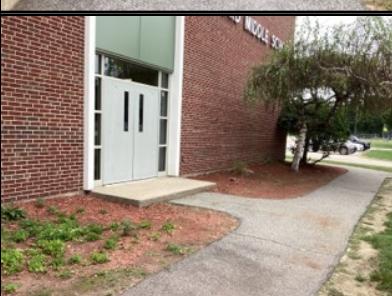
| ID | Location | Floor | Room | Element | Type | Photo | Issues | Current Measure | Recommendations | Quantity | Price | Cost Estimation |
|---|---|---|---|---|---|--|--|---|--|---|---|---|
| 24 | Door 3 | Ext. | | Entrance | N/A | | Directional sign to accessible entrance not provided | - | Provide a directional sign indicating the location of the nearest accessible entrance. | 1 | Labor | Labor |

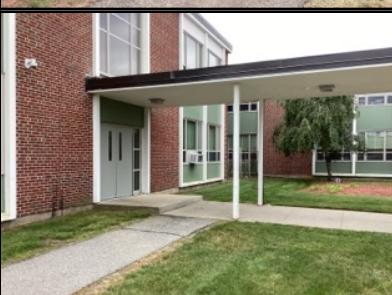
| ID | Location | Floor | Room | Element | Type | Photo | Issues | Current Measure | Recommendations | Quantity | Price | Cost Estimation |
|---|---|---|---|---|---|--|--|---|--|---|---|---|
| 25 | Door 20 | Ext. | | Entrance | N/A | | Directional sign to accessible entrance not provided | - | Provide a directional sign indicating the location of the nearest accessible entrance. | 1 | Labor | Labor |
