Town of Oxford

# ADA Self-Evaluation and Transition Plan

July 2024

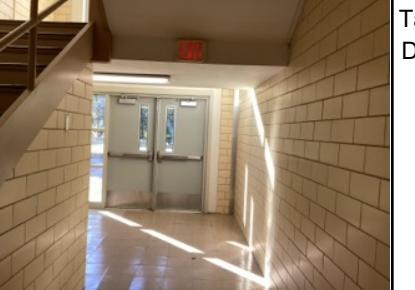
| ID | Location | Floor | Room | Element | Type | Photo | Issues | Current Measure | Recommendations | Quantity | Price | Cost Estimation |
|---|--|---|---|---|---|--|--|---|--|---|---|---|
| 26 | Door 42 | 1 | | Means of Egress | N/A | | Tactile exit sign not provided<br>Directional sign to accessible emergency exit not provided | -<br>- | Ensure that a tactile exit sign with raised characters and braille is provided at the exit door. Mount the sign between 48"- 60" above the finished floor located on the latch side of the door.<br>Provide a directional sign indicating the location of the nearest accessible emergency exit. | 2 | 250 | \$500 |

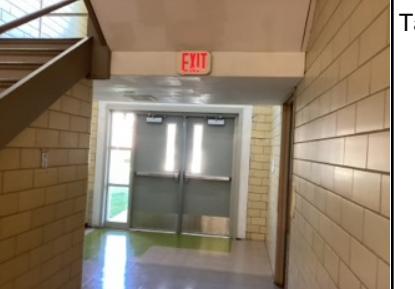
| ID | Location | Floor | Room | Element | Type | Photo | Issues | Current Measure | Recommendations | Quantity | Price | Cost Estimation |
|---|--|---|---|---|---|--|--|---|--|---|---|---|
| 27 | Door 2 | 1 | 104 | Means of Egress | N/A | | Tactile exit sign not provided | - | Ensure that a tactile exit sign with raised characters and braille is provided at the exit door. Mount the sign between 48"- 60" above the finished floor located on the latch side of the door. | 1 | 250 | \$250 |

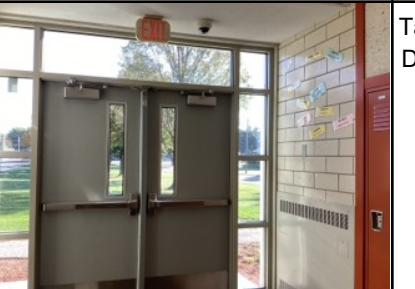
| ID | Location | Floor | Room | Element | Type | Photo | Issues | Current Measure | Recommendations | Quantity | Price | Cost Estimation |
|---|--|---|---|---|---|--|--|---|--|---|---|---|
| 28 | Door 3 | 1 | | Means of Egress | N/A | | Tactile exit sign not provided<br>Directional sign to accessible emergency exit not provided | -<br>- | Ensure that a tactile exit sign with raised characters and braille is provided at the exit door. Mount the sign between 48"- 60" above the finished floor located on the latch side of the door.<br>Provide a directional sign indicating the location of the nearest accessible emergency exit. | 2 | 250 | \$500 |

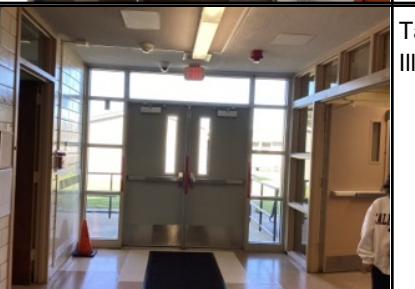
| ID | Location | Floor | Room | Element | Type | Photo | Issues | Current Measure | Recommendations | Quantity | Price | Cost Estimation |
|---|--|---|---|---|---|--|--|---|--|---|---|---|
| 29 | Door 5<br>Ramped<br>Rear<br>Accessible<br>Entrance | 1 | | Means of Egress | N/A | | Tactile exit sign not provided<br>Illuminated ISA symbol not provided (MAAB) | -<br>-- | Ensure that a tactile exit sign with raised characters and braille is provided at the exit door.<br>When the illuminated exit sign is repaired or replaced, provide an illuminated sign with the International Symbol of Accessibility (ISA). | 1 | 250<br>200 | \$450 |

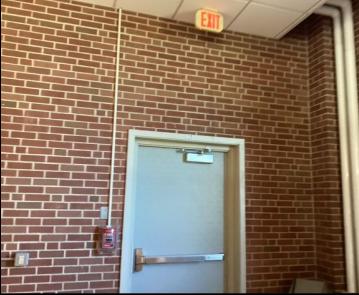
| ID | Location | Floor | Room | Element | Type | Photo | Issues | Current Measure | Recommendations | Quantity | Price | Cost Estimation |
|---|---|---|---|---|---|--|--|---|--|---|---|---|
| 31 | Door 25 | 1 | | Means of Egress | N/A | | Tactile exit sign not provided<br>Directional sign to accessible emergency exit not provided | -<br>- | Ensure that a tactile exit sign with raised characters and braille is provided at the exit door. Mount the sign between 48"- 60" above the finished floor located on the latch side of the door.<br>Provide a directional sign indicating the location of the nearest accessible emergency exit. | 2 | 250 | \$500 |

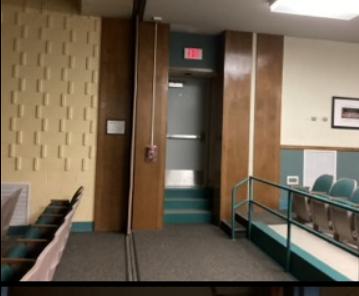
| ID | Location | Floor | Room | Element | Type | Photo | Issues | Current Measure | Recommendations | Quantity | Price | Cost Estimation |
|---|---|---|---|---|---|--|--|---|--|---|---|---|
| 32 | Auditorium | 1 | | Means of Egress | N/A | | Tactile exit sign not provided<br>Directional sign to accessible emergency exit not provided | | Ensure that a tactile exit sign with raised characters and braille is provided at the exit door. Mount the sign between 48"- 60" above the finished floor located on the latch side of the door.<br>Provide a directional sign indicating the location of the nearest accessible emergency exit. | 2 | 250 | \$500 |

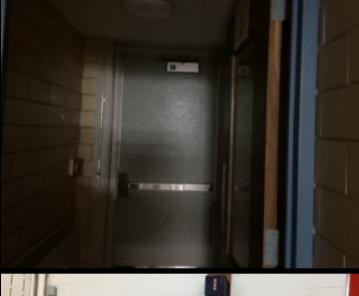
| ID | Location | Floor | Room | Element | Type | Photo | Issues | Current Measure | Recommendations | Quantity | Price | Cost Estimation |
|---|---|---|---|---|---|--|--|---|--|---|---|---|
| 33 | Boys' Locker Room Door 16 to Outside | 1 | | Means of Egress | N/A | | Tactile exit sign not provided<br>Directional sign to accessible emergency exit not provided | -<br>- | Ensure that a tactile exit sign with raised characters and braille is provided at the exit door. Mount the sign between 48"- 60" above the finished floor located on the latch side of the door.<br>Provide a directional sign indicating the location of the nearest accessible emergency exit. | 2 | 250 | \$500 |

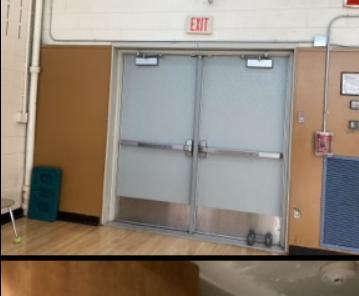
| ID | Location | Floor | Room | Element | Type | Photo | Issues | Current Measure | Recommendations | Quantity | Price | Cost Estimation |
|---|---|---|---|---|---|--|--|---|--|---|---|---|
| 34 | Gym Doors 14 and 15 | 1 | | Means of Egress | N/A | | Tactile exit sign not provided<br>Directional sign to accessible emergency exit not provided | -<br>- | Ensure that a tactile exit sign with raised characters and braille is provided at the exit door. Mount the sign between 48"- 60" above the finished floor located on the latch side of the door.<br>Provide a directional sign indicating the location of the nearest accessible emergency exit. | 2 | 250 | \$500 |

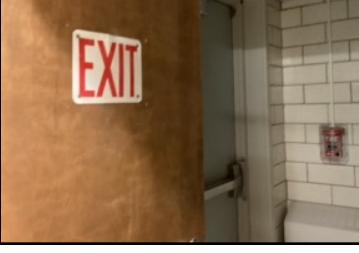
| ID | Location | Floor | Room | Element | Type | Photo | Issues | Current Measure | Recommendations | Quantity | Price | Cost Estimation |
|---|---|---|---|---|---|--|--|---|--|---|---|---|
| 35 | Girls' Locker Room Door 13 | 1 | | Means of Egress | N/A | | Tactile exit sign not provided<br>Directional sign to accessible emergency exit not provided | -<br>- | Ensure that a tactile exit sign with raised characters and braille is provided at the exit door. Mount the sign between 48"- 60" above the finished floor located on the latch side of the door.<br>Provide a directional sign indicating the location of the nearest accessible emergency exit. | 2 | 250 | \$500 |

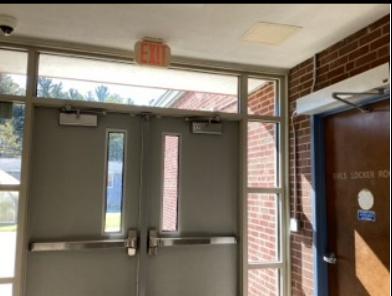
| ID | Location | Floor | Room | Element | Type | Photo | Issues | Current Measure | Recommendations | Quantity | Price | Cost Estimation |
|---|---|---|---|---|---|--|--|---|--|---|---|---|
| 36 | Door 12 | 1 | | Means of Egress | N/A | | Tactile exit sign not provided<br>Directional sign to accessible emergency exit not provided | -<br>- | Ensure that a tactile exit sign with raised characters and braille is provided at the exit door. Mount the sign between 48"- 60" above the finished floor located on the latch side of the door.<br>Provide a directional sign indicating the location of the nearest accessible emergency exit. | 2 | 250 | \$500 |

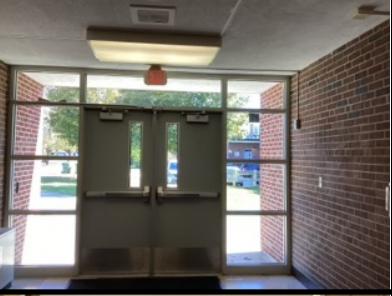
| ID | Location | Floor | Room | Element | Type | Photo | Issues | Current Measure | Recommendations | Quantity | Price | Cost Estimation |
|---|---|---|---|---|---|--|--|---|--|---|---|---|
| 37 | Door 20 | 1 | | Means of Egress | N/A | | Tactile exit sign not provided | - | Ensure that a tactile exit sign with raised characters and braille is provided at the exit door. Mount the sign between 48"- 60" above the finished floor located on the latch side of the door. | 1 | 250 | \$250 |

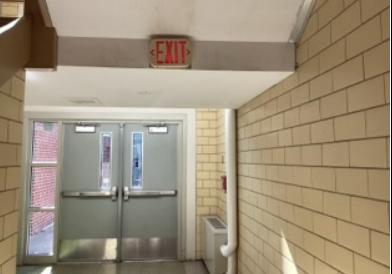
| ID | Location | Floor | Room | Element | Type | Photo | Issues | Current Measure | Recommendations | Quantity | Price | Cost Estimation |
|---|---|---|---|---|---|--|--|---|--|---|---|---|
| 38 | Door 11 | 1 | | Means of Egress | N/A | | Tactile exit sign not provided<br>Directional sign to accessible emergency exit not provided | -<br>- | Ensure that a tactile exit sign with raised characters and braille is provided at the exit door. Mount the sign between 48"- 60" above the finished floor located on the latch side of the door.<br>Provide a directional sign indicating the location of the nearest accessible emergency exit. | 2 | 250 | \$500 |

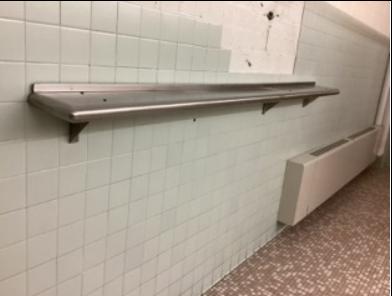
| ID | Location | Floor | Room | Element | Type | Photo | Issues | Current Measure | Recommendations | Quantity | Price | Cost Estimation |
|---|---|---|---|---|---|--|--|---|--|---|---|---|
| 40 | Girls' Multi-User Toilet Room | 1 | 118 | Interior Access Route | N/A | | Obstructed by protruding objects | 8" | Provide a cane-detectable barrier. | 1 | 398 | \$398 |

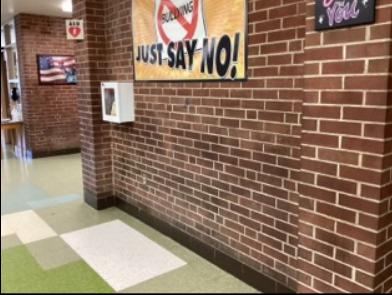
| ID | Location | Floor | Room | Element | Type | Photo | Issues | Current Measure | Recommendations | Quantity | Price | Cost Estimation |
|---|--|---|---|---|---|--|---|---|--|---|---|---|
| 41 | Hallway | 1 | | Interior Access Route | N/A | | Obstructed by protruding objects | 8" | Relocate defibrillator out of the accessible route or provide a cane-detectable barrier. | 1 | 500 | \$500 |

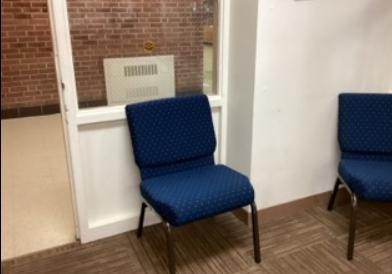
| ID | Location | Floor | Room | Element | Type | Photo | Issues | Current Measure | Recommendations | Quantity | Price | Cost Estimation |
|---|--|---|---|---|---|--|---|---|--|---|---|---|
| 42 | Office | 1 | | Doors, Doorways, & Gates | Office | | Maneuvering clearance(s) not provided | 13" | Relocate chair to provide 18" min. pull-side maneuvering clearance at the door. | 2 | Labor | Labor |

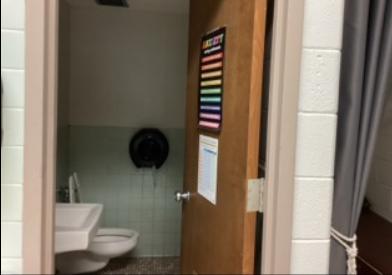
| ID | Location | Floor | Room | Element | Type | Photo | Issues | Current Measure | Recommendations | Quantity | Price | Cost Estimation |
|---|--|---|---|---|---|--|---|---|--|---|---|---|
| 43 | Nurse's Office Single-User Toilet Room | 1 | | Doors, Doorways, & Gates | Office | | Clear width at door < 32"<br>Hardware not compliant | 24"<br>- | Widen the door so that there is 32" min. clear width.<br>Provide hardware that can be operable with one hand and not require tight grasping, pinching, or twisting of the wrist.<br><b>Note:</b> These costs are included in the \$31985 estimated expense to renovate this toilet room. | 1 | Labor | Labor |

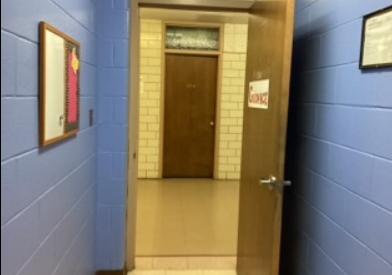
| ID | Location | Floor | Room | Element | Type | Photo | Issues | Current Measure | Recommendations | Quantity | Price | Cost Estimation |
|---|--|---|---|---|---|--|---|---|--|---|---|---|
| 44 | Guidance | 1 | 134 | Doors, Doorways, & Gates | Office | | Maneuvering clearance not provided at recess > 6"<br>Hardware not compliant | 8.5"<br>- | Install an automatic door opener.<br>Provide hardware that can be operable with one hand and not require tight grasping, pinching, or twisting of the wrist. | 1 | 6000 | \$6000 |

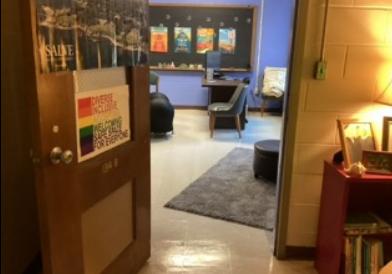
| ID | Location | Floor | Room | Element | Type | Photo | Issues | Current Measure | Recommendations | Quantity | Price | Cost Estimation |
|---|--|---|---|---|---|--|---|---|--|---|---|---|
| 45 | Councilor's Office | 1 | 134 | Doors, Doorways, & Gates | Office | | Maneuvering clearance(s) not provided<br>Hardware not compliant | 9"<br>- | Relocate furniture to provide 18" min. pull-side maneuvering clearance at the door.<br>Provide hardware that can be operable with one hand and not require tight grasping, pinching, or twisting of the wrist. | 1 | 750 | \$750 |

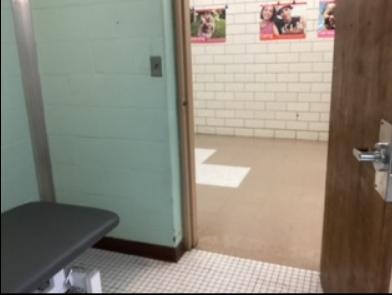
| ID | Location | Floor | Room | Element | Type | Photo | Issues | Current Measure | Recommendations | Quantity | Price | Cost Estimation |
|---|---|---|---|---|---|--|--|---|---|---|---|---|
| 46 | All-Gender Single-User Toilet Room | 1 | 132 | Doors, Doorways, & Gates | Toilet Room | | Maneuvering clearance(s) not provided | 5" | Relocate furniture to provide 18" min. pull-side maneuvering clearance at the door. | 1 | Labor | Labor |

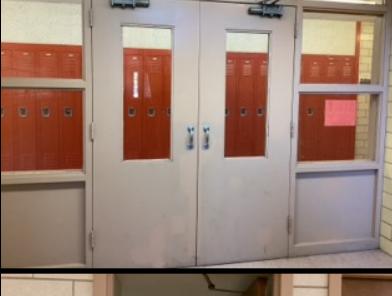
| ID | Location | Floor | Room | Element | Type | Photo | Issues | Current Measure | Recommendations | Quantity | Price | Cost Estimation |
|---|---|---|---|---|---|--|--|---|---|---|---|---|
| 48 | To Door 2 | 1 | | Doors, Doorways, & Gates | Circulation | | If double-leaf door, neither compliant<br>Door requires > 5 lbs. of force to open | 30"<br>15 lbs. | Ensure that at least one of the active leaves is at least 32" min. wide.<br>Adjust closers so doors do not require more than 5 pounds of force to open. | 1 | 4376 | \$4376 |

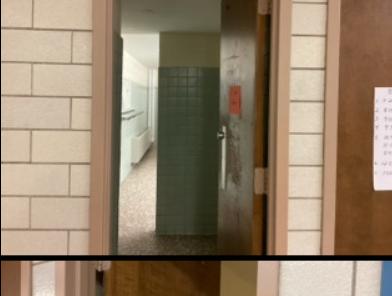
| ID | Location | Floor | Room | Element | Type | Photo | Issues | Current Measure | Recommendations | Quantity | Price | Cost Estimation |
|---|---|---|---|---|---|--|--|---|---|---|---|---|
| 49 | Girls' Multi-User Toilet Room | 1 | 118 | Doors, Doorways, & Gates | Toilet Room | | Clear width at door < 32"<br>Raised characters not provided on sign<br>Braille not provided on sign<br>Sign not located on the latch side of the door<br>Directional sign to access. toilet not provided | 25" | Provide text with raised characters duplicated in braille on the sign.<br>Provide braille on the sign.<br>Locate the sign at permanent rooms alongside the door on the latch side.<br>Install a sign indicating the location of the nearest accessible toilet room. | 2 | 250 | \$500 |

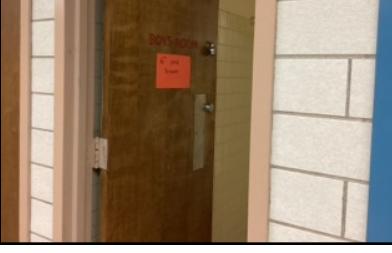
| ID | Location | Floor | Room | Element | Type | Photo | Issues | Current Measure | Recommendations | Quantity | Price | Cost Estimation |
|---|---|---|---|---|---|--|--|---|---|---|---|---|
| 50 | Boys' Multi-User Toilet Room | 1 | 121 | Doors, Doorways, & Gates | Toilet Room | | Clear width at door < 32"<br>Raised characters not provided on sign<br>Braille not provided on sign<br>Sign not located on the latch side of the door<br>Directional sign to access. toilet not provided | 25" | Provide text with raised characters duplicated in braille on the sign.<br>Provide braille on the sign.<br>Locate the sign at permanent rooms alongside the door on the latch side.<br>Install a sign indicating the location of the nearest accessible toilet room. | 2 | 250 | \$500 |

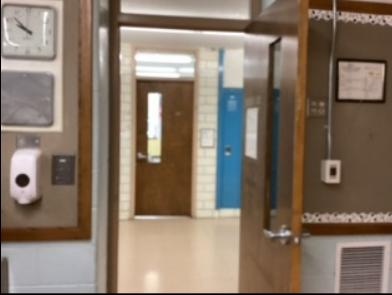
| ID | Location | Floor | Room | Element | Type | Photo | Issues | Current Measure | Recommendations | Quantity | Price | Cost Estimation |
|---|---|---|---|---|---|--|---|---|--|---|---|---|
| 51 | Chorus, Music and Band Room | 1 | 122 | Doors, Doorways, & Gates | Classroom | | Maneuvering clearance not provided at recess > 6" | 2" | Install an automatic door opener. | 1 | 6000 | \$6000 |

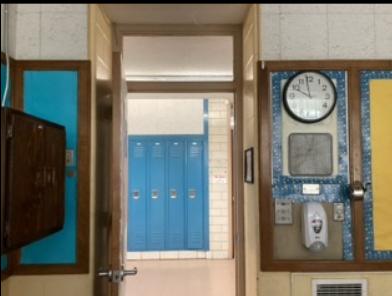
| ID | Location | Floor | Room | Element | Type | Photo | Issues | Current Measure | Recommendations | Quantity | Price | Cost Estimation |
|---|---|---|---|---|---|--|---|---|--|---|---|---|
| 52 | Science | 1 | 112 | Doors, Doorways, & Gates | Classroom | | Maneuvering clearance not provided at recess > 6" | 2" | Install an automatic door opener. | 1 | 6000 | \$6000 |

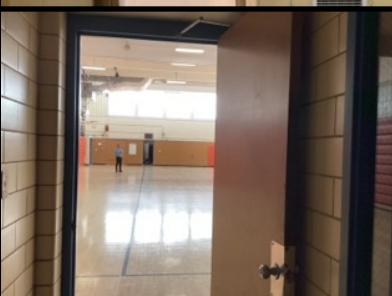
| ID | Location | Floor | Room | Element | Type | Photo | Issues | Current Measure | Recommendations | Quantity | Price | Cost Estimation |
|---|---|---|---|---|---|--|---|---|--|---|---|---|
| 53 | Boys' and Girl's Locker Rooms | 1 | | Doors, Doorways, & Gates | Circulation | | Maneuvering clearance(s) not provided<br>Hardware not compliant<br>Directional sign to accessible door in this locker room not provided | 5" - | Provide a sign indicating the location of the accessible door with an automatic door opener in this locker room that connects the locker room to the gym area. | 2 | 250 | \$500 |

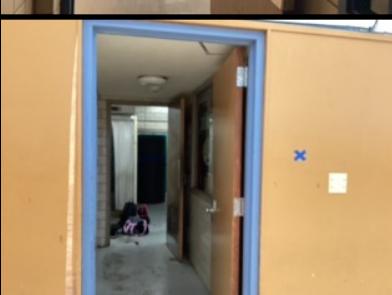
| ID | Location | Floor | Room | Element | Type | Photo | Issues | Current Measure | Recommendations | Quantity | Price | Cost Estimation |
|---|---|---|---|---|---|--|---|---|--|---|---|---|
| 54 | Girls' Locker Room | 1 | | Doors, Doorways, & Gates | Circulation | | Hardware not compliant | -, | Provide hardware that can be operable with one hand and not require tight grasping, pinching, or twisting of the wrist. | 1 | 750 | \$750 |

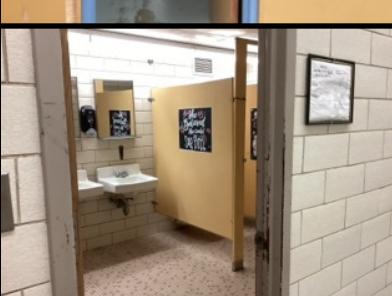
| ID | Location | Floor | Room | Element | Type | Photo | Issues | Current Measure | Recommendations | Quantity | Price | Cost Estimation |
|---|---|---|---|---|---|--|---|---|--|---|---|---|
| 55 | Girls' Locker Room Multi-User Toilet Room | 1 | | Doors, Doorways, & Gates | Toilet Room | | Clear width at door < 32"<br>Hardware not compliant | 25" - | Widen the door so that there is 32" min. clear width.<br>Provide hardware that can be operable with one hand and not require tight grasping, pinching, or twisting of the wrist. | 1 | 4376<br>750 | \$5126 |

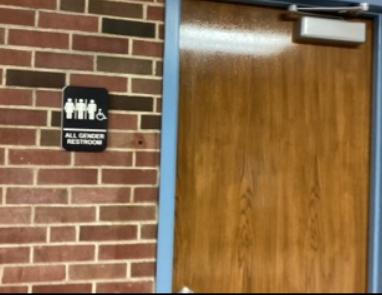
| ID | Location | Floor | Room | Element | Type | Photo | Issues | Current Measure | Recommendations | Quantity | Price | Cost Estimation |
|---|---|---|---|---|---|--|---|---|---|---|---|---|
| 56 | All-Gender Toilet Room by Door 20 | 1 | | Doors, Doorways, & Gates | Toilet Room | | Door requires > 5 lbs. of force to open | 14 lbs. | Adjust closers so doors do not require more than 5 pounds of force to open. | 1 | Labor | Labor |

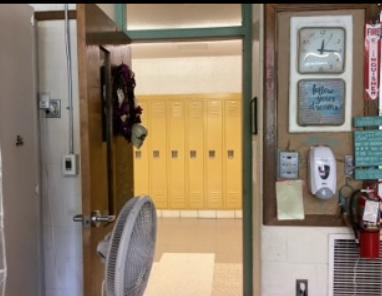
| ID | Location | Floor | Room | Element | Type | Photo | Issues | Current Measure | Recommendations | Quantity | Price | Cost Estimation |
|---|---|---|---|---|---|--|---|---|---|---|---|---|
| 57 | Art | 1 | 167 | Doors, Doorways, & Gates | Classroom | | Maneuvering clearance not provided at recess > 6" | 2" | Install an automatic door opener. | 1 | 6000 | \$6000 |

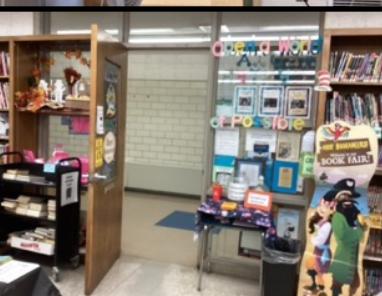
| ID | Location | Floor | Room | Element | Type | Photo | Issues | Current Measure | Recommendations | Quantity | Price | Cost Estimation |
|---|---|---|---|---|---|--|---|---|---|---|---|---|
| 58 | Library | 2 | | Doors, Doorways, & Gates | Other | | Maneuvering clearance(s) not provided | - | Relocate stored items to provide 18" min. pull side maneuvering clearance at the door. | 1 | Labor | Labor |

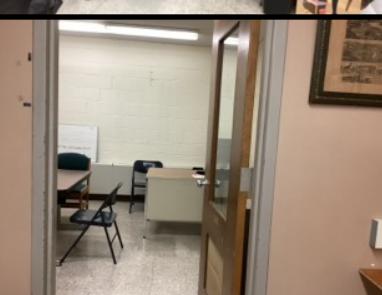
| ID | Location | Floor | Room | Element | Type | Photo | Issues | Current Measure | Recommendations | Quantity | Price | Cost Estimation |
|---|---|---|---|---|---|--|---|---|---|---|---|---|
| 59 | Library Student Work Room | 2 | 249 | Doors, Doorways, & Gates | Circulation | | Hardware not compliant | - | Provide hardware that can be operable with one hand and not require tight grasping, pinching, or twisting of the wrist. | 1 | 750 | \$750 |

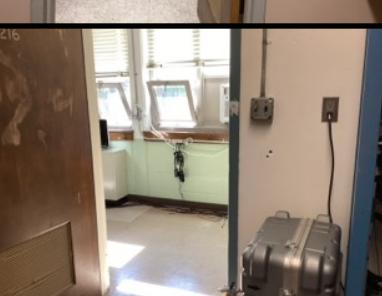
| ID | Location | Floor | Room | Element | Type | Photo | Issues | Current Measure | Recommendations | Quantity | Price | Cost Estimation |
|---|---|---|---|---|---|--|---|---|---|---|---|---|
| 60 | Media Production and Video Control Room | 2 | 216 | Doors, Doorways, & Gates | Classroom | | Maneuvering clearance(s) not provided | 8" | Relocate stored item to provide 18" min. pull side maneuvering clearance at the door. | 1 | Labor | Labor |

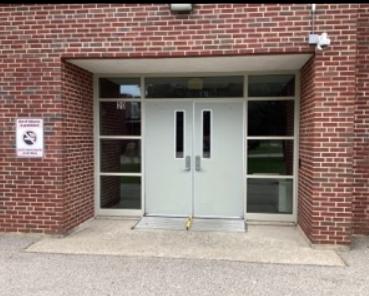
| ID | Location | Floor | Room | Element | Type | Photo | Issues | Current Measure | Recommendations | Quantity | Price | Cost Estimation |
|---|---|---|---|---|---|--|--|---|--|---|---|---|
| 61 | Door 20 | Ext. | | Doors, Doorways, & Gates | Emergency Egress | | Maneuvering clearance(s) not provided | 11.7% | Reduce slope at door landing to 2% max. in all directions. | 1 | Labor | Labor |

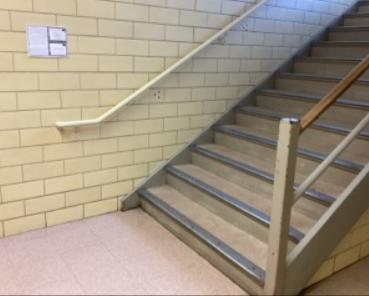
| ID | Location | Floor | Room | Element | Type | Photo | Issues | Current Measure | Recommendations | Quantity | Price | Cost Estimation |
|---|---|---|---|---|---|--|--|---|--|---|---|---|
| 62 | All Four Staircases | 1 | 104 | Stairways | Interior | | Handrail height < 34" or > 38"<br>Handrails do not extend 12" from stairs<br>Handrails not continuous where required | 39"<br>-<br>- | Alter so the handrails are 34"- 38" high above the floor.<br>Ensure that the handrail extends at least 12" plus the width of one tread beyond the bottom riser.<br>Provide continuous handrails. | 4 | - | - |

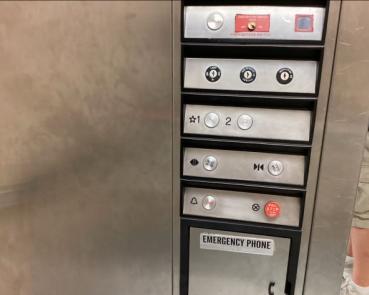
| ID | Location | Floor | Room | Element | Type | Photo | Issues | Current Measure | Recommendations | Quantity | Price | Cost Estimation |
|---|---|---|---|---|---|--|--|---|--|---|---|---|
| 63 | Elevator by Door 6 | 1 | | Elevator | Interior | | | | <b>Note:</b> IHCD team understands that it is the policy of the school that students who need to use the elevator to move between floors must contact a staff member who brings a key to activates the elevator. | 1 | - | - |

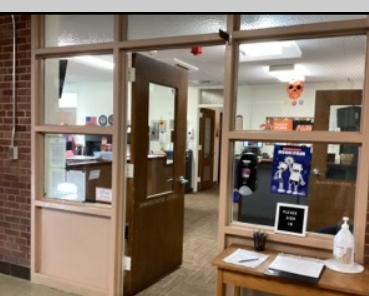
| ID | Location | Floor | Room | Element | Type | Photo | Issues | Current Measure | Recommendations | Quantity | Price | Cost Estimation |
|---|---|---|---|---|---|--|--|---|--|---|---|---|
| 64 | Office | 1 | | Signage | Designation | | Raised characters not provided on sign<br>Braille not provided on sign<br>Sign not located on the latch side of the door | -<br>-<br>- | Provide text with raised characters duplicated in braille on the sign.<br>Locate the sign at permanent rooms alongside the door on the latch side. | 1 | 250 | \$250 |

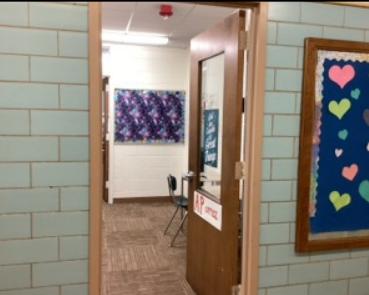
| ID | Location | Floor | Room | Element | Type | Photo | Issues | Current Measure | Recommendations | Quantity | Price | Cost Estimation |
|---|---|---|---|---|---|--|--|---|--|---|---|---|
| 65 | AP Room | 1 | | Signage | Designation | | Raised characters not provided on sign<br>Braille not provided on sign<br>Sign not located on the latch side of the door | -<br>-<br>- | Provide text with raised characters duplicated in braille on the sign.<br>Locate the sign at permanent rooms alongside the door on the latch side. | 1 | 250 | \$250 |

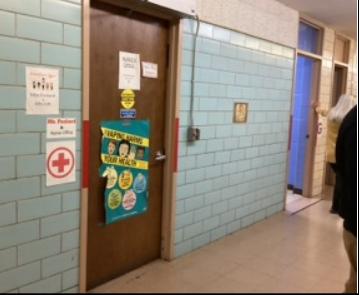
| ID | Location | Floor | Room | Element | Type | Photo | Issues | Current Measure | Recommendations | Quantity | Price | Cost Estimation |
|---|---|---|---|---|---|--|--|---|--|---|---|---|
| 66 | Nurse's Office | 1 | | Signage | Designation | | Raised characters not provided on sign<br>Braille not provided on sign<br>Sign not located on the latch side of the door | -<br>-<br>- | Provide text with raised characters duplicated in braille on the sign.<br>Locate the sign at permanent rooms alongside the door on the latch side. | 1 | 250 | \$250 |

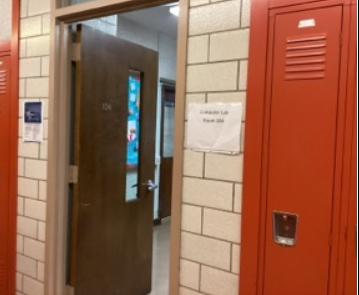
| ID | Location | Floor | Room | Element | Type | Photo | Issues | Current Measure | Recommendations | Quantity | Price | Cost Estimation |
|---|---|---|---|---|---|--|--|---|--|---|---|---|
| 67 | Computer Lab | 1 | 104 | Signage | Designation | | Raised characters not provided on sign<br>Braille not provided on sign<br>Sign not located on the latch side of the door | -<br>-<br>- | Provide text with raised characters duplicated in braille on the sign.<br>Locate the sign at permanent rooms alongside the door on the latch side. | 1 | 250 | \$250 |

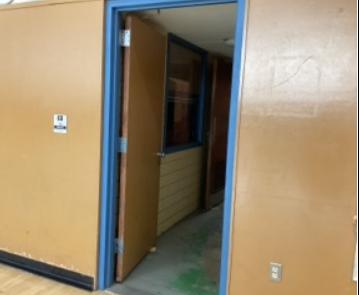
| ID | Location | Floor | Room | Element | Type | Photo | Issues | Current Measure | Recommendations | Quantity | Price | Cost Estimation |
|---|---|---|---|---|---|--|--|---|--|---|---|---|
| 68 | Boys' Locker Room Multi-User Toilet Room | 1 | | Signage | Designation | | Signage is not provided | - | Locate compliant signage with raised characters and braille alongside the door on the latch side. | 1 | 250 | \$250 |

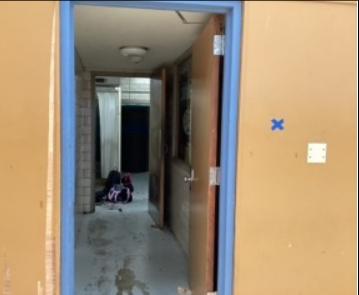
| ID | Location | Floor | Room | Element | Type | Photo | Issues | Current Measure | Recommendations | Quantity | Price | Cost Estimation |
|---|---|---|---|---|---|--|--|---|--|---|---|---|
| 69 | Girls' Locker Room | 1 | | Signage | Designation | | Signage is not provided | - | Locate compliant signage with raised characters and braille alongside the door on the latch side. | 1 | 250 | \$250 |

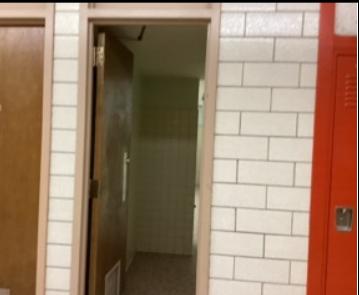
| ID | Location | Floor | Room | Element | Type | Photo | Issues | Current Measure | Recommendations | Quantity | Price | Cost Estimation |
|---|---|---|---|---|---|--|--|---|--|---|---|---|
| 70 | Boys' and Girls' Multi-User Toilet Room by Door 172 | 1 | | Signage | Designation | | Directional sign to access. toilet not provided | 2 | Install a sign indicating the location of the nearest accessible toilet room. | 2 | 250 | \$500 |

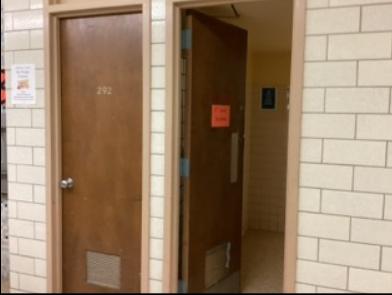
| ID | Location | Floor | Room | Element | Type | Photo | Issues | Current Measure | Recommendations | Quantity | Price | Cost Estimation |
|---|--|---|---|---|---|--|---|---|---|---|---|---|
| 71 | Boys' and Girls' Multi-User Toilet Room | 2 | | Signage | Designation | | Directional sign to access. toilet not provided | - | Install a sign indicating the location of the nearest accessible toilet room. | 2 | Labor | Labor |

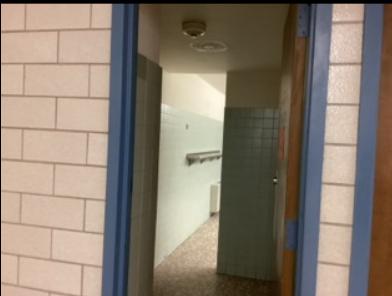
| ID | Location | Floor | Room | Element | Type | Photo | Issues | Current Measure | Recommendations | Quantity | Price | Cost Estimation |
|---|--|---|---|---|---|--|---|---|---|---|---|---|
| 72 | Boys' and Girls' Multi-User Toilet Rooms 224 and 236 | 2 | | Signage | Designation | | Raised characters not provided on sign<br>Braille not provided on sign<br>Sign not located on the latch side of the door<br>Directional sign to access. toilet not provided | | Provide text with raised characters duplicated in braille on the sign.<br>Locate the sign at permanent rooms alongside the door on the latch side.<br>Install a sign indicating the location of the nearest accessible toilet room. | 4 | 250 | \$1000<br><br>1000 |

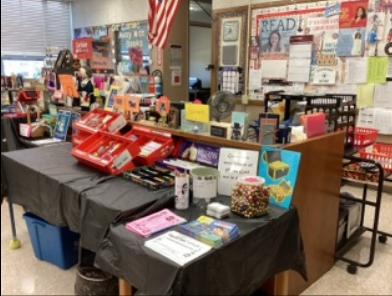
| ID | Location | Floor | Room | Element | Type | Photo | Issues | Current Measure | Recommendations | Quantity | Price | Cost Estimation |
|---|--|---|---|---|---|--|---|---|---|---|---|---|
| 73 | Library | 2 | | Service Counter | N/A | | Counter not connected to an accessible route<br>Counter > 36" high | - 38" | Ensure the counter is connected to an accessible route.<br>Provide a counter that is 36" max. above the ground or finished floor. | 1 | 1144 | \$1144<br><br>1144 |

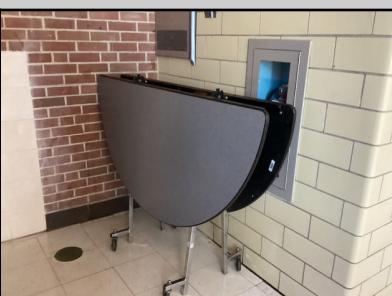
| ID | Location | Floor | Room | Element | Type | Photo | Issues | Current Measure | Recommendations | Quantity | Price | Cost Estimation |
|---|--|---|---|---|---|--|---|---|---|---|---|---|
| 74 | Cafeteria | 1 | | Dining or Work Surfaces | Dining Surface | | | | <b>Note:</b> IHCD team understands that an accessible dining surface is provided as needed in the cafeteria. | 1 | - | - |

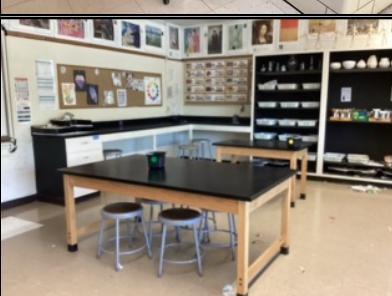
| ID | Location | Floor | Room | Element | Type | Photo | Issues | Current Measure | Recommendations | Quantity | Price | Cost Estimation |
|---|--|---|---|---|---|--|---|---|---|---|---|---|
| 75 | Art | 1 | 167 | Dining or Work Surfaces | Work Surface | | Knee or toe clearance not provided | 24" | Provide at least one work surface with 27" min. high knee and toe clearance. For children, provide at least one work surface with 24" min. high knee and toe clearance. | 1 | 455 | \$455<br><br>455 |

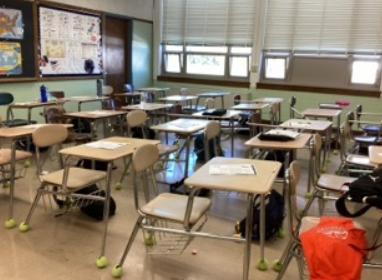
| ID | Location | Floor | Room | Element | Type | Photo | Issues | Current Measure | Recommendations | Quantity | Price | Cost Estimation |
|---|---|---|---|---|---|--|---|---|---|---|---|---|
| 76 | History | 2 | 259 | Dining or Work Surfaces | Work Surface | | At least one or 5% accessible tables not provided | - | Ensure that at least one work surface is accessible. | 1 | 455 | \$455 |

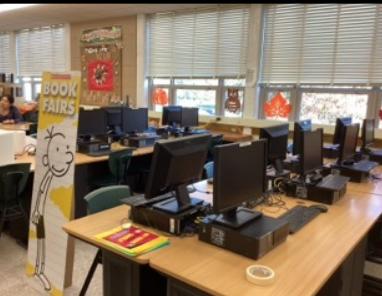
| ID | Location | Floor | Room | Element | Type | Photo | Issues | Current Measure | Recommendations | Quantity | Price | Cost Estimation |
|---|---|---|---|---|---|--|---|---|---|---|---|---|
| 77 | Library | 2 | | Dining or Work Surfaces | Work Surface | | At least one or 5% accessible tables not provided<br>Knee or toe clearance not provided | - 22" | Ensure that at least one work surface is accessible.<br>Provide at least one work surface with 27" min. high knee and toe clearance. For children, provide at least one dining or work surface with 24" min. high knee and toe clearance. | 1 | 455 | \$455 |

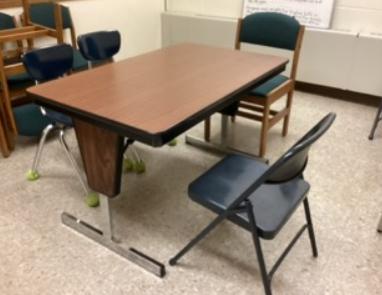
| ID | Location | Floor | Room | Element | Type | Photo | Issues | Current Measure | Recommendations | Quantity | Price | Cost Estimation |
|---|---|---|---|---|---|--|---|---|---|---|---|---|
| 78 | Library Student Work Room | 2 | 249 | Dining or Work Surfaces | Work Surface | | Knee or toe clearance not provided | 26" | Provide at least one work surface with 27" min. high knee and toe clearance. For children, provide at least one dining or work surface with 24" min. high knee and toe clearance. | 1 | 455 | \$455 |

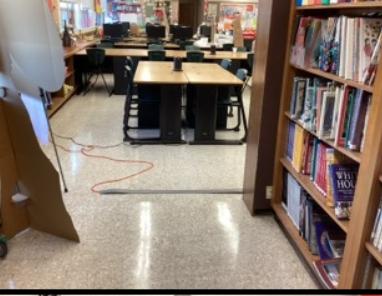
| ID | Location | Floor | Room | Element | Type | Photo | Issues | Current Measure | Recommendations | Quantity | Price | Cost Estimation |
|---|---|---|---|---|---|--|---|---|---|---|---|---|
| 79 | Library | 2 | | Dining or Work Surfaces | Work Surface | | Knee or toe clearance not provided | 22" | Provide at least one work surface with 27" min. high knee and toe clearance. For children, provide at least one work surface with 24" min. high knee and toe clearance. | 1 | 455 | \$455 |

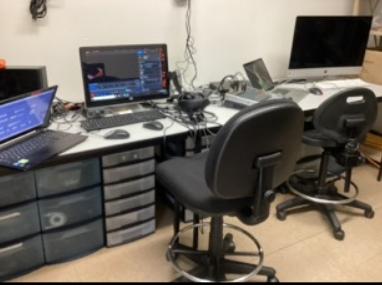
| ID | Location | Floor | Room | Element | Type | Photo | Issues | Current Measure | Recommendations | Quantity | Price | Cost Estimation |
|---|---|---|---|---|---|--|---|---|---|---|---|---|
| 80 | Media Production and Video Control Room | 2 | 216 | Dining or Work Surfaces | Work Surface | | Knee or toe clearance not provided | 12" | Provide at least one work surface with 27" min. high knee and toe clearance. For children, provide at least one work surface with 24" min. high knee and toe clearance. | 1 | 455 | \$455 |

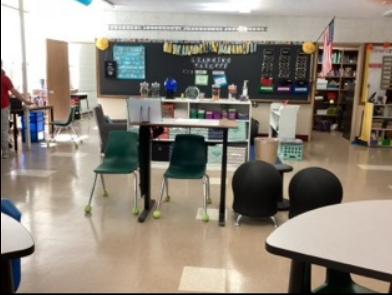
| ID | Location | Floor | Room | Element | Type | Photo | Issues | Current Measure | Recommendations | Quantity | Price | Cost Estimation |
|---|---|---|---|---|---|--|---|---|---|---|---|---|
| 81 | Intensive Learning Center | 2 | 216 | Dining or Work Surfaces | | | Knee or toe clearance not provided | 28" | Provide at least one work surface with 27" min. high knee and toe clearance. For children, provide at least one work surface with 24" min. high knee and toe clearance. | 1 | 455 | \$455 |

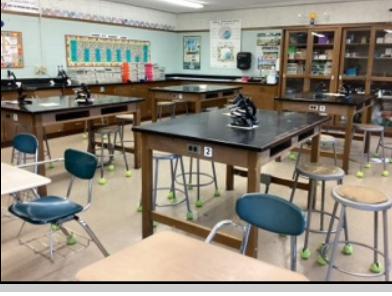
| ID | Location | Floor | Room | Element | Type | Photo | Issues | Current Measure | Recommendations | Quantity | Price | Cost Estimation |
|---|---|---|---|---|---|--|---|---|---|---|---|---|
| 82 | Science | 2 | 275 | Dining or Work Surfaces | Work Surface | | Top of dining/work surface < 28" or > 34" | 36" | Provide at least one work surface with tops between 28"- 34" above the floor and 27" clear height underneath. | 1 | 455 | \$455 |

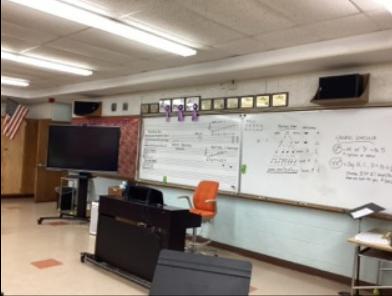
| ID | Location | Floor | Room | Element | Type | Photo | Issues | Current Measure | Recommendations | Quantity | Price | Cost Estimation |
|---|---|---|---|---|---|--|---|---|---|---|---|---|
| 83 | Chorus, Music and Band Room | 1 | 122 | Assembly Area | N/A | | Assistive listening devices not provided | - | If audible communication is integral to the use of the space, provide an assistive listening system. | 1 | 1578 | \$1578 |

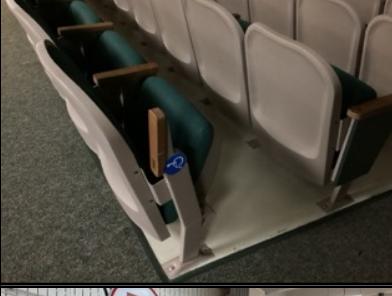
| ID | Location | Floor | Room | Element | Type | Photo | Issues | Current Measure | Recommendations | Quantity | Price | Cost Estimation |
|---|---|---|---|---|---|--|---|---|---|---|---|---|
| 84 | Auditorium | 1 | | Assembly Area | N/A | | Number of seats<br>Number of designated wheelchair spaces<br>Assistive listening devices not provided | 469<br>-<br>- | Ensure accessible seating complies with Table 221.2.1.1 Number of Wheelchair Spaces in Assembly Areas in the 2010 Standards for Accessible Design. Based on an estimated seating count of 469, six accessible seats are required in this assembly area.<br>If audible communication is integral to the use of the space, provide an assistive listening system. (Cost for provision of assistive listening system.) | 1 | 1578 | \$1578 |

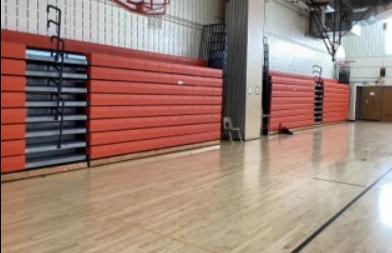
| ID | Location | Floor | Room | Element | Type | Photo | Issues | Current Measure | Recommendations | Quantity | Price | Cost Estimation |
|---|---|---|---|---|---|--|---|---|---|---|---|---|
| 85 | Gym | 1 | | Assembly Area | N/A | | Number of seats<br>Number of designated wheelchair spaces | -<br>- | Ensure accessible seating complies with Table 221.2.1.1 Number of Wheelchair Spaces in Assembly Areas in the 2010 Standards for Accessible Design. | 1 | - | - |

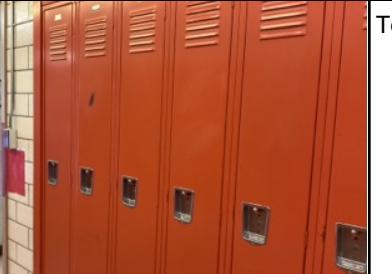
| ID | Location | Floor | Room | Element | Type | Photo | Issues | Current Measure | Recommendations | Quantity | Price | Cost Estimation |
|---|---|---|---|---|---|--|---|---|--|---|---|---|
| 86 | Lockers | 1 | | Locker Room | N/A | | Total # of accessible locker | - | Note: IHCD team was told that the lockers are not used by students or members of the public. | 1 | - | - |

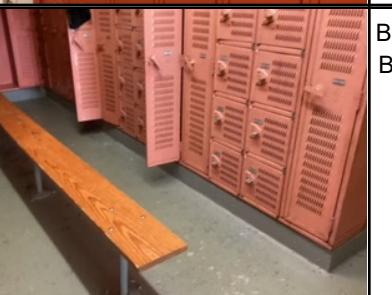
| ID | Location | Floor | Room | Element | Type | Photo | Issues | Current Measure | Recommendations | Quantity | Price | Cost Estimation |
|---|---|---|---|---|---|--|---|---|--|---|---|---|
| 87 | Boys' Locker Room | 1 | | Locker Room | Boys' | | Bench is not 17"-19" high<br>Bench < 24" deep | 21"<br>9" | Install a bench with the top of the seat between 17"- 19" above the finished floor.<br>Provide a bench that is 24" deep. | 1 | 260 | \$260 |

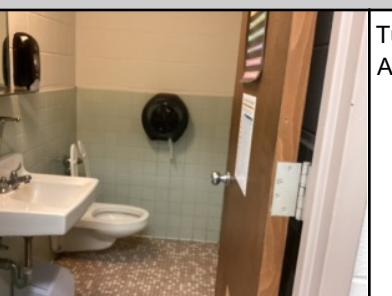
| ID | Location | Floor | Room | Element | Type | Photo | Issues | Current Measure | Recommendations | Quantity | Price | Cost Estimation |
|---|---|---|---|---|---|--|---|---|--|---|---|---|
| 88 | Nurse's Office Single-User Toilet Room | 1 | | Overall Access | Toilet Room | | Turning space not provided<br>Accessible plumbing fixtures or stalls not provided | 48'<br>- | Renovate to provide or add an accessible single-user toilet room in the nurse's office. | 1 | 31985 | \$31985 |

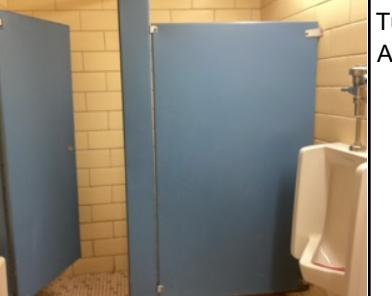
| ID | Location | Floor | Room | Element | Type | Photo | Issues | Current Measure | Recommendations | Quantity | Price | Cost Estimation |
|---|---|---|---|---|---|--|---|---|--|---|---|---|
| 89 | Boys' Locker Room Multi-User Toilet Room | 1 | | Overall Access | | | Turning space not provided<br>Accessible plumbing fixtures or stalls not provided | -<br>- | Provide one accessible wheelchair compartment. | 1 | 8037 | \$8037 |

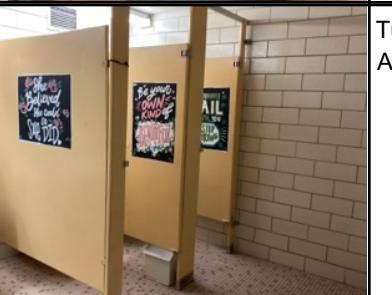
| ID | Location | Floor | Room | Element | Type | Photo | Issues | Current Measure | Recommendations | Quantity | Price | Cost Estimation |
|---|---|---|---|---|---|--|---|---|--|---|---|---|
| 90 | Girls' Locker Room Multi-User Toilet Room | 1 | | Overall Access | Toilet Room | | Turning space not provided<br>Accessible plumbing fixtures or stalls not provided | -<br>- | Provide one accessible wheelchair compartment. | 1 | 8037 | \$8037 |

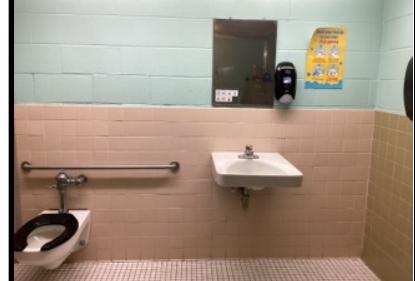
| ID | Location | Floor | Room | Element | Type | Photo | Issues | Current Measure | Recommendations | Quantity | Price | Cost Estimation |
|---|---|---|---|---|---|--|---|---|--|---|---|---|
| 91 | All-Gender Single-User Toilet Room | 1 | 132 | Lavatory | N/A | | Plumbing underneath is exposed<br>Mirror above lavatory w/reflective surface > 40" | - 49" | Insulate or otherwise configure pipes to prevent contact for at least one lavatory.<br>Lower mirror so that the bottom surface is at 40" max. above the finished floor. | 1 | 150 500 | \$650 |

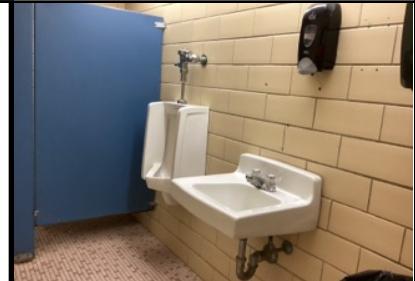
| ID | Location | Floor | Room | Element | Type | Photo | Issues | Current Measure | Recommendations | Quantity | Price | Cost Estimation |
|---|---|---|---|---|---|--|---|---|--|---|---|---|
| 92 | Boys' Locker Room Multi-User Toilet Room | 1 | | Lavatory | N/A | | Faucet is not compliant<br>Plumbing underneath is exposed | - - | Provide a faucet that can be operable with one hand and not require tight grasping, pinching, or twisting of the wrist for at least one lavatory.<br>Insulate or otherwise configure pipes to prevent contact for at least one lavatory. | 1 | 1282 150 | \$1432 |

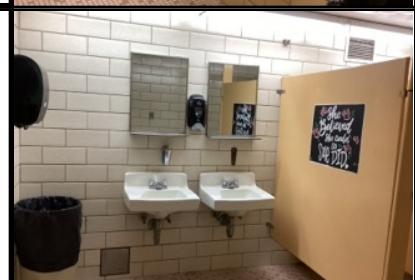
| ID | Location | Floor | Room | Element | Type | Photo | Issues | Current Measure | Recommendations | Quantity | Price | Cost Estimation |
|---|---|---|---|---|---|--|---|---|--|---|---|---|
| 93 | Girls' Locker Room Multi-User Toilet Room | 1 | | Lavatory | N/A | | Faucet is not compliant<br>Plumbing underneath is exposed<br>Mirror above lavatory w/reflective surface > 40" | - 49" | Provide a faucet that can be operable with one hand and not require tight grasping, pinching, or twisting of the wrist for at least one lavatory.<br>Insulate or otherwise configure pipes to prevent contact for at least one lavatory.<br>Lower mirror so that the bottom surface is at 40" max. above the finished floor. | 1 | 1282 150 500 | \$1932 |

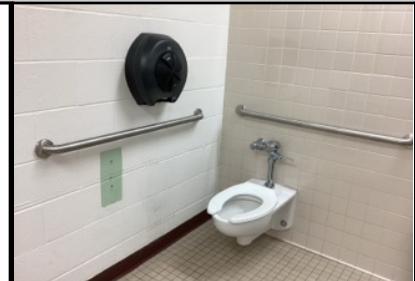
| ID | Location | Floor | Room | Element | Type | Photo | Issues | Current Measure | Recommendations | Quantity | Price | Cost Estimation |
|---|---|---|---|---|---|--|---|---|--|---|---|---|
| 94 | All-Gender Single-User Toilet Room by Door 20 | 1 | | Single-User Toilet | N/A | | Toilet seat < 17" or > 19" high<br>Toilet paper dispenser is not compliant | 15" - | Install a toilet with a seat between 17"- 19" high above the finished floor.<br>Relocate toilet paper so that it is 24" min. high, located under the grab bar, and between 7" and 9" from the front of the toilet./Replace dispenser as it does not allow continuous paper flow. | 1 | 2816 500 | \$3316 |

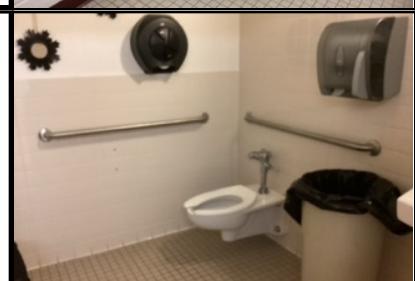
| ID | Location | Floor | Room | Element | Type | Photo | Issues | Current Measure | Recommendations | Quantity | Price | Cost Estimation |
|---|---|---|---|---|---|--|---|---|--|---|---|---|
| 95 | All-Gender Single-User Toilet Room | 2 | 242 | Single-User Toilet | N/A | | Toilet seat < 17" or > 19" high<br>Clearance at toilet < 60" clear width<br>Toilet paper dispenser is not compliant | 15" - - | Install a toilet with a seat between 17"- 19" high above the finished floor.<br>Ensure that there is 60" wide min. clear floor space at the toilet. (relocate trash container.)<br>Relocate toilet paper so that it is 24" min. high, located under the grab bar, and between 7" and 9" from the front of the toilet./Replace dispenser as it does not allow continuous paper flow.<br>Ensure dispenser is not above the grab bar. | 1 | 2816 500 | \$3316 |

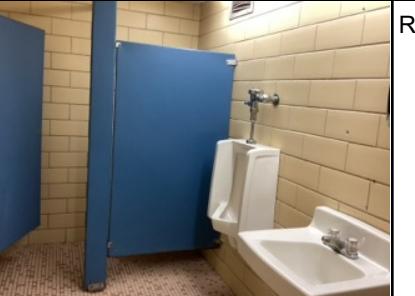
| ID | Location | Floor | Room | Element | Type | Photo | Issues | Current Measure | Recommendations | Quantity | Price | Cost Estimation |
|---|---|---|---|---|---|--|---|---|--|---|---|---|
| 96 | Boys' Locker Room Multi-User Toilet Room | 1 | | Urinal | N/A | | Rim > 17" high | 26" | Provide at least one urinal with the rim no higher than 17" above the finished floor. | 1 | 4222 | \$4222 |

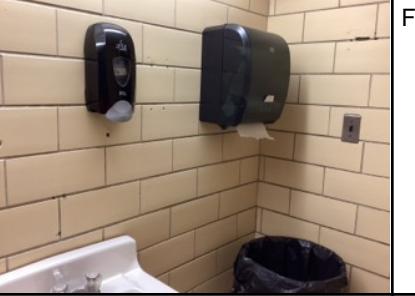
| ID | Location | Floor | Room | Element | Type | Photo | Issues | Current Measure | Recommendations | Quantity | Price | Cost Estimation |
|---|---|---|---|---|---|--|---|---|--|---|---|---|
| 97 | Boys' Locker Room Multi-User Toilet Room | 1 | | Dispensers | Paper Towel Dispenser | | Forward reach if obstruction > 20"- 25" deep is > 44" high | 54" | Relocate the ... dispenser so that the controls are between 15" - 48" above the finished floor. (Relocate trash container.) | 1 | Labor | Labor |

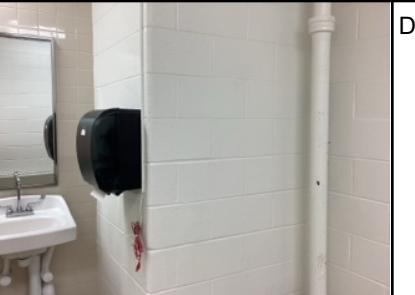
| ID | Location | Floor | Room | Element | Type | Photo | Issues | Current Measure | Recommendations | Quantity | Price | Cost Estimation |
|---|---|---|---|---|---|--|---|---|--|---|---|---|
| 98 | All-Gender Single-User Toilet Room by Door 20 | 1 | | Dispensers | Paper Towel Dispenser | | Dispenser acts as a protruding object | 9.5" | Relocate dispenser out of the circulation path. | 1 | 500 | \$500 |

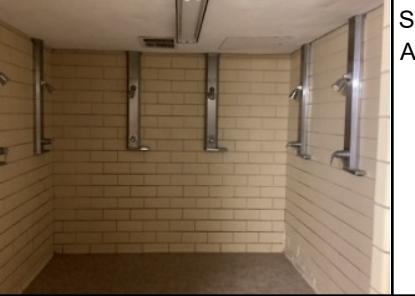
| ID | Location | Floor | Room | Element | Type | Photo | Issues | Current Measure | Recommendations | Quantity | Price | Cost Estimation |
|---|---|---|---|---|---|--|---|---|--|---|---|---|
| 99 | Boys' Locker Room | 1 | | Shower Compartment | Other | | Shower not on an accessible route<br>Accessible shower not provided | 3"<br>- | Provide an accessible route to an accessible shower (this gang shower is recessed).<br>Provide at least one accessible shower. | 1 | 3606 | \$3606 |

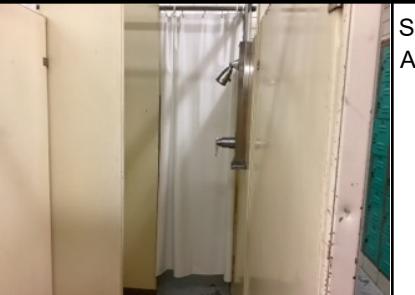
| ID | Location | Floor | Room | Element | Type | Photo | Issues | Current Measure | Recommendations | Quantity | Price | Cost Estimation |
|---|---|---|---|---|---|--|---|---|--|---|---|---|
| 100 | Girls' Locker Room | 1 | | Shower Compartment | No compliant | | Shower not on an accessible route<br>Accessible shower not provided | -<br>- | Locate the accessible shower on an accessible route.<br>Provide at least one accessible shower. | 1 | 7894 | \$7894 |

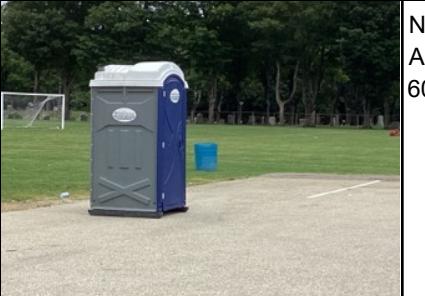
| ID | Location | Floor | Room | Element | Type | Photo | Issues | Current Measure | Recommendations | Quantity | Price | Cost Estimation |
|---|---|---|---|---|---|--|---|---|--|---|---|---|
| 101 | By Field D | Ext. | | Portable Toilet | N/A | | Not located on an accessible route<br>Accessible portable toilets not provided<br>60" by 72" clear space not provided | 4"<br>-<br>- | Locate portable toilet on an accessible route with a door threshold no greater than 1/4".<br>Ensure that at least 5% and at least one of the portable toilets in each distinct areas where they are provided is accessible.<br>Provide an accessible portable toilet that has 60" wide and 72" deep at the toilet per 521 CMR, the regulations of the Massachusetts Architectural Access Board (MAAB). | 1 | Labor | Labor |

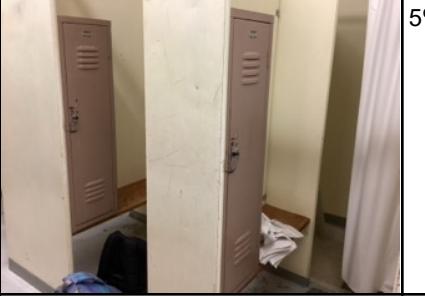
| ID | Location | Floor | Room | Element | Type | Photo | Issues | Current Measure | Recommendations | Quantity | Price | Cost Estimation |
|---|---|---|---|---|---|--|---|---|--|---|---|---|
| 102 | Girls' Locker Room | 1 | | Changing Rooms | Girls' | | 5% of changing rooms are not accessible | - | Provide an accessible changing room. | 1 | 7626 | \$7626 |

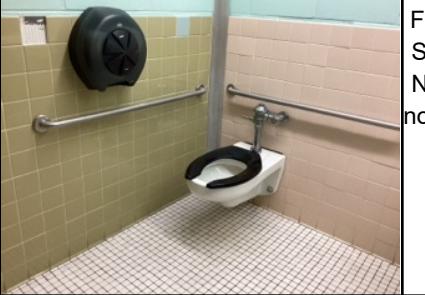
| ID | Location | Floor | Room | Element | Type | Photo | Issues | Current Measure | Recommendations | Quantity | Price | Cost Estimation |
|---|---|---|---|---|---|--|---|---|--|---|---|---|
| 103 | All-Gender Single-User Toilet Room | 1 | 132 | Single-User Toilet (Children) | All Gender | | Flush control not on open side<br>Side or rear grab bar < 25" or > 27" high (4 - 6)<br>Noncompliant toilet paper dispenser. (Ensure toilet paper dispenser not located above the grab bar.) | -<br>31" | Move the flush control to the open side. Mount flush control between 20" - 30" above the floor.<br>Locate grab bar between 25"- 27" above the floor.<br>Relocate toilet paper dispenser so that it is between 14"- 19" above the floor and between 7"- 9" in front of the toilet. Ensure dispensers and other devices are not mounted above grab bars./Replace dispenser as it does not allow | 1 | 1000<br>500<br>500<br><br><b>2000</b> | \$2000 |

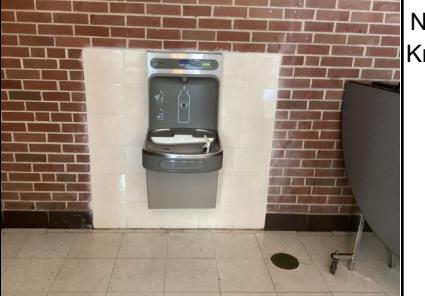
| ID | Location | Floor | Room | Element | Type | Photo | Issues | Current Measure | Recommendations | Quantity | Price | Cost Estimation |
|---|---|---|---|---|---|--|---|---|--|---|---|---|
| 104 | Cafeteria | 1 | | Drinking Fountains | Low | | No drinking fountain provided for standing users<br>Knee or toe clearance not provided | 24" | Provide an additional drinking fountain for standing users or install a Hi-Lo drinking fountain.<br>Provide knee and toe clearance, 27" min. high at drinking fountain for seated users. | 1 | 5236<br><br><b>5236</b> | \$5236 |

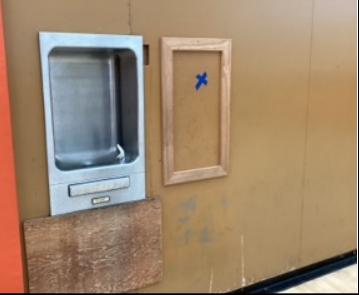
| ID | Location | Floor | Room | Element | Type | Photo | Issues | Current Measure | Recommendations | Quantity | Price | Cost Estimation |
|---|---|---|---|---|---|--|--|---|---|---|---|---|
| 105 | Gym | 1 | | Drinking Fountains | High | | No drinking fountain provided for seated users | - | Provide an additional drinking fountain for seated users or install a Hi-Lo drinking fountain. | 1 | 5481 | \$5481 |

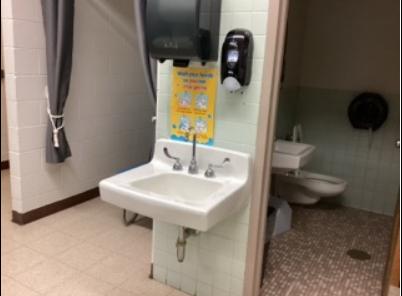
| ID | Location | Floor | Room | Element | Type | Photo | Issues | Current Measure | Recommendations | Quantity | Price | Cost Estimation |
|---|---|---|---|---|---|--|--|---|---|---|---|---|
| 106 | Nurse's Office | 1 | | Sink | N/A | | Exposed plumbing underneath sink<br>Dispenser not within reach range | - 56" | Insulate or otherwise configure pipes at sink.<br>Relocate dispenser 48" max. above the finished floor or ground. | 1 | 150 500 | \$650 |

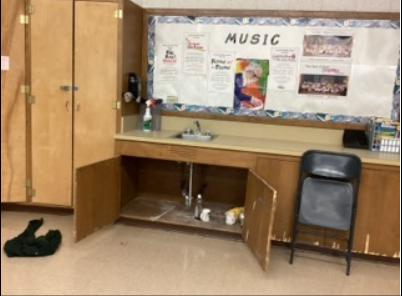
| ID | Location | Floor | Room | Element | Type | Photo | Issues | Current Measure | Recommendations | Quantity | Price | Cost Estimation |
|---|---|---|---|---|---|--|--|---|---|---|---|---|
| 107 | Chorus, Music and Band Room | 1 | 122 | Sink | N/A | | Toe and knee clearances not provided<br>Rim or counter > 34"<br>Exposed plumbing underneath sink | - 36"<br>- | Ensure there is a 27" min. knee clearance positioned for a forward approach.<br>Relocate sink with the front of the rim or counter no higher than 34" above the finished floor.<br>Insulate or otherwise configure pipes at sink. | 1 | 1500 150 | \$1650 |

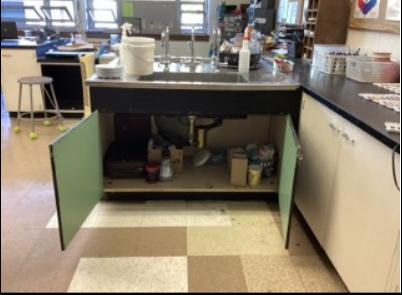
| ID | Location | Floor | Room | Element | Type | Photo | Issues | Current Measure | Recommendations | Quantity | Price | Cost Estimation |
|---|---|---|---|---|---|--|--|---|---|---|---|---|
| 108 | Art | 1 | 167 | Sink | N/A | | Toe and knee clearances not provided<br>Rim or counter > 34" | - 36" | Ensure there is a 27" min. knee clearance positioned for a forward approach.<br>Relocate sink with the front of the rim or counter no higher than 34" above the finished floor. | 1 | 1500 | \$1500 |

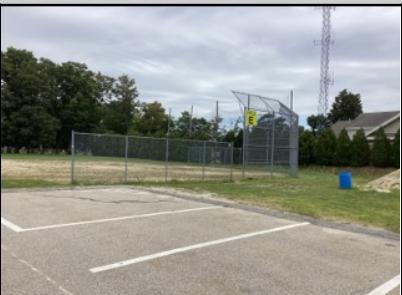
| ID | Location | Floor | Room | Element | Type | Photo | Issues | Current Measure | Recommendations | Quantity | Price | Cost Estimation |
|---|---|---|---|---|---|--|--|---|---|---|---|---|
| 109 | Softball Field E | Ext. | | Field | Softball | | Field not connected to an accessible route<br>No accessible route to all areas of sport activity | -<br>- | Provide a 48" wide min. stable, firm and slip resistant accessible route to the boundary of sport activity at the softball field.<br>Install an accessible route between all areas of sport activity. | 1 | Labor | Labor |

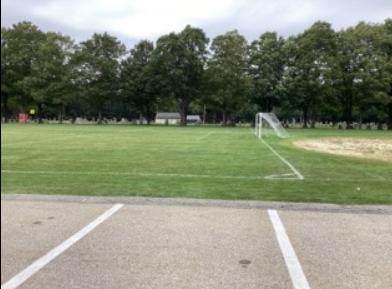
| ID | Location | Floor | Room | Element | Type | Photo | Issues | Current Measure | Recommendations | Quantity | Price | Cost Estimation |
|---|---|---|---|---|---|--|--|---|---|---|---|---|
| 110 | Soccer Field D | Ext. | | Field | Soccer | | Field not connected to an accessible route<br>No accessible route to all areas of sport activity | + | Provide a 48" wide min. stable, firm and slip resistant accessible route to the boundary of sport activity at the soccer field.<br>Install an accessible route between all areas of sport activity. | 1 | Labor | Labor |

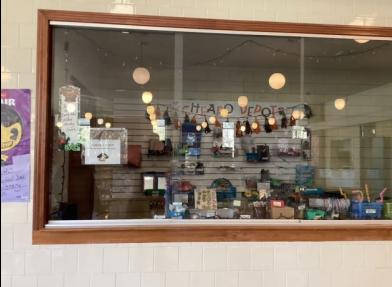
| 111 | Cafeteria Store | 1 | | Service Window | N/A | | | | Recommend, if the service window at the cafeteria store is renovated, ensuring that the base of the service window is between 36" and 43" above the finished floor. If a service counter is installed following a renovation, it should be no higher than 36" above the finished floor. | 1 | - | - |
