Town of Oxford

# ADA Self-Evaluation and Transition Plan

July 2024

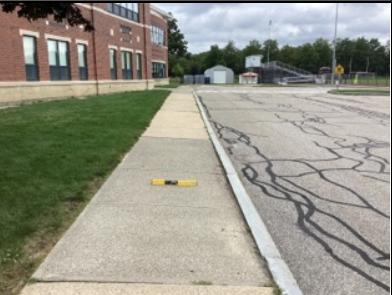
| ID | Location | Floor | Room | Element | Type | Photo | Issues | Current Measure | Recommendations | Quantity | Price | Cost Estimation |
|---|---|---|---|---|---|--|---|---|---|---|---|---|
| 1 | By Main Entrance | Ext. | | Exterior Access Route | Sidewalk | | Cross slope > 1:50 (2.00%) | 6.2% | Reduce cross slope to be no steeper than 1:50 (2.00%). | 1 | - | - |

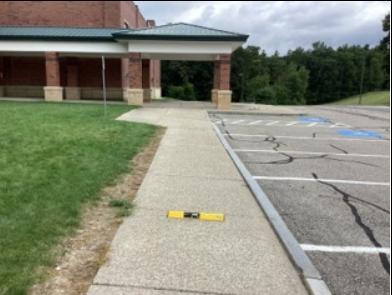
| ID | Location | Floor | Room | Element | Type | Photo | Issues | Current Measure | Recommendations | Quantity | Price | Cost Estimation |
|---|---|---|---|---|---|--|---|---|---|---|---|---|
| 2 | By Concession Stand | Ext. | | Exterior Access Route | Sidewalk | | Cross slope > 1:50 (2.00%) | 6.2% | Reduce cross slope to be no steeper than 1:50 (2.00%). | 1 | - | - |

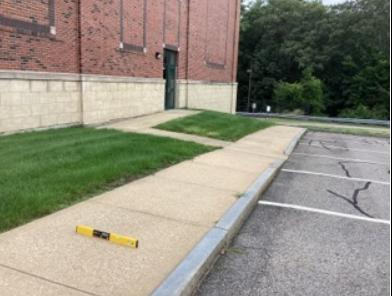
| ID | Location | Floor | Room | Element | Type | Photo | Issues | Current Measure | Recommendations | Quantity | Price | Cost Estimation |
|---|---|---|---|---|---|--|---|---|---|---|---|---|
| 3 | By Door 12 | Ext. | | Exterior Access Route | Sidewalk | | Cross slope > 1:50 (2.00%) | 4.8% | Reduce cross slope to be no steeper than 1:50 (2.00%). | 1 | - | - |

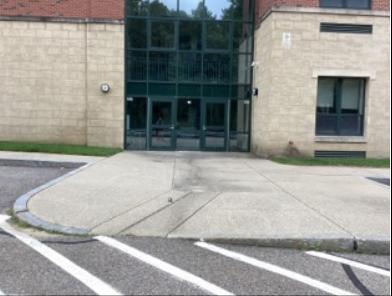
| ID | Location | Floor | Room | Element | Type | Photo | Issues | Current Measure | Recommendations | Quantity | Price | Cost Estimation |
|---|---|---|---|---|---|--|---|---|---|---|---|---|
| 4 | Door 11 | Ext. | | Exterior Access Route | | | Surface openings > 1/2" | 1.5" | Replace or reposition so that openings are 1/2" max. and the long opening dimension is perpendicular to the dominant direction of travel. | 1 | - | - |

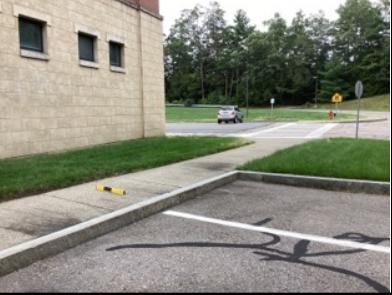
| ID | Location | Floor | Room | Element | Type | Photo | Issues | Current Measure | Recommendations | Quantity | Price | Cost Estimation |
|---|---|---|---|---|---|--|---|---|---|---|---|---|
| 5 | Near Door 11 | Ext. | | Exterior Access Route | Sidewalk | | Cross slope > 1:50 (2.00%) | 4.5" | Reduce cross slope to be no steeper than 1:50 (2.00%). | 1 | - | - |

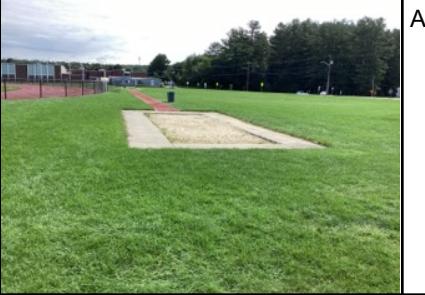
| ID | Location | Floor | Room | Element | Type | Photo | Issues | Current Measure | Recommendations | Quantity | Price | Cost Estimation |
|---|---|---|---|---|---|--|--|---|---|---|---|---|
| 6 | Long Jump | Ext. | | Exterior Access Route | | | Accessible route not provided | - | Ensure an accessible route is provided to the long jump area. | 1 | - | - |

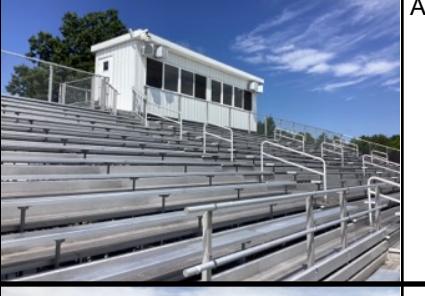
| ID | Location | Floor | Room | Element | Type | Photo | Issues | Current Measure | Recommendations | Quantity | Price | Cost Estimation |
|---|---|---|---|---|---|--|--|---|---|---|---|---|
| 7 | Football Bleachers Press Box | Ext. | | Exterior Access Route | | | Accessible route not provided | - | Ensure an accessible route is provided to the press box.<br>Note: The press box was locked on the day of the survey, so the inside of the press box was not surveyed. | 1 | - | - |

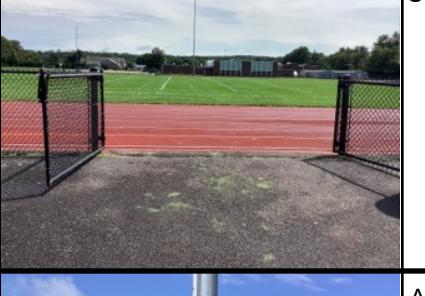
| ID | Location | Floor | Room | Element | Type | Photo | Issues | Current Measure | Recommendations | Quantity | Price | Cost Estimation |
|---|---|---|---|---|---|--|--|---|---|---|---|---|
| 8 | Football and Track | Ext. | | Exterior Access Route | | | Surface openings > 1/2" | 2" | Replace or reposition so that openings are 1/2" max. and the long opening dimension is perpendicular to the dominant direction of travel. | 1 | - | - |

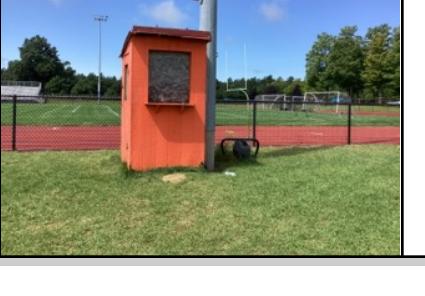
| ID | Location | Floor | Room | Element | Type | Photo | Issues | Current Measure | Recommendations | Quantity | Price | Cost Estimation |
|---|---|---|---|---|---|--|--|---|---|---|---|---|
| 9 | Ticket Booth | Ext. | | Exterior Access Route | | | Accessible route not provided | - | Ensure an accessible route is provided. | 3 | - | - |

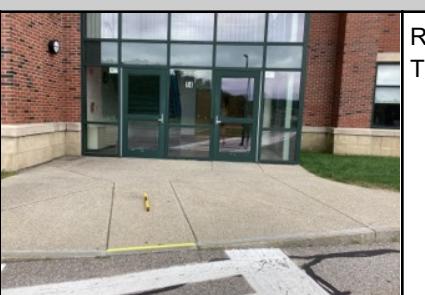
| ID | Location | Floor | Room | Element | Type | Photo | Issues | Current Measure | Recommendations | Quantity | Price | Cost Estimation |
|---|---|---|---|---|---|--|--|---|---|---|---|---|
| 10 | Door 14 | Ext. | | Curb Ramp | N/A | | Running slope is > 1:12 (8.33%)<br>Transition from curb ramp to street not flush | 11%<br>- | Reduce running slope to be no steeper than 1:12 (8.33%).<br>Ensure transition from curb ramp to street is flush or free of changes in level. | 1 | - | - |

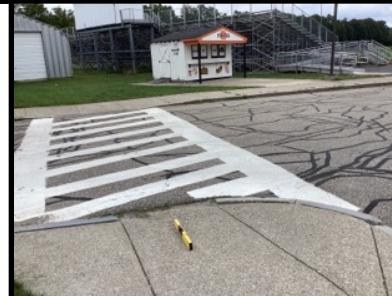
| ID | Location | Floor | Room | Element | Type | Photo | Issues | Current Measure | Recommendations | Quantity | Price | Cost Estimation |
|---|---|---|---|---|---|--|--|---|--|---|---|---|
| 11 | By Concession Stand | Ext. | | Curb Ramp | | | Running slope is > 1:12 (8.33%)<br>Transition from curb ramp to street not flush | 9.8%<br>- | Reduce running slope to be no steeper than 1:12 (8.33%).<br><br>Ensure transition from curb ramp to street is flush or free of changes in level. | 1 | - | - |

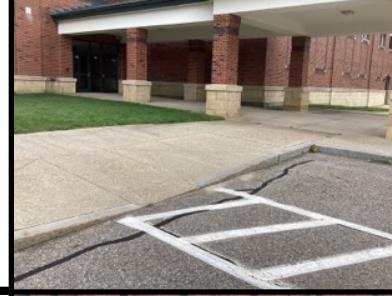
| ID | Location | Floor | Room | Element | Type | Photo | Issues | Current Measure | Recommendations | Quantity | Price | Cost Estimation |
|---|---|---|---|---|---|--|--|---|--|---|---|---|
| 12 | By Door 13 | Ext. | | Curb Ramp | N/A | | Transition from curb ramp to street not flush | - | Ensure transition from curb ramp to street is flush or free of changes in level. | 1 | - | - |

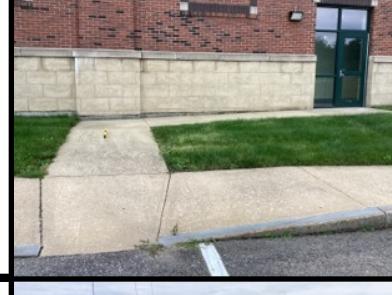
| ID | Location | Floor | Room | Element | Type | Photo | Issues | Current Measure | Recommendations | Quantity | Price | Cost Estimation |
|---|---|---|---|---|---|--|--|---|--|---|---|---|
| 13 | By Door 12 | Ext. | | Curb Ramp | | | Landing not provided at top of curb ramp | 5.2% | Provide landing at top of curb ramp with a slope no greater than 1:50 (2.00%) in all directions or reconfigure ramp. | 1 | - | - |

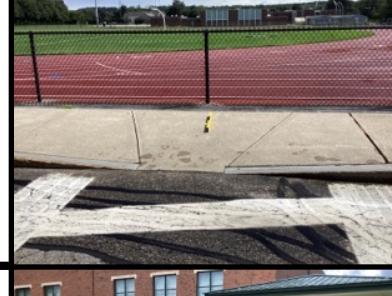
| ID | Location | Floor | Room | Element | Type | Photo | Issues | Current Measure | Recommendations | Quantity | Price | Cost Estimation |
|---|---|---|---|---|---|--|--|---|--|---|---|---|
| 14 | By Track | Ext. | | Curb Ramp | N/A | | Running slope is > 1:12 (8.33%) | 10.2% | Reduce running slope to be no steeper than 1:12 (8.33%). | 1 | - | - |

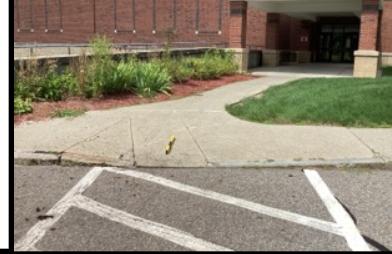
| ID | Location | Floor | Room | Element | Type | Photo | Issues | Current Measure | Recommendations | Quantity | Price | Cost Estimation |
|---|---|---|---|---|---|--|--|---|--|---|---|---|
| 15 | Door 3 | | | Curb Ramp | N/A | | Running slope is > 1:12 (8.33%) | 11.5" | Reduce running slope to be no steeper than 1:12 (8.33%). | 1 | - | - |

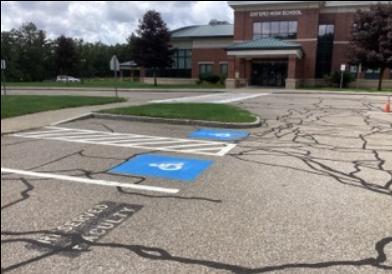
| ID | Location | Floor | Room | Element | Type | Photo | Issues | Current Measure | Recommendations | Quantity | Price | Cost Estimation |
|---|---|---|---|---|---|--|---|---|--|---|---|---|
| 16 | Parking | | | Off-Street Parking Lot or Garage | N/A | | Total # of designated car accessible parking spaces<br>Access aisle < 60" wide at car/van space<br>Sign with the International Symbol of Acc. not provided | 2<br>54"<br>- | Re-stripe to ensure access aisle is at least 60" wide.<br>Provide a sign with the International Symbol of Accessibility (ISA) with the bottom of the sign 60" min. above the ground and the top 96" max. above the ground at both car accessible parking spaces. | 2 | 150<br>500<br><br><b>1300</b> | \$1300 |

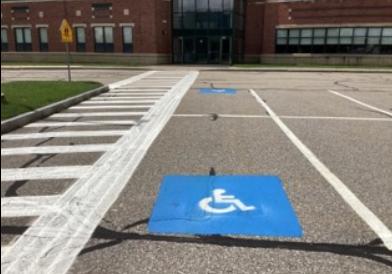
| ID | Location | Floor | Room | Element | Type | Photo | Issues | Current Measure | Recommendations | Quantity | Price | Cost Estimation |
|---|---|---|---|---|---|--|---|---|--|---|---|---|
| 17 | Parking | | | Off-Street Parking Lot or Garage | N/A | | Total # of designated car accessible parking spaces<br>Sign with the International Symbol of Acc. not provided | 1<br>- | Provide a sign at both car accessible parking spaces with the International Symbol of Accessibility (ISA) with the bottom of the sign 60" min. above the ground and the top 96" max. above the ground. | 2 | 500<br><br><b>1000</b> | \$1000 |

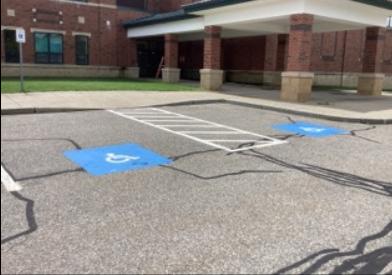
| ID | Location | Floor | Room | Element | Type | Photo | Issues | Current Measure | Recommendations | Quantity | Price | Cost Estimation |
|---|---|---|---|---|---|--|---|---|--|---|---|---|
| 18 | Parking | | | Off-Street Parking Lot or Garage | N/A | | Total # of designated van accessible spaces<br>Sign with the International Symbol of Acc. not provided<br>Sign does not have the designation "Van Accessible" | 2<br>-<br>- | Provide a sign with the International Symbol of Accessibility (ISA) at the space lacking an accessible parking identification sign. Mount the sign with the bottom of the sign 60" min. above the ground and the top 96" max. above the ground.<br>Add the designation "Van Accessible" to the signs located at both of the van accessible parking spaces. | 1 | 500<br><br><b>500</b> | \$500 |

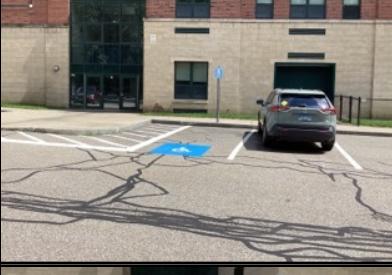
| ID | Location | Floor | Room | Element | Type | Photo | Issues | Current Measure | Recommendations | Quantity | Price | Cost Estimation |
|---|---|---|---|---|---|--|---|---|--|---|---|---|
| 19 | Parking | | | Off-Street Parking Lot or Garage | N/A | | Total # of designated car accessible parking spaces | 1 | This car accessible parking space is compliant. | 1 | - | - |

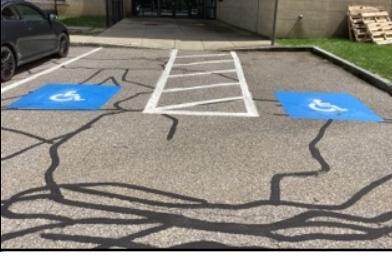
| ID | Location | Floor | Room | Element | Type | Photo | Issues | Current Measure | Recommendations | Quantity | Price | Cost Estimation |
|---|---|---|---|---|---|--|---|---|--|---|---|---|
| 20 | Parking by Door 12 | | | Off-Street Parking Lot or Garage | N/A | | Total # of designated car accessible parking spaces<br>Sign with the International Symbol of Acc. not provided | 2<br>- | Provide a sign with the International Symbol of Accessibility (ISA) at the one car accessible parking space lacking an accessible parking identification sign. Mount the sign with the bottom of the sign 60" min. above the ground and the top 96" max. above the ground. | 1 | 500<br><br><b>500</b> | \$500 |

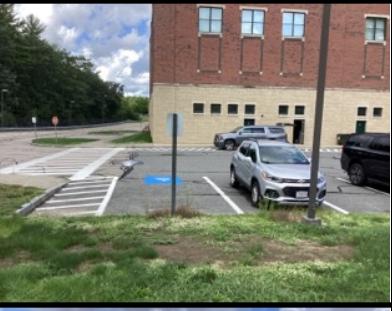
| ID | Location | Floor | Room | Element | Type | Photo | Issues | Current Measure | Recommendations | Quantity | Price | Cost Estimation |
|---|---|---|---|---|---|--|---|---|--|---|---|---|
| 21 | Parking | | | Off-Street Parking Lot or Garage | N/A | | Total # of designated van accessible spaces<br>Sign does not have the designation "Van Accessible" | 1 - | Add the designation "Van Accessible" to the sign located at the van accessible space. | 1 | 500 | \$500 |

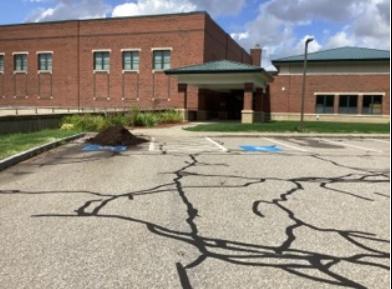
| ID | Location | Floor | Room | Element | Type | Photo | Issues | Current Measure | Recommendations | Quantity | Price | Cost Estimation |
|---|---|---|---|---|---|--|---|---|--|---|---|---|
| 22 | Parking by Door 3 | | | Off-Street Parking Lot or Garage | N/A | | Total # of designated van accessible spaces<br>Sign with the International Symbol of Acc. not provided<br>Sign does not have the designation "Van Accessible" | 2 - | Provide a sign with the International Symbol of Accessibility (ISA) with the bottom of the sign 60" min. above the ground and the top 96" max. above the ground.<br>Add the designation "Van Accessible" to the sign located at the van accessible space.<br>Remove soil from accessible parking space. | 2 | 500 | \$1000 |

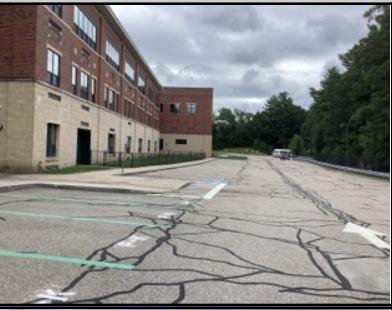
| ID | Location | Floor | Room | Element | Type | Photo | Issues | Current Measure | Recommendations | Quantity | Price | Cost Estimation |
|---|---|---|---|---|---|--|---|---|--|---|---|---|
| 23 | Student Drop-off by Door 11 | Ext. | | Passenger Loading Zones | N/A | | Vehicle pull-up space < 96" wide<br>Sign with ISA not provided (MAAB) | 66" - | Provide a vehicle pull-up space that is at least 96" wide.<br>Provide a sign that includes the International Symbol of Accessibility (ISA) at the head of the space. Locate the sign so that the bottom is 60" min. above the ground and the top is 96" max. above the ground. | 1 | 300<br>500 | \$800 |

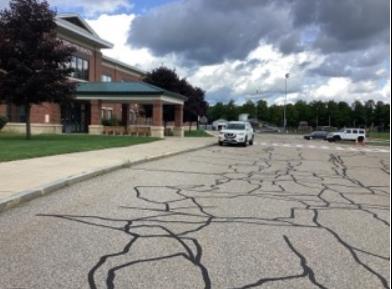
| ID | Location | Floor | Room | Element | Type | Photo | Issues | Current Measure | Recommendations | Quantity | Price | Cost Estimation |
|---|---|---|---|---|---|--|---|---|--|---|---|---|
| 24 | Front Entrance | | | Passenger Loading Zones | N/A | | Access aisle not provided<br>Sign with ISA not provided (MAAB) | - | Provide a marked access aisle that is at least 60" wide and that extends the full length of the vehicle.<br>Provide a sign that includes the International Symbol of Accessibility (ISA) at the head of the space. Locate the sign so that the bottom is 60" min. above the ground and the top is 96" max. above the ground. | 1 | 300<br>500 | \$800 |

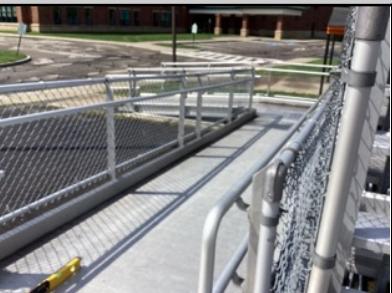
| ID | Location | Floor | Room | Element | Type | Photo | Issues | Current Measure | Recommendations | Quantity | Price | Cost Estimation |
|---|---|---|---|---|---|--|---|---|--|---|---|---|
| 25 | Football Bleachers | Ext. | | Exterior Ramp | N/A | | Running slope > 1:12 (8.33%) | 9.0% | Reduce running slope to be no steeper than 1:12 (8.33%). | 1 | Labor | Labor |

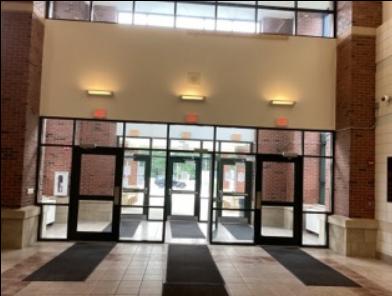
| ID | Location | Floor | Room | Element | Type | Photo | Issues | Current Measure | Recommendations | Quantity | Price | Cost Estimation |
|---|---|---|---|---|---|--|--|---|---|---|---|---|
| 26 | Main Entrance | 1 | | Means of Egress | N/A | | Tactile exit sign not provided<br>Illuminated ISA symbol not provided (MAAB) | -<br>- | Ensure that a tactile exit sign with raised characters and braille is provided at the exit door. Mount the sign between 48"- 60" above the finished floor located on the latch side of the door.<br>When the illuminated exit sign is repaired or replaced, provide an illuminated sign with the International Symbol of Accessibility (ISA). | 3 | 250<br>200 | \$1350<br><br><b>1350</b> |

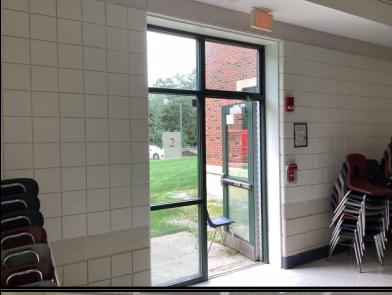
| ID | Location | Floor | Room | Element | Type | Photo | Issues | Current Measure | Recommendations | Quantity | Price | Cost Estimation |
|---|---|---|---|---|---|--|--|---|---|---|---|---|
| 27 | Cafeteria | 1 | | Means of Egress | N/A | | Tactile exit sign not provided<br>Directional sign to accessible emergency exit not provided | -<br>- | Ensure that a tactile exit sign with raised characters and braille is provided at the exit door. Mount the sign between 48"- 60" above the finished floor located on the latch side of the door.<br>Provide a directional sign indicating the location of the nearest accessible emergency exit. | 2 | 250 | \$500<br><br><b>500</b> |

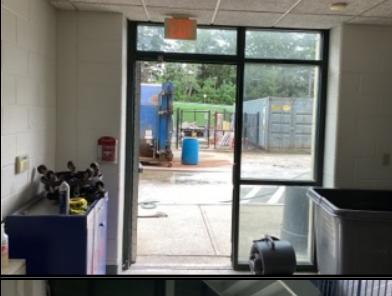
| ID | Location | Floor | Room | Element | Type | Photo | Issues | Current Measure | Recommendations | Quantity | Price | Cost Estimation |
|---|---|---|---|---|---|--|--|---|---|---|---|---|
| 28 | By Weight Room | G | G | Means of Egress | N/A | | Tactile exit sign not provided<br>Directional sign to accessible emergency exit not provided | -<br>- | Ensure that a tactile exit sign with raised characters and braille is provided at the exit door. Mount the sign between 48"- 60" above the finished floor located on the latch side of the door.<br>If exterior area is fenced in, provide a directional sign indicating the location of the nearest accessible emergency exit. | 2 | 250 | \$500<br><br><b>500</b> |

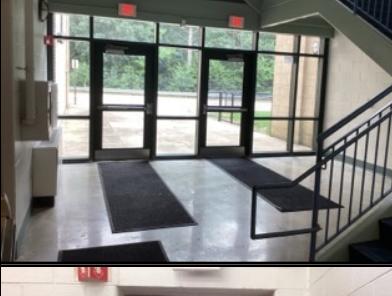
| ID | Location | Floor | Room | Element | Type | Photo | Issues | Current Measure | Recommendations | Quantity | Price | Cost Estimation |
|---|---|---|---|---|---|--|--|---|---|---|---|---|
| 29 | By Locker Room | G | | Means of Egress | N/A | | Tactile exit sign not provided<br>Illuminated ISA symbol not provided (MAAB) | -<br>- | Ensure that a tactile exit sign with raised characters and braille is provided at the exit door. Mount the sign between 48"- 60" above the finished floor located on the latch side of the door.<br>When the illuminated exit sign is repaired or replaced, provide an illuminated sign with the International Symbol of Accessibility (ISA). | 1 | 250<br>200 | \$450<br><br><b>450</b> |

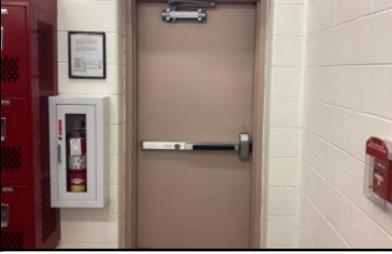
| ID | Location | Floor | Room | Element | Type | Photo | Issues | Current Measure | Recommendations | Quantity | Price | Cost Estimation |
|---|---|---|---|---|---|--|--|---|---|---|---|---|
| 30 | Girls' Locker Room | G | | Means of Egress | N/A | | Tactile exit sign not provided | - | Ensure that a tactile exit sign with raised characters and braille is provided at the exit door. Mount the sign between 48"- 60" above the finished floor located on the latch side of the door. | 1 | 250 | \$250<br><br><b>250</b> |

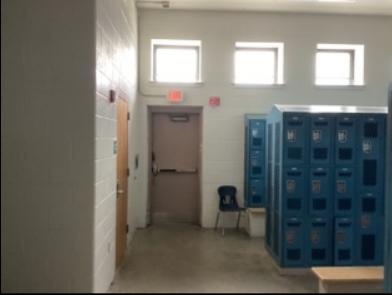
| ID | Location | Floor | Room | Element | Type | Photo | Issues | Current Measure | Recommendations | Quantity | Price | Cost Estimation |
|---|--|---|---|---|---|--|--|---|---|---|---|---|
| 31 | Boys' Locker Room | G | | Means of Egress | N/A | | Tactile exit sign not provided | | Ensure that a tactile exit sign with raised characters and braille is provided at the exit door. Mount the sign between 48"- 60" above the finished floor located on the latch side of the door. | 1 | 250 | \$250 |

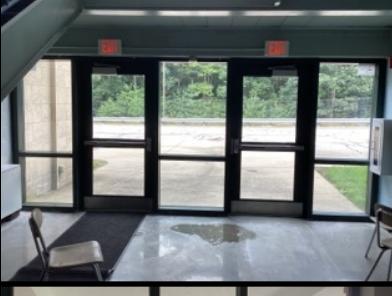
| ID | Location | Floor | Room | Element | Type | Photo | Issues | Current Measure | Recommendations | Quantity | Price | Cost Estimation |
|---|--|---|---|---|---|--|--|---|---|---|---|---|
| 32 | By Nursing Program | G | C5 | Means of Egress | N/A | | Tactile exit sign not provided<br>Illuminated ISA symbol not provided (MAAB) | -<br>- | Ensure that a tactile exit sign with raised characters and braille is provided at the exit door. Mount the sign between 48"- 60" above the finished floor located on the latch side of the door.<br>When the illuminated exit sign is repaired or replaced, provide an illuminated sign with the International Symbol of Accessibility (ISA). | 1 | 250<br>200 | \$450 |

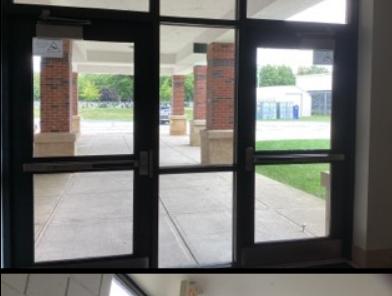
| ID | Location | Floor | Room | Element | Type | Photo | Issues | Current Measure | Recommendations | Quantity | Price | Cost Estimation |
|---|--|---|---|---|---|--|--|---|---|---|---|---|
| 33 | Door 13 by Auditorium | 1 | | Means of Egress | N/A | | Tactile exit sign not provided<br>Directional sign to accessible emergency exit not provided | -<br>- | Ensure that a tactile exit sign with raised characters and braille is provided at the exit door. Mount the sign between 48"- 60" above the finished floor located on the latch side of the door.<br>Provide a directional sign indicating the location of the nearest accessible emergency exit. | 2 | 250 | \$500 |

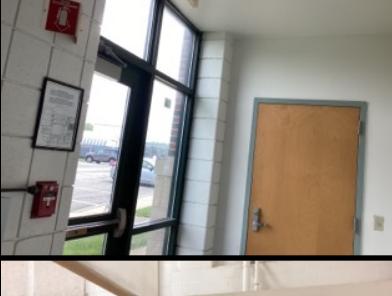
| ID | Location | Floor | Room | Element | Type | Photo | Issues | Current Measure | Recommendations | Quantity | Price | Cost Estimation |
|---|--|---|---|---|---|--|--|---|---|---|---|---|
| 34 | Auditorium Door 12 | 1 | | Means of Egress | N/A | | Tactile exit sign not provided<br>Illuminated ISA symbol not provided (MAAB) | -<br>- | Ensure that a tactile exit sign with raised characters and braille is provided at the exit door. Mount the sign between 48"- 60" above the finished floor located on the latch side of the door.<br>When the illuminated exit sign is repaired or replaced, provide an illuminated sign with the International Symbol of Accessibility (ISA). | 1 | 250<br>200 | \$450 |

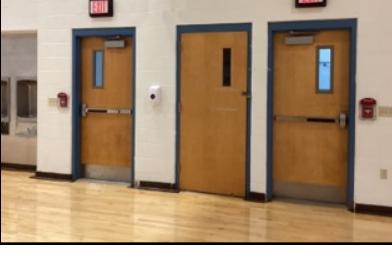
| ID | Location | Floor | Room | Element | Type | Photo | Issues | Current Measure | Recommendations | Quantity | Price | Cost Estimation |
|---|--|---|---|---|---|--|--|---|---|---|---|---|
| 35 | Gymnasium Egress to Stairwell and Exterior of Building | 1 | | Means of Egress | | | Tactile exit sign not provided | - | Ensure that a tactile exit sign with raised characters and braille is provided at the exit door. Mount the sign between 48"- 60" above the finished floor located on the latch side of the door. | 2 | 250 | \$500 |

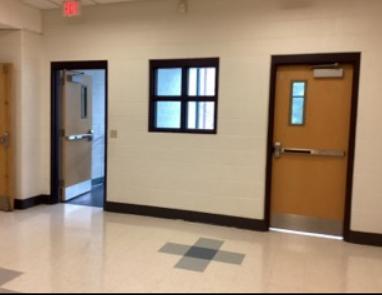
| ID | Location | Floor | Room | Element | Type | Photo | Issues | Current Measure | Recommendations | Quantity | Price | Cost Estimation |
|---|---|---|---|---|---|--|---|---|--|---|---|---|
| 36 | Stair C | 2 | | Means of Egress | N/A | | Tactile exit sign not provided | - | Ensure that a tactile exit sign with raised characters and braille is provided at the exit door. Mount the sign between 48"- 60" above the finished floor located on the latch side of the door. | 2 | 250 | \$500 |

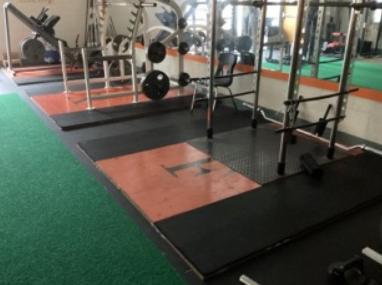
| ID | Location | Floor | Room | Element | Type | Photo | Issues | Current Measure | Recommendations | Quantity | Price | Cost Estimation |
|---|---|---|---|---|---|--|---|---|--|---|---|---|
| 37 | Weight Room | G | G | Interior Access Route | N/A | | Level changes > 1/4" | 1.5" | Alter change in level to be 1/4" high max. | 1 | Labor | Labor |

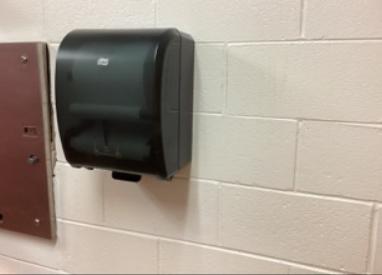
| ID | Location | Floor | Room | Element | Type | Photo | Issues | Current Measure | Recommendations | Quantity | Price | Cost Estimation |
|---|---|---|---|---|---|--|---|---|--|---|---|---|
| 38 | Women's Multi-User Toilet Room | G | | Interior Access Route | N/A | | Obstructed by protruding objects | 10" | Relocate paper towel dispenser out of the accessible route or provide a cane-detectable barrier 27" max. above the finished floor below the dispenser. | 1 | 398 | \$398 |

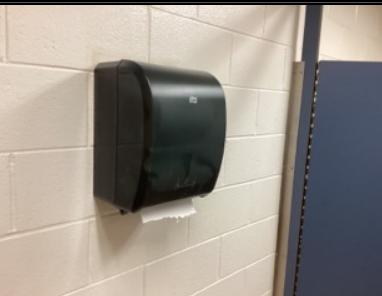
| ID | Location | Floor | Room | Element | Type | Photo | Issues | Current Measure | Recommendations | Quantity | Price | Cost Estimation |
|---|---|---|---|---|---|--|---|---|--|---|---|---|
| 39 | Men's Multi-User Toilet Room | G | | Interior Access Route | N/A | | Obstructed by protruding objects | 12" | Relocate paper towel dispenser out of the circulation path or provide a cane-detectable barrier 27" max. above the finished floor under the paper towel dispenser. | 1 | 398 | \$398 |

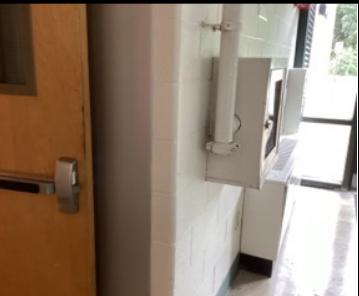
| ID | Location | Floor | Room | Element | Type | Photo | Issues | Current Measure | Recommendations | Quantity | Price | Cost Estimation |
|---|---|---|---|---|---|--|---|---|---|---|---|---|
| 41 | By Locker Room | G | | Interior Access Route | N/A | | Obstructed by protruding objects | 9" | Provide a cane-detectable barrier 27" max. above the finished floor below case. | 1 | 398 | \$398 |

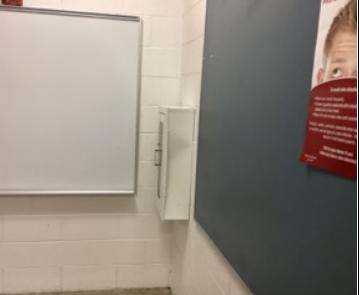
| ID | Location | Floor | Room | Element | Type | Photo | Issues | Current Measure | Recommendations | Quantity | Price | Cost Estimation |
|---|---|---|---|---|---|--|---|---|---|---|---|---|
| 42 | Boys' Locker Room | G | | Interior Access Route | N/A | | Obstructed by protruding objects | 28.5" | Provide a cane-detectable barrier 27" max. above the finished floor. | 1 | 398 | \$398 |

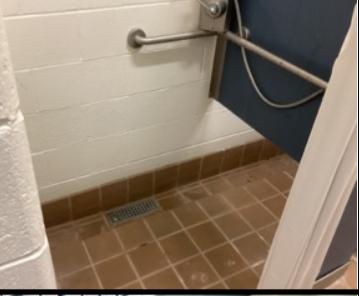
| ID | Location | Floor | Room | Element | Type | Photo | Issues | Current Measure | Recommendations | Quantity | Price | Cost Estimation |
|---|---|---|---|---|---|--|---|---|---|---|---|---|
| 43 | Boys' Locker Room Shower | G | D14 | Interior Access Route | Transfer Shower | | Surface openings > 1/2"<br>Level changes > 1/4" | 8"<br>3.5" | Replace or reposition so that openings are 1/2" max. and the long opening dimension is perpendicular to the dominant direction of travel.<br>Alter change in level to be 1/4" high max.<br><b>Note:</b> Cost to correct this issue with change in level at drain along wall is not known. | 1 | - | - |

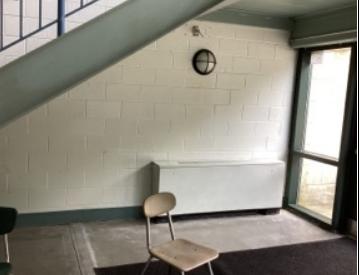
| ID | Location | Floor | Room | Element | Type | Photo | Issues | Current Measure | Recommendations | Quantity | Price | Cost Estimation |
|---|---|---|---|---|---|--|---|---|---|---|---|---|
| 44 | By Nursing Program | G | C5 | Interior Access Route | N/A | | Obstructed by protruding objects | - | Provide a cane-detectable barrier under stairs. | 1 | 1141 | \$1141 |

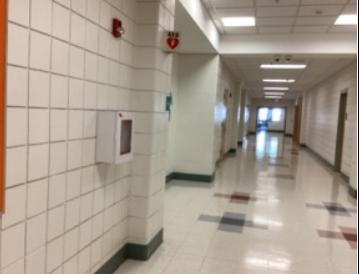
| ID | Location | Floor | Room | Element | Type | Photo | Issues | Current Measure | Recommendations | Quantity | Price | Cost Estimation |
|---|---|---|---|---|---|--|---|---|---|---|---|---|
| 45 | Hall | 1 | | Interior Access Route | N/A | | Obstructed by protruding objects | 7" | Relocate defibrillator out of the circulation path or provide a cane-detectable barrier 27" max. above the finished floor under the defibrillator. | 1 | 398 | \$398 |

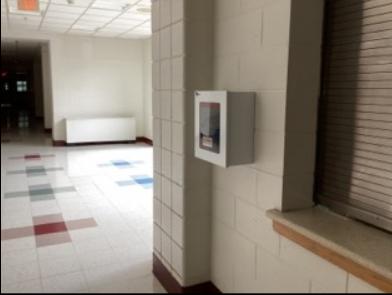
| ID | Location | Floor | Room | Element | Type | Photo | Issues | Current Measure | Recommendations | Quantity | Price | Cost Estimation |
|---|---|---|---|---|---|--|---|---|--|---|---|---|
| 46 | By D122 | 1 | | Interior Access Route | N/A | | Obstructed by protruding objects | 7" | Relocate defibrillator out of the circulation path or provide a cane-detectable barrier 27" max. above the finished floor under the defibrillator. | 1 | 398 | \$398 |

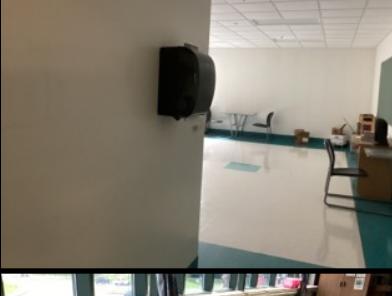
| ID | Location | Floor | Room | Element | Type | Photo | Issues | Current Measure | Recommendations | Quantity | Price | Cost Estimation |
|---|---|---|---|---|---|--|---|---|--|---|---|---|
| 48 | B211 | 2 | B221 | Interior Access Route | | | Obstructed by protruding objects | 9" | Relocate paper towel dispenser out of the circulation path or provide a cane-detectable barrier 27" max. above the finished floor below the paper towel dispenser. | 1 | 398 | \$398 |

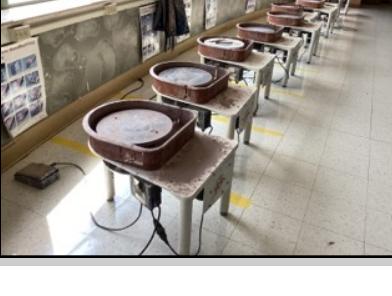
| ID | Location | Floor | Room | Element | Type | Photo | Issues | Current Measure | Recommendations | Quantity | Price | Cost Estimation |
|---|---|---|---|---|---|--|---|---|--|---|---|---|
| 49 | B208 Art | 2 | B208 | Interior Access Route | N/A | | Route < 36" wide | 26.5" | Ensure that a clear width of 36" min. is maintained at the accessible route. | 1 | Labor | Labor |

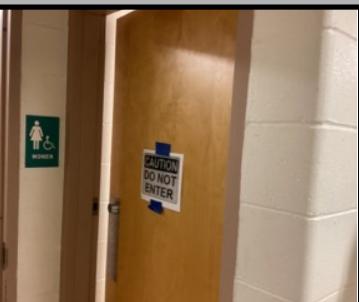
| ID | Location | Floor | Room | Element | Type | Photo | Issues | Current Measure | Recommendations | Quantity | Price | Cost Estimation |
|---|---|---|---|---|---|--|---|---|---|---|---|---|
| 51 | Women's Multi-User Toilet Room | G | | Doors, Doorways, & Gates | Toilet Room | | Door requires > 5 lbs. of force to open | 11 lbs. | Adjust closers so doors do not require more than 5 pounds of force to open. | 1 | Labor | Labor |

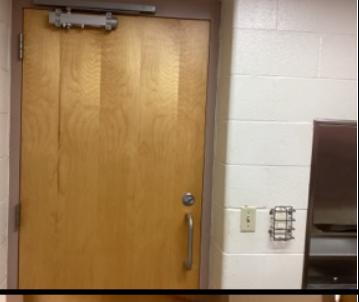
| ID | Location | Floor | Room | Element | Type | Photo | Issues | Current Measure | Recommendations | Quantity | Price | Cost Estimation |
|---|---|---|---|---|---|--|---|---|---|---|---|---|
| 52 | Women's Multi-User Toilet Room | G | | Doors, Doorways, & Gates | Toilet Room | | Maneuvering clearance not provided at recess > 6" | 2" | Install an automatic door opener. | 1 | 6000 | \$6000 |

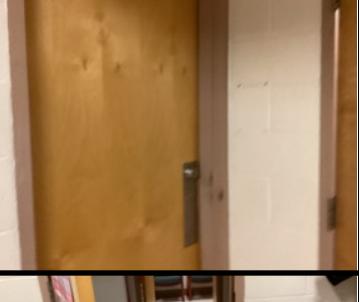
| ID | Location | Floor | Room | Element | Type | Photo | Issues | Current Measure | Recommendations | Quantity | Price | Cost Estimation |
|---|---|---|---|---|---|--|---|---|---|---|---|---|
| 53 | Men's Multi-User Toilet Room | G | | Doors, Doorways, & Gates | Toilet Room | | Door requires > 5 lbs. of force to open | 13 lbs. | Adjust closers so doors do not require more than 5 pounds of force to open. | 1 | Labor | Labor |

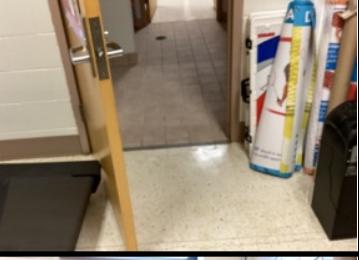
| ID | Location | Floor | Room | Element | Type | Photo | Issues | Current Measure | Recommendations | Quantity | Price | Cost Estimation |
|---|---|---|---|---|---|--|---|---|---|---|---|---|
| 54 | Girls' Locker Room<br>Women's Single-User Toilet Room | G | | Doors, Doorways, & Gates | Toilet Room | | Maneuvering clearance(s) not provided | - | Relocate running machine so door opens to 90 degrees and relocate stored items to provide 18" min. pull side maneuvering clearance at the door. | 1 | Labor | Labor |

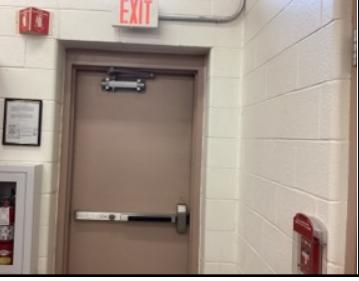
| ID | Location | Floor | Room | Element | Type | Photo | Issues | Current Measure | Recommendations | Quantity | Price | Cost Estimation |
|---|---|---|---|---|---|--|---|---|---|---|---|---|
| 55 | Girls' Locker Room | G | | Doors, Doorways, & Gates | Circulation | | Maneuvering clearance not provided at recess > 6" | 8" | Install an automatic door opener. | 1 | 6000 | \$6000 |

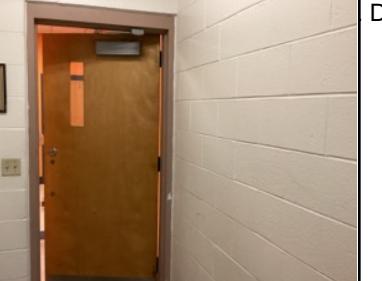
| ID | Location | Floor | Room | Element | Type | Photo | Issues | Current Measure | Recommendations | Quantity | Price | Cost Estimation |
|---|--|---|---|---|---|--|---|---|--|---|---|---|
| 56 | Boys' Locker Room | G | | Doors, Doorways, & Gates | Circulation | | Door requires > 5 lbs. of force to open | 12 lbs. | Adjust closers so doors do not require more than 5 pounds of force to open. | 1 | Labor | Labor |

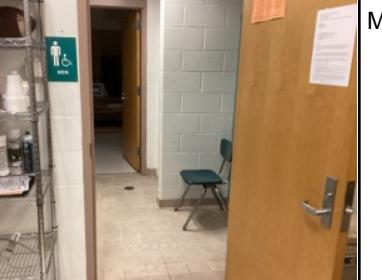
| ID | Location | Floor | Room | Element | Type | Photo | Issues | Current Measure | Recommendations | Quantity | Price | Cost Estimation |
|---|--|---|---|---|---|--|---|---|--|---|---|---|
| 57 | Boys' Locker Room | G | | Doors, Doorways, & Gates | Toilet Room | | Maneuvering clearance(s) not provided | 9" | Relocate shelving to provide 18" min. pull-side maneuvering clearance at the door. | 1 | Labor | Labor |

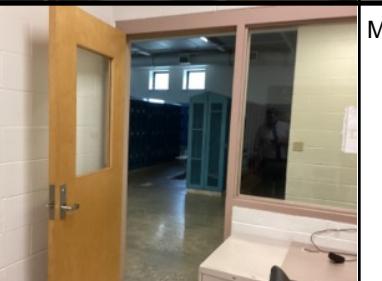
| ID | Location | Floor | Room | Element | Type | Photo | Issues | Current Measure | Recommendations | Quantity | Price | Cost Estimation |
|---|--|---|---|---|---|--|---|---|--|---|---|---|
| 58 | Boys' Locker Room<br>Coach's Room | G | | Doors, Doorways, & Gates | Office | | Maneuvering clearance(s) not provided | - | Relocate file cabinet to provide 18" min. pull-side maneuvering clearance at the door. | 1 | Labor | Labor |

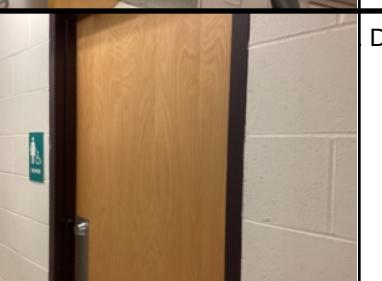
| ID | Location | Floor | Room | Element | Type | Photo | Issues | Current Measure | Recommendations | Quantity | Price | Cost Estimation |
|---|--|---|---|---|---|--|---|---|--|---|---|---|
| 59 | Women's Multi-User Toilet Room for Preschool | G | | Doors, Doorways, & Gates | Toilet Room | | Door requires > 5 lbs. of force to open | 10 Lbs | Adjust closers so doors do not require more than 5 pounds of force to open. | 1 | Labor | Labor |

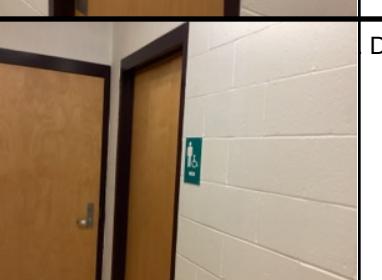
| ID | Location | Floor | Room | Element | Type | Photo | Issues | Current Measure | Recommendations | Quantity | Price | Cost Estimation |
|---|--|---|---|---|---|--|---|---|--|---|---|---|
| 60 | Men's Multi-User Toilet Room for Preschool | G | | Doors, Doorways, & Gates | Toilet Room | | Door requires > 5 lbs. of force to open | 10 lbs | Adjust closers so doors do not require more than 5 pounds of force to open. | 1 | Labor | Labor |

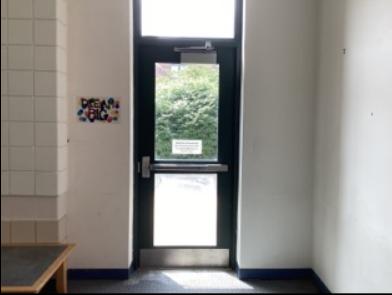
| ID | Location | Floor | Room | Element | Type | Photo | Issues | Current Measure | Recommendations | Quantity | Price | Cost Estimation |
|---|---|---|---|---|---|--|---|---|---|---|---|---|
| 61 | Media Center | 1 | B115 | Doors, Doorways, & Gates | Circulation | | Maneuvering clearance not provided at recess > 6" | 1.5" | Install an automatic door opener. | 1 | 6000 | \$6000 |

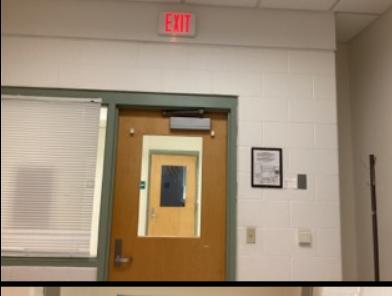
| ID | Location | Floor | Room | Element | Type | Photo | Issues | Current Measure | Recommendations | Quantity | Price | Cost Estimation |
|---|---|---|---|---|---|--|---|---|---|---|---|---|
| 62 | Nurse's Office | 1 | A129 | Doors, Doorways, & Gates | Circulation | | Door requires > 5 lbs. of force to open | 10 Lbs. | Adjust closers so doors do not require more than 5 pounds of force to open. | 1 | Labor | Labor |

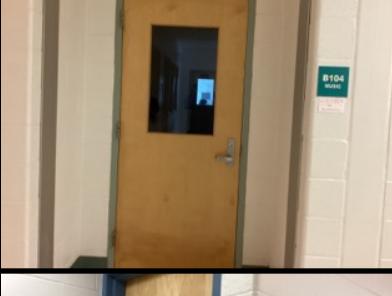
| ID | Location | Floor | Room | Element | Type | Photo | Issues | Current Measure | Recommendations | Quantity | Price | Cost Estimation |
|---|---|---|---|---|---|--|---|---|---|---|---|---|
| 63 | Music by B104 | 1 | | Doors, Doorways, & Gates | Classroom | | Maneuvering clearance not provided at recess > 6" | 10" | Install an automatic door opener. | 1 | 6000 | \$6000 |

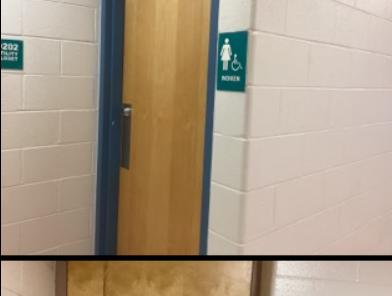
| ID | Location | Floor | Room | Element | Type | Photo | Issues | Current Measure | Recommendations | Quantity | Price | Cost Estimation |
|---|---|---|---|---|---|--|---|---|---|---|---|---|
| 64 | Women's Multi-User Toilet Room | 2 | | Doors, Doorways, & Gates | Toilet Room | | Door requires > 5 lbs. of force to open | 10 Lbs. | Adjust closers so doors do not require more than 5 pounds of force to open. | 1 | Labor | Labor |

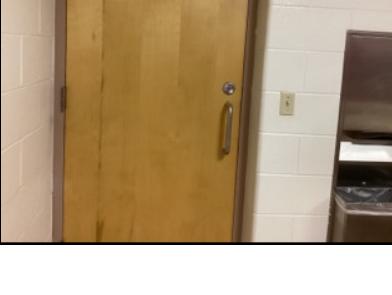
| ID | Location | Floor | Room | Element | Type | Photo | Issues | Current Measure | Recommendations | Quantity | Price | Cost Estimation |
|---|---|---|---|---|---|--|---|---|---|---|---|---|
| 65 | Women's Multi-User Toilet Room | 2 | | Doors, Doorways, & Gates | Toilet Room | | Maneuvering clearance not provided at recess > 6" | 2" | Install an automatic door opener. | 1 | 6000 | \$6000 |

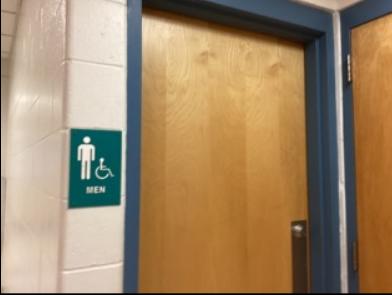
| ID | Location | Floor | Room | Element | Type | Photo | Issues | Current Measure | Recommendations | Quantity | Price | Cost Estimation |
|---|---|---|---|---|---|--|---|---|---|---|---|---|
| 66 | Men's Multi-User Toilet Room | 2 | | Doors, Doorways, & Gates | Toilet Room | | Door requires > 5 lbs. of force to open | 10 lbs. | Adjust closers so doors do not require more than 5 pounds of force to open. | 1 | Labor | Labor |

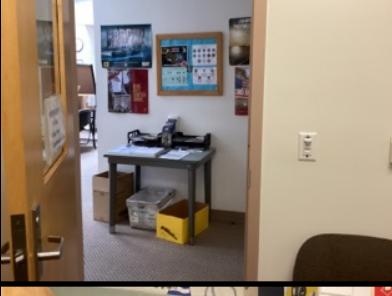
| ID | Location | Floor | Room | Element | Type | Photo | Issues | Current Measure | Recommendations | Quantity | Price | Cost Estimation |
|---|---|---|---|---|---|--|---|---|---|---|---|---|
| 67 | B221 Guidance Counselor | 2 | B221 | Doors, Doorways, & Gates | Circulation | | Maneuvering clearance(s) not provided | - | Relocate furniture and stored items to provide 18" min. pull-side maneuvering clearance at the door. | 4 | Labor | Labor |

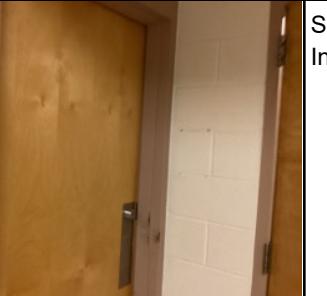
| ID | Location | Floor | Room | Element | Type | Photo | Issues | Current Measure | Recommendations | Quantity | Price | Cost Estimation |
|---|---|---|---|---|---|--|--|---|--|---|---|---|
| 71 | Men's Multi-User Toilet Room | G | | Signage | Designation | | Signage is not provided<br>International Symbol of Acc. not provided | -<br>- | Locate compliant signage with raised characters and braille alongside the door on the latch side. Replace the sign with a sign containing the International Symbol of Accessibility (ISA). | 2 | 250 | \$500<br><b>500</b> |

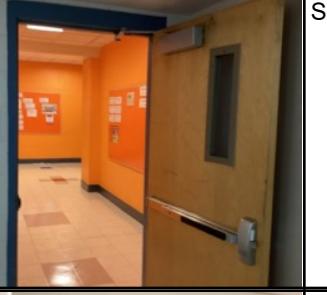
| ID | Location | Floor | Room | Element | Type | Photo | Issues | Current Measure | Recommendations | Quantity | Price | Cost Estimation |
|---|---|---|---|---|---|--|--|---|--|---|---|---|
| 72 | Locker Room | G | | Signage | Designation | | Signage is not provided | - | Locate compliant signage with raised characters and braille alongside the door on the latch side. | 1 | 250 | \$250<br><b>250</b> |

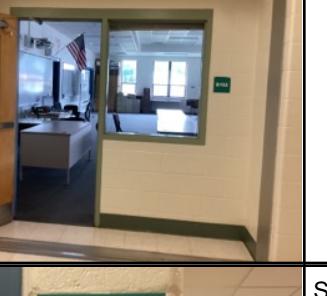
| ID | Location | Floor | Room | Element | Type | Photo | Issues | Current Measure | Recommendations | Quantity | Price | Cost Estimation |
|---|---|---|---|---|---|--|--|---|--|---|---|---|
| 74 | Marching Band | 1 | B102 | Signage | Designation | | Sign not located on the latch side of the door | - | Locate the sign at permanent rooms alongside the door closer to the door latch. (Relocate sign to glass by latch side of door.) | 1 | Labor | Labor |

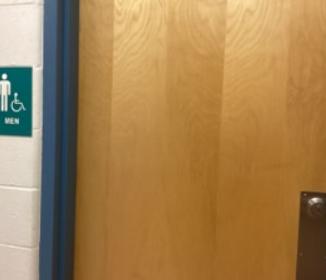
| ID | Location | Floor | Room | Element | Type | Photo | Issues | Current Measure | Recommendations | Quantity | Price | Cost Estimation |
|---|---|---|---|---|---|--|--|---|--|---|---|---|
| 76 | Men's Multi-User Toilet Room | 2 | | Signage | Designation | | Sign not located on the latch side of the door | - | Locate the sign at permanent rooms alongside the door on the latch side. | 1 | Labor | Labor |

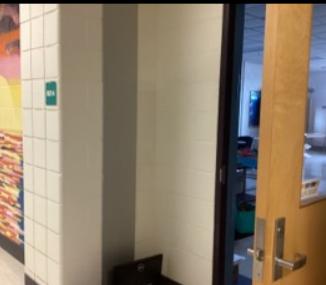
| ID | Location | Floor | Room | Element | Type | Photo | Issues | Current Measure | Recommendations | Quantity | Price | Cost Estimation |
|---|---|---|---|---|---|--|--|---|--|---|---|---|
| 77 | B214, B211 | 2 | B214, B211 | Signage | Designation | | Sign not located on the latch side of the door | - | Locate the sign at permanent rooms alongside the door on the latch side. | 2 | Labor | Labor |

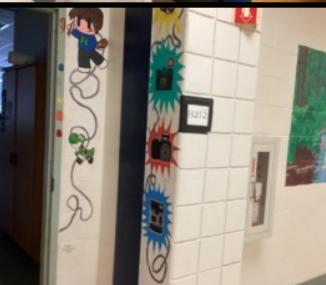
| ID | Location | Floor | Room | Element | Type | Photo | Issues | Current Measure | Recommendations | Quantity | Price | Cost Estimation |
|---|---|---|---|---|---|--|--|---|--|---|---|---|
| 78 | B212 Digital Design | 2 | B212 | Signage | Designation | | Raised characters not provided on sign<br>Braille not provided on sign | -<br>- | Provide text with raised characters duplicated in braille on the sign.<br>Provide braille on the sign. | 1 | Labor | Labor |

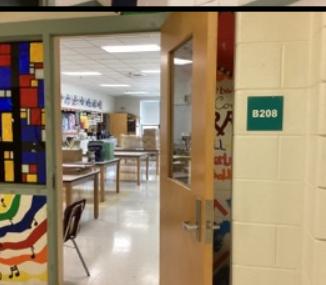
| ID | Location | Floor | Room | Element | Type | Photo | Issues | Current Measure | Recommendations | Quantity | Price | Cost Estimation |
|---|---|---|---|---|---|--|--|---|--|---|---|---|
| 79 | B208 Art | 2 | B208 | Signage | Designation | | Sign not located on the latch side of the door | - | Locate the sign at permanent rooms alongside the door on the latch side. | 1 | Labor | Labor |

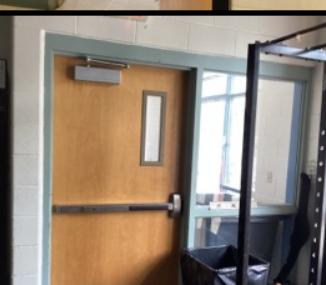
| ID | Location | Floor | Room | Element | Type | Photo | Issues | Current Measure | Recommendations | Quantity | Price | Cost Estimation |
|---|---|---|---|---|---|--|--|---|--|---|---|---|
| 80 | Weight Room | G | G | Signage | Designation | | Signage is not provided | - | Locate compliant signage with raised characters and braille alongside the door on the latch side. | 1 | 250 | \$250 |

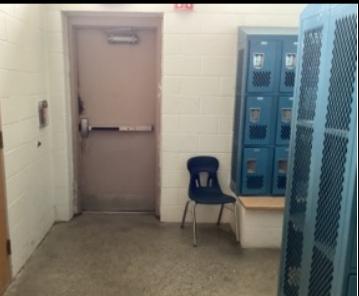
| ID | Location | Floor | Room | Element | Type | Photo | Issues | Current Measure | Recommendations | Quantity | Price | Cost Estimation |
|---|---|---|---|---|---|--|--|---|---|---|---|---|
| 81 | Boys' Locker Room | G | | Signage | Egress | | Raised characters not provided on sign | - | Provide text with raised characters duplicated in braille on the sign. | 1 | 250 | \$250 |

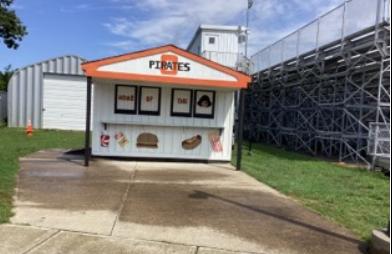
| ID | Location | Floor | Room | Element | Type | Photo | Issues | Current Measure | Recommendations | Quantity | Price | Cost Estimation |
|---|---|---|---|---|---|--|--|---|---|---|---|---|
| 82 | Concession Stand | Ext. | | Service Counter | N/A | | Counter > 36" high | 41.5" | Provide a counter that is 36" max. above the ground or finished floor. | 1 | 1144 | \$1144 |

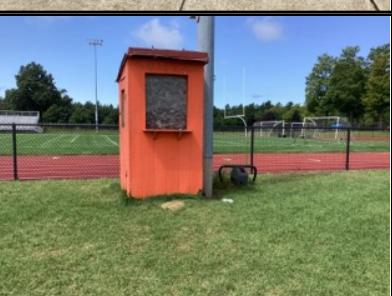
| ID | Location | Floor | Room | Element | Type | Photo | Issues | Current Measure | Recommendations | Quantity | Price | Cost Estimation |
|---|---|---|---|---|---|--|--|---|---|---|---|---|
| 83 | Ticket Booth | Ext. | | Service Counter | N/A | | Counter > 36" high | 45.25" | Provide a counter that is 36" max. above the ground or finished floor. | 3 | 1144 | \$3432 |

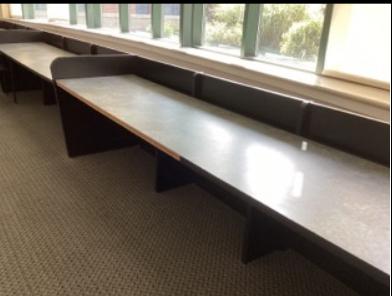
| ID | Location | Floor | Room | Element | Type | Photo | Issues | Current Measure | Recommendations | Quantity | Price | Cost Estimation |
|---|---|---|---|---|---|--|---|---|---|---|---|---|
| 86 | Media Center | 1 | B115 | Dining or Work Surfaces | Work Surface | | Knee clearance less than 19" deep | 26" | Provide at least one work surface with knee clearance that is 19" deep min. | 1 | 455 | \$455 |

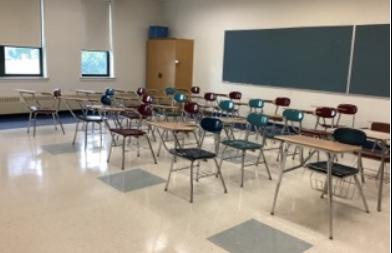
| ID | Location | Floor | Room | Element | Type | Photo | Issues | Current Measure | Recommendations | Quantity | Price | Cost Estimation |
|---|---|---|---|---|---|--|---|---|---|---|---|---|
| 87 | Health A102 | 1 | A102 | Dining or Work Surfaces | Work Surface | | At least one or 5% accessible tables not provided<br>Knee or toe clearance not provided | -<br>- | Ensure that at least one work surface is accessible.<br>Provide at least one work surface with 27" min. high knee and toe clearance. For children, provide at least one dining or work surface with 24" min. high knee and toe clearance. | 1 | 455 | \$455 |

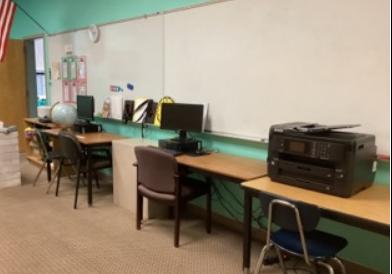
| ID | Location | Floor | Room | Element | Type | Photo | Issues | Current Measure | Recommendations | Quantity | Price | Cost Estimation |
|---|---|---|---|---|---|--|---|---|---|---|---|---|
| 88 | Special Education Area | 1 | A109 | Dining or Work Surfaces | Work Surface | | Knee clearance less than 19" deep | 25.5" | Provide at least one work surface with knee clearance that is 19" deep min. | 1 | 455 | \$455 |

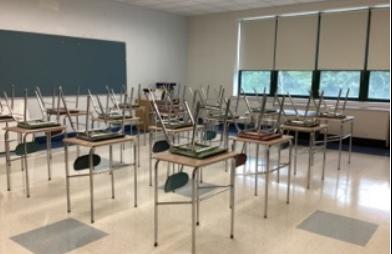
| ID | Location | Floor | Room | Element | Type | Photo | Issues | Current Measure | Recommendations | Quantity | Price | Cost Estimation |
|---|---|---|---|---|---|--|---|---|---|---|---|---|
| 89 | C214 English Language Arts | 2 | C214 | Dining or Work Surfaces | Dining Surface | | Knee clearance less than 19" deep | - | Provide at least one work surface with knee clearance that is 19" deep min. | 1 | 455 | \$455 |

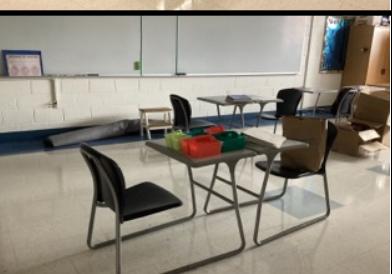
| ID | Location | Floor | Room | Element | Type | Photo | Issues | Current Measure | Recommendations | Quantity | Price | Cost Estimation |
|---|---|---|---|---|---|--|---|---|---|---|---|---|
| 90 | B214, B211 | 2 | B214, B211 | Dining or Work Surfaces | Dining Surface | | Knee clearance less than 19" deep | - | Provide at least one work surface with knee clearance that is 19" deep min. | 1 | 455 | \$455 |

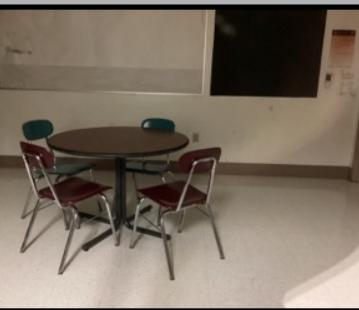
| ID | Location | Floor | Room | Element | Type | Photo | Issues | Current Measure | Recommendations | Quantity | Price | Cost Estimation |
|---|---|---|---|---|---|--|--|---|---|---|---|---|
| 91 | B210<br>Yearbook | 2 | B210 | Dining or Work Surfaces | Work Surface | | Knee or toe clearance not provided | - | Provide at least one work surface with 27" min. high knee and toe clearance. For children, provide at least one dining or work surface with 24" min. high knee and toe clearance. | 1 | 455 | \$455 |

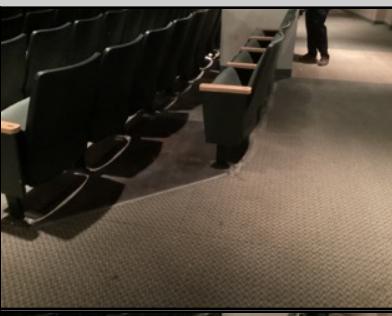
| ID | Location | Floor | Room | Element | Type | Photo | Issues | Current Measure | Recommendations | Quantity | Price | Cost Estimation |
|---|---|---|---|---|---|--|--|---|---|---|---|---|
| 92 | Auditorium | 1 | | Assembly Area | N/A | | Number of seats<br>Number of designated wheelchair spaces<br>Designated aisle seats < 5% | 700<br>7<br>4 | At least 5% of the total number of aisle seats provided must be identified by a sign or marker and have folding or retractable armrests.<br><b>Note:</b> None of the four aisle seats with folding arms had a marker on the folding seat or seat arm. | 1 | - | - |

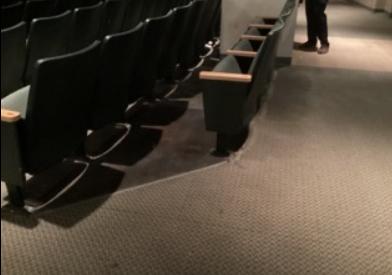
| ID | Location | Floor | Room | Element | Type | Photo | Issues | Current Measure | Recommendations | Quantity | Price | Cost Estimation |
|---|---|---|---|---|---|--|--|---|---|---|---|---|
| 93 | Auditorium | 1 | | Assembly Area | N/A | | Assistive listening devices not provided | - | If audible communication is integral to the use of the space, provide an assistive listening system.<br><b>Note:</b> Approximate cost for a transmitter, receiver, ear speaker, neck loop and USB charger for 700 seat capacity. Also, IHCD team was told that student-specific assistive listening systems are available in some classrooms. It was not clear if there is an assistive listening system in the auditorium. | 1 | 1688 | \$1688 |

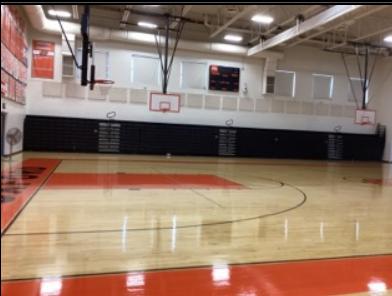
| ID | Location | Floor | Room | Element | Type | Photo | Issues | Current Measure | Recommendations | Quantity | Price | Cost Estimation |
|---|---|---|---|---|---|--|--|---|---|---|---|---|
| 94 | Gymnasium | 1 | | Assembly Area | N/A | | Number of designated wheelchair spaces<br>Minimum # wheelchair spaces not provided | 0<br>- | When the bleachers are renovated or replaced, provide at least the required number of compliant wheelchair seating spaces.<br><b>Note:</b> As the bleachers were not opened on the day of the survey, it was not possible to fully confirm the lack of accessible wheelchair spaces. | 1 | - | - |

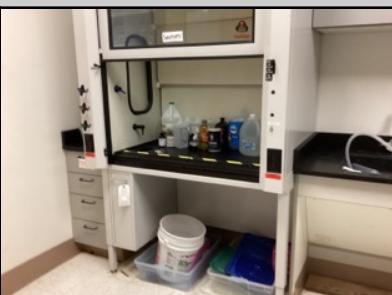
| ID | Location | Floor | Room | Element | Type | Photo | Issues | Current Measure | Recommendations | Quantity | Price | Cost Estimation |
|---|---|---|---|---|---|--|---|---|--|---|---|---|
| 97 | Physics | 1 | C111 | Laboratory | Physics | | At least one (or 5%) acc. fume hood not provided | - | Provide one accessible fume hood. (Relocate stored items under fume hood.) | 1 | Labor | Labor |

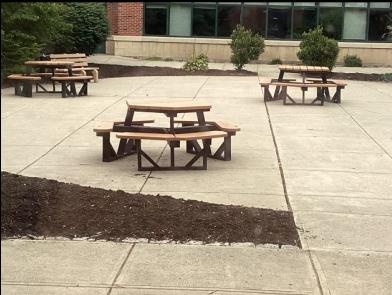
| ID | Location | Floor | Room | Element | Type | Photo | Issues | Current Measure | Recommendations | Quantity | Price | Cost Estimation |
|---|---|---|---|---|---|--|---|---|--|---|---|---|
| 98 | Courtyard | 1 | | Picnic Tables | N/A | | Number of seating spaces at picnic tables<br>At least 5% accessible spaces not provided | 4 - | Ensure that at least 5% (minimum one) of picnic tables are accessible. | 1 | 1400 | \$1400 |

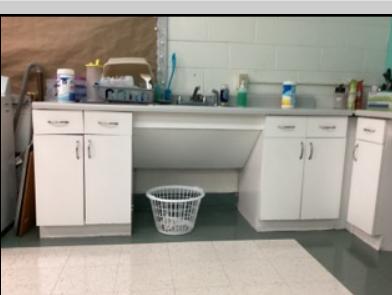
| ID | Location | Floor | Room | Element | Type | Photo | Issues | Current Measure | Recommendations | Quantity | Price | Cost Estimation |
|---|---|---|---|---|---|--|---|---|--|---|---|---|
| 99 | Special Education Kitchen | 1 | A111 | Kitchens and Kitchenettes | N/A | | Knee/toe clearance not provided at sink<br>Sink > 34" high | - 36" | Provide a sink with knee and toe clearance positioned for a forward approach (remove stored items from under sink). Lower sink to be no higher than 34" positioned for a forward approach. | 1 | Labor 4022 | \$4022 |

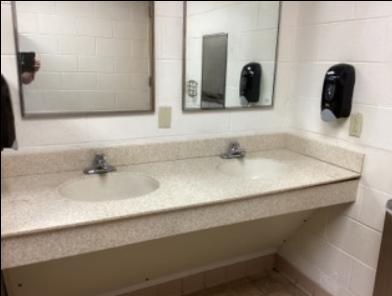
| ID | Location | Floor | Room | Element | Type | Photo | Issues | Current Measure | Recommendations | Quantity | Price | Cost Estimation |
|---|--|---|---|---|---|--|---|---|---|---|---|---|
| 100 | Men's Multi-User Toilet Room | G | | Lavatory | N/A | | Toe or knee clearances not provided<br>Mirror above lavatory w/reflective surface > 40" | 5"<br>45" | Provide at least one lavatory with knee and toe clearance positioned for a forward approach.<br>(Increase knee clearance by top of sink to at least 8" of depth.)<br>Lower mirror so that the bottom surface is at 40" max. above the finished floor. | 1 | 2192<br>333 | \$2525<br><br><b>2525</b> |

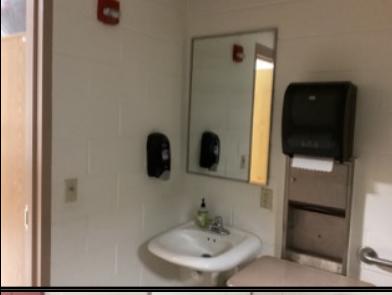
| ID | Location | Floor | Room | Element | Type | Photo | Issues | Current Measure | Recommendations | Quantity | Price | Cost Estimation |
|---|--|---|---|---|---|--|---|---|---|---|---|---|
| 101 | Girls' Locker Room<br>Women's Single-User Lavatory | G | | Lavatory | N/A | | Mirror above lavatory w/reflective surface > 40" | 46" | Lower mirror so that the bottom surface is at 40" max. above the finished floor. | 1 | 333 | \$333<br><br><b>333</b> |
