Town of Oxford

# ADA Self-Evaluation and Transition Plan

July 2024

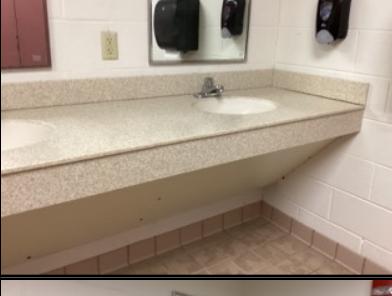
| ID | Location | Floor | Room | Element | Type | Photo | Issues | Current Measure | Recommendations | Quantity | Price | Cost Estimation |
|---|--|---|---|---|---|--|---|---|---|---|---|---|
| 102 | Girls' Locker Room Multi-User Toilet Room | G | | Lavatory | N/A | | Toe or knee clearances not provided | 2" | Provide at least one lavatory with knee and toe clearance positioned for a forward approach.<br>(Increase knee clearance by top of sink to at least 8" of depth.) | 1 | 2192 | \$2192<br><br><b>2192</b> |

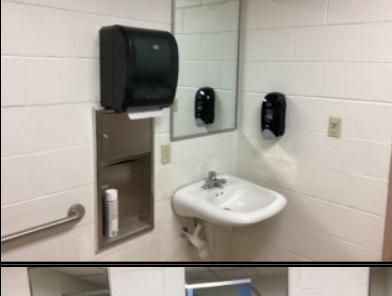
| ID | Location | Floor | Room | Element | Type | Photo | Issues | Current Measure | Recommendations | Quantity | Price | Cost Estimation |
|---|--|---|---|---|---|--|---|---|---|---|---|---|
| 103 | Boys' Locker Room Single-User | G | | Lavatory | N/A | | Mirror above lavatory w/reflective surface > 40" | 46" | Lower mirror so that the bottom surface is at 40" max. above the finished floor. | 1 | 333 | \$333<br><br><b>333</b> |

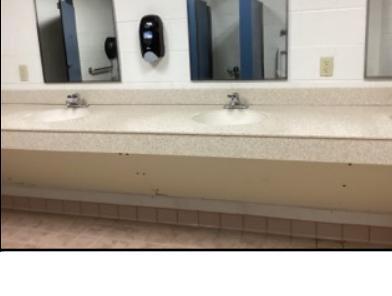
| ID | Location | Floor | Room | Element | Type | Photo | Issues | Current Measure | Recommendations | Quantity | Price | Cost Estimation |
|---|--|---|---|---|---|--|---|---|---|---|---|---|
| 104 | Boys' Locker Room Multi-User Toilet Room | G | D14 | Lavatory | N/A | | Toe or knee clearances not provided | 2" | Provide at least one lavatory with knee and toe clearance positioned for a forward approach.<br>(Increase knee clearance by top of sink to at least 8" of depth.) | 1 | 2192 | \$2192<br><br><b>2192</b> |

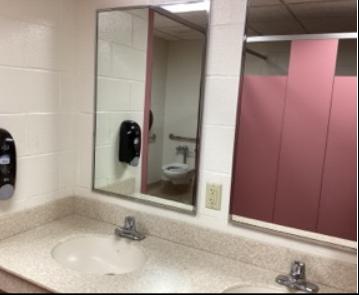
| ID | Location | Floor | Room | Element | Type | Photo | Issues | Current Measure | Recommendations | Quantity | Price | Cost Estimation |
|---|---|---|---|---|---|--|--|---|--|---|---|---|
| 105 | Women's Multi-User Toilet Room for Preschool | G | | Lavatory | N/A | | Toe or knee clearances not provided | 6.5 | Provide at least one lavatory with knee and toe clearance positioned for a forward approach. (Increase knee clearance by top of sink to at least 8" of depth.) | 1 | 2192 | \$2192 |

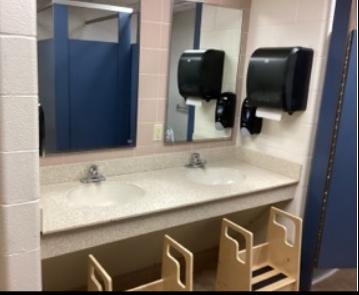
| ID | Location | Floor | Room | Element | Type | Photo | Issues | Current Measure | Recommendations | Quantity | Price | Cost Estimation |
|---|---|---|---|---|---|--|--|---|--|---|---|---|
| 106 | Men's Multi-User Toilet Room for Preschool | G | | Lavatory | N/A | | Toe or knee clearances not provided | 5.5" | Provide at least one lavatory with knee and toe clearance positioned for a forward approach. (Increase knee clearance by top of sink to at least 8" of depth.) | 1 | 2192 | \$2192 |

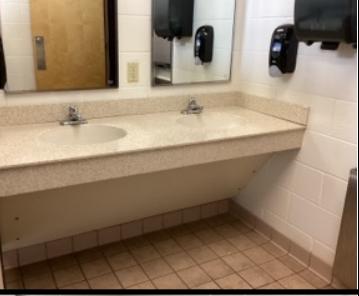
| ID | Location | Floor | Room | Element | Type | Photo | Issues | Current Measure | Recommendations | Quantity | Price | Cost Estimation |
|---|---|---|---|---|---|--|--|---|--|---|---|---|
| 107 | Men's and Women's Multi-User Toilet Room by Door 13 | 1 | | Lavatory | N/A | | Toe or knee clearances not provided | 6" | Provide at least one lavatory with knee and toe clearance positioned for a forward approach. | 2 | 2192 | \$4384 |

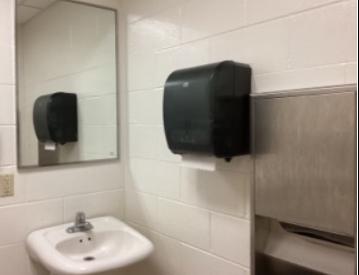
| ID | Location | Floor | Room | Element | Type | Photo | Issues | Current Measure | Recommendations | Quantity | Price | Cost Estimation |
|---|---|---|---|---|---|--|--|---|--|---|---|---|
| 108 | Nurse's Office Single-User Toilet Room | 1 | A129 | Lavatory | N/A | | Clear floor space not provided at lavatory<br>Mirror above lavatory w/reflective surface > 40" | - 48" | Provide at least one lavatory with a 30" min. by 48" min. clear floor space positioned for a forward approach. (Relocate paper towel dispenser.)<br>Lower mirror so that the bottom surface is at 40" max. above the finished floor. | 1 | 500<br>333 | \$833 |

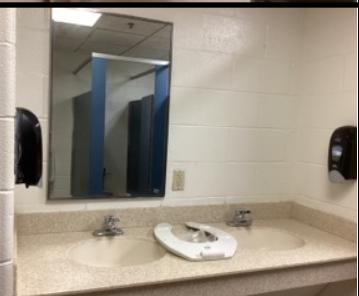
| ID | Location | Floor | Room | Element | Type | Photo | Issues | Current Measure | Recommendations | Quantity | Price | Cost Estimation |
|---|---|---|---|---|---|--|--|---|--|---|---|---|
| 109 | Men's Multi-User Toilet Room by Stair C | 2 | | Lavatory | N/A | | Mirror above lavatory w/reflective surface > 40" | 41.5" | Lower mirror so that the bottom surface is at 40" max. above the finished floor. | 1 | 333 | \$333 |

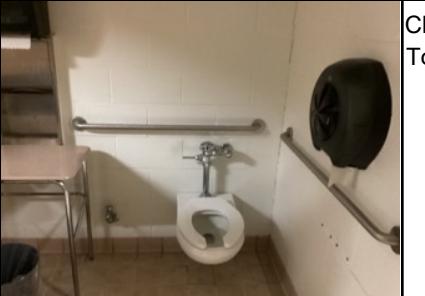
| ID | Location | Floor | Room | Element | Type | Photo | Issues | Current Measure | Recommendations | Quantity | Price | Cost Estimation |
|---|---|---|---|---|---|--|--|---|---|---|---|---|
| 110 | Girls' Locker Room<br>Women's Single-User Toilet | G | | Single-User Toilet | N/A | | Clearance at toilet < 60" clear width<br>Toilet paper dispenser is not compliant | -<br>- | Remove furniture to ensure that there is 60" wide min. clear floor space at the toilet.<br>Relocate toilet paper so that it is 24" min. high, located under the grab bar, and between 7" and 9" from the front of the toilet./Replace dispenser as it does not allow continuous paper flow. | 1 | Labor 500<br><br><b>500</b> | \$500 |

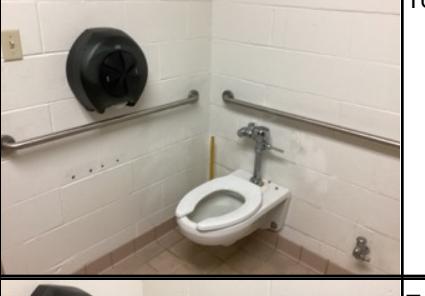
| ID | Location | Floor | Room | Element | Type | Photo | Issues | Current Measure | Recommendations | Quantity | Price | Cost Estimation |
|---|---|---|---|---|---|--|--|---|---|---|---|---|
| 112 | Boys' Locker Room Single-User Toilet | G | | Single-User Toilet | N/A | | Toilet paper dispenser is not compliant | - | Relocate toilet paper so that it is 24" min.. high, located under the grab bar, and between 7" and 9" from the front of the toilet./Replace dispenser as it does not allow continuous paper flow. | 1 | 500<br><br><b>500</b> | \$500 |

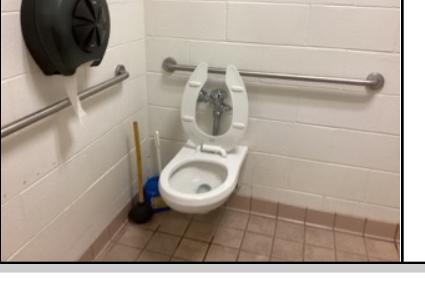
| ID | Location | Floor | Room | Element | Type | Photo | Issues | Current Measure | Recommendations | Quantity | Price | Cost Estimation |
|---|---|---|---|---|---|--|--|---|---|---|---|---|
| 113 | Nurse's Office Single-User Toilet Room | 1 | A129 | Single-User Toilet | N/A | | Toilet paper dispenser is not compliant | - | Relocate toilet paper so that it is 24" min. high, located under the grab bar, and between 7" and 9" from the front of the toilet./Replace dispenser as it does not allow continuous paper flow. | 1 | 500<br><br><b>500</b> | \$500 |

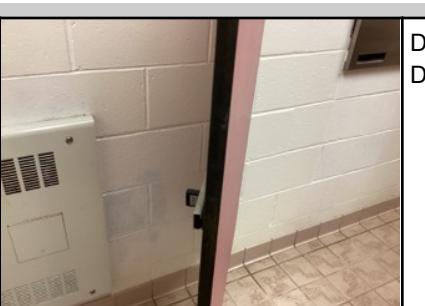
| ID | Location | Floor | Room | Element | Type | Photo | Issues | Current Measure | Recommendations | Quantity | Price | Cost Estimation |
|---|---|---|---|---|---|--|--|---|---|---|---|---|
| 114 | Women's Multi-User Toilet Room | G | | Toilet Compartment | Accessible Compartment | | Door has noncompliant hardware<br>Door pull not provided | -<br>- | Provide a door pull on each side of the door between 34" to 48" above the finished floor that does not require tight grasping, pinching or twisting of the wrist. | 1<br><br><b>91</b> | 91<br><br><b>91</b> | \$91 |

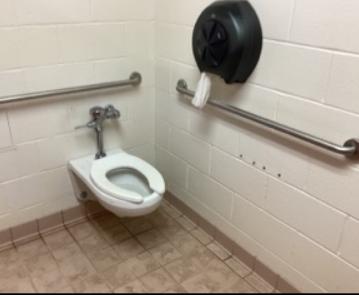
| ID | Location | Floor | Room | Element | Type | Photo | Issues | Current Measure | Recommendations | Quantity | Price | Cost Estimation |
|---|---|---|---|---|---|--|--|---|--|---|---|---|
| 115 | Women's Multi-User Toilet Room | G | | Toilet Compartment | Accessible Compartment | | Noncompliant toilet paper dispenser | - | Relocate toilet paper so that it is 24" min. high, located under the grab bar, and between 7" and 9" from the front of the toilet./Replace dispenser as it does not allow continuous paper flow. | 1 | 500 | \$500 |

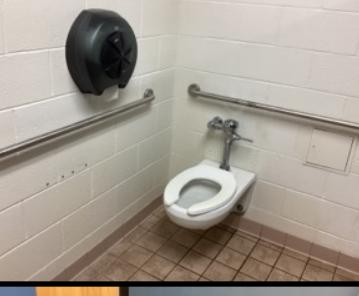
| ID | Location | Floor | Room | Element | Type | Photo | Issues | Current Measure | Recommendations | Quantity | Price | Cost Estimation |
|---|---|---|---|---|---|--|--|---|--|---|---|---|
| 116 | Men's Multi-User Toilet Room | G | | Toilet Compartment | Accessible Compartment | | Noncompliant toilet paper dispenser | - | Relocate toilet paper so that it is 24" min. high, located under the grab bar, and between 7" and 9" from the front of the toilet./Replace dispenser as it does not allow continuous paper flow. | 1 | 500 | \$500 |

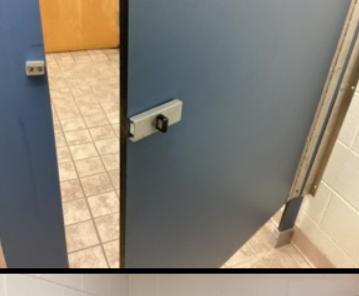
| ID | Location | Floor | Room | Element | Type | Photo | Issues | Current Measure | Recommendations | Quantity | Price | Cost Estimation |
|---|---|---|---|---|---|--|--|---|--|---|---|---|
| 117 | Men's Multi-User Toilet Room | G | | Toilet Compartment | Accessible Compartment | | Door pull not provided | - | Provide a door pull on each side of the door between 34" to 48" above the finished floor that does not require tight grasping, pinching or twisting of the wrist. | 1 | 91 | \$91 |

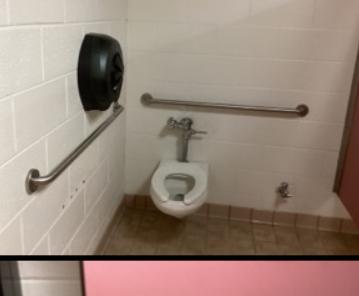
| ID | Location | Floor | Room | Element | Type | Photo | Issues | Current Measure | Recommendations | Quantity | Price | Cost Estimation |
|---|---|---|---|---|---|--|--|---|--|---|---|---|
| 118 | Girls' Locker Room Multi-User | G | | Toilet Compartment | Accessible Compartment | | Noncompliant toilet paper dispenser | - | Relocate toilet paper so that it is 24" min. high, located under the grab bar, and between 7" and 9" from the front of the toilet./Replace dispenser as it does not allow continuous paper flow. | 1 | 500 | \$500 |

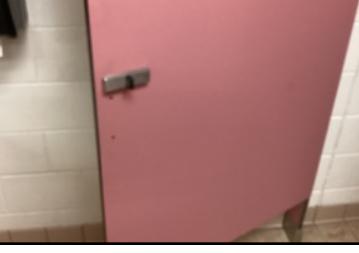
| ID | Location | Floor | Room | Element | Type | Photo | Issues | Current Measure | Recommendations | Quantity | Price | Cost Estimation |
|---|---|---|---|---|---|--|--|---|--|---|---|---|
| 119 | Girls' Locker Room Multi-User Toilet Room | G | | Toilet Compartment | Accessible Compartment | | Door has malfunctioning self-closing hinge<br>Door pull not provided | -<br>- | Repair hinge.<br>Provide a door pull on each side of the door between 34" to 48" above the finished floor that does not require tight grasping, pinching or twisting of the wrist. | 1 | Labor 91 | \$91 |

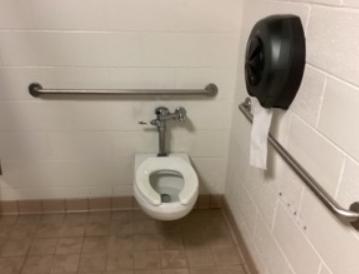
| ID | Location | Floor | Room | Element | Type | Photo | Issues | Current Measure | Recommendations | Quantity | Price | Cost Estimation |
|---|--|---|---|---|---|--|--|---|--|---|---|---|
| 120 | Boys' Locker Room Multi-User Toilet Room | G | D14 | Toilet Compartment | Accessible Compartment | | Noncompliant toilet paper dispenser | - | Relocate toilet paper so that it is 24" min. high, located under the grab bar, and between 7" and 9" from the front of the toilet./Replace dispenser as it does not allow continuous paper flow. | 1 | 500 | \$500 |

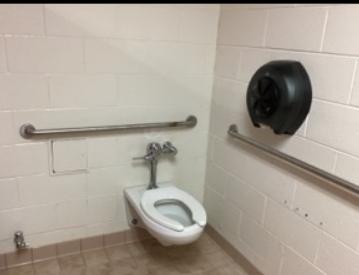
| ID | Location | Floor | Room | Element | Type | Photo | Issues | Current Measure | Recommendations | Quantity | Price | Cost Estimation |
|---|--|---|---|---|---|--|--|---|--|---|---|---|
| 121 | Women's Multi-User Toilet Room for Preschool | G | | Toilet Compartment | Accessible Compartment | | Noncompliant toilet paper dispenser | - | Relocate toilet paper so that it is 24" min. high, located under the grab bar, and between 7" and 9" from the front of the toilet./Replace dispenser as it does not allow continuous paper flow. | 1 | 500 | \$500 |

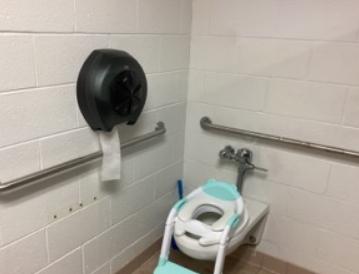
| ID | Location | Floor | Room | Element | Type | Photo | Issues | Current Measure | Recommendations | Quantity | Price | Cost Estimation |
|---|--|---|---|---|---|--|--|---|--|---|---|---|
| 123 | Men's and Women's Multi-User Toilet Room for Preschool | G | | Toilet Compartment | Accessible Compartment | | Noncompliant toilet paper dispenser | - | Relocate toilet paper so that it is 24" min. high, located under the grab bar, and between 7" and 9" from the front of the toilet./Replace dispenser as it does not allow continuous paper flow. | 2 | 500 | \$1000 |

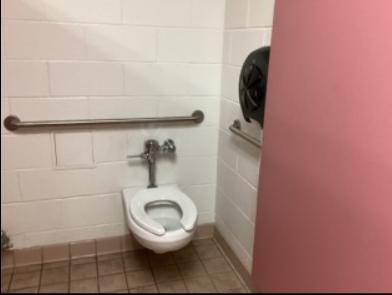
| ID | Location | Floor | Room | Element | Type | Photo | Issues | Current Measure | Recommendations | Quantity | Price | Cost Estimation |
|---|---|---|---|---|---|--|---|---|--|---|---|---|
| 125 | Women's Multi-User Toilet Room by Auditorium | 1 | | Toilet Compartment | | | Noncompliant toilet paper dispenser<br>Clearance at toilet < 72" clear depth (MAAB) | -<br>70.25" | Relocate toilet paper so that it is 24" min. high, located under the grab bar, and between 7" and 9" from the front of the toilet./Replace dispenser as it does not allow continuous paper flow.<br>Provide a wheelchair accessible compartment that is 60" wide and 72" deep. | 1 | 500<br>8037<br><br><b>8537</b> | \$8537 |

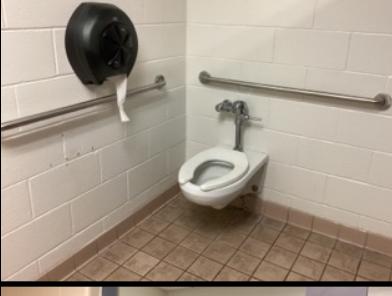
| ID | Location | Floor | Room | Element | Type | Photo | Issues | Current Measure | Recommendations | Quantity | Price | Cost Estimation |
|---|---|---|---|---|---|--|---|---|--|---|---|---|
| 126 | Men's Multi-User Toilet Room by Auditorium | 1 | | Toilet Compartment | Accessible Compartment | | Noncompliant toilet paper dispenser | - | Relocate toilet paper so that it is 24" min. high, located under the grab bar, and between 7" and 9" from the front of the toilet./Replace dispenser as it does not allow continuous paper flow. | 1 | 500<br><br><b>500</b> | \$500 |

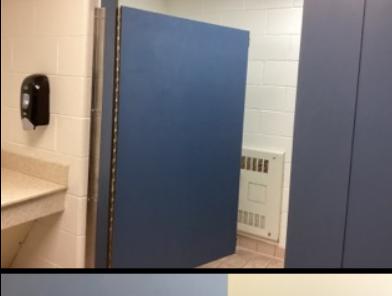
| ID | Location | Floor | Room | Element | Type | Photo | Issues | Current Measure | Recommendations | Quantity | Price | Cost Estimation |
|---|---|---|---|---|---|--|---|---|--|---|---|---|
| 127 | Men's Multi-User Toilet Room by Auditorium | 1 | | Toilet Compartment | Accessible Compartment | | Door has malfunctioning self-closing hinge<br>Door pull not provided | -<br>- | Repair hinge.<br>Provide a door pull on each side of the door between 34" to 48" above the finished floor that does not require tight grasping, pinching or twisting of the wrist. | 1 | Labor 70<br><br><b>70</b> | \$70 |

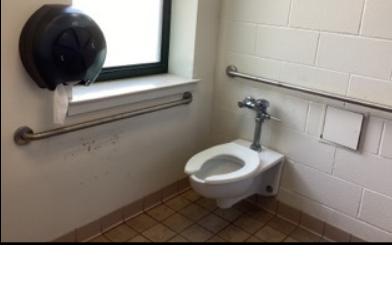
| ID | Location | Floor | Room | Element | Type | Photo | Issues | Current Measure | Recommendations | Quantity | Price | Cost Estimation |
|---|---|---|---|---|---|--|---|---|--|---|---|---|
| 129 | Men's and Women's Multi-User Toilet Room by Door 13 | 1 | | Toilet Compartment | | | Side or rear grab bar < 33" or >36" high<br>Noncompliant toilet paper dispenser | 28.5"<br>- | Locate grab bars between 33"- 36" above the finished floor.<br>Relocate toilet paper so that it is 24" min. high, located under the grab bar, and between 7" and 9" from the front of the toilet./Replace dispenser as it does not allow continuous paper flow. | 2 | 396<br>500<br><br><b>1792</b> | \$1792 |

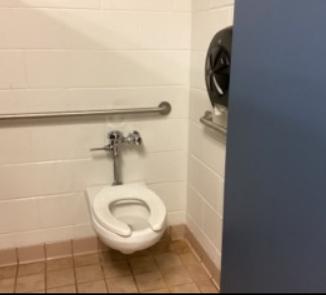
| ID | Location | Floor | Room | Element | Type | Photo | Issues | Current Measure | Recommendations | Quantity | Price | Cost Estimation |
|---|---|---|---|---|---|--|---|---|--|---|---|---|
| 130 | Men's Multi-User Project Success | 1 | | Toilet Compartment | Accessible Compartment | | Door has incorrect swing<br>Noncompliant toilet paper dispenser<br>Door pull not provided | -<br>-<br>= | Reverse swing at door and replace keeper.<br>Relocate toilet paper so that it is 24" min. high, located under the grab bar, and between 7" and 9" from the front of the toilet.<br>Provide a door pull on each side of the door between 34" to 48" above the finished floor that does not require tight grasping, pinching or twisting of the wrist. | 1 | 333<br>500<br>91<br><br><b>924</b> | \$924 |

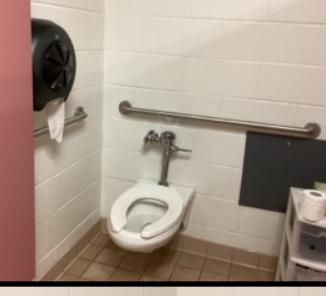
| ID | Location | Floor | Room | Element | Type | Photo | Issues | Current Measure | Recommendations | Quantity | Price | Cost Estimation |
|---|---|---|---|---|---|--|---|---|--|---|---|---|
| 131 | Women's Multi-User Project Success | 1 | | Toilet Compartment | Accessible Compartment | | Door has incorrect swing<br>Noncompliant toilet paper dispenser<br>Door pull not provided | -<br>-<br>- | Reverse swing at door and replace keeper.<br>Relocate toilet paper so that it is 24" min. high, located under the grab bar, and between 7" and 9" from the front of the toilet.<br>Provide a door pull on each side of the door between 34" to 48" above the finished floor that does not require tight grasping, pinching or twisting of the wrist. | 1 | 333<br>500<br>91<br><br><b>924</b> | \$924 |

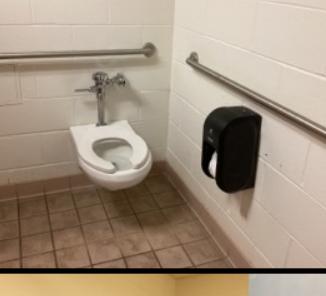
| ID | Location | Floor | Room | Element | Type | Photo | Issues | Current Measure | Recommendations | Quantity | Price | Cost Estimation |
|---|---|---|---|---|---|--|---|---|--|---|---|---|
| 132 | Women's Multi-User Toilet Room | 2 | | Toilet Compartment | Accessible Compartment | | Centerline < or > 18" (MAAB) | 19" | Relocate toilet so the centerline is 18" from the side wall. | 1 | 3676<br><br><b>3676</b> | \$3676 |

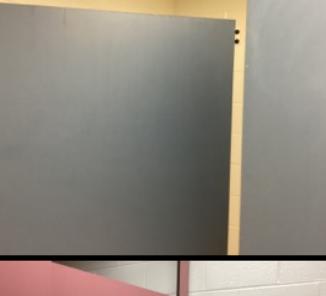
| ID | Location | Floor | Room | Element | Type | Photo | Issues | Current Measure | Recommendations | Quantity | Price | Cost Estimation |
|---|---|---|---|---|---|--|---|---|--|---|---|---|
| 133 | Men's and Women's Multi-User Toilet Room | 2 | | Toilet Compartment | Accessible Compartment | | Door has incorrect swing<br>Door pull not provided | -<br>- | Reverse swing at door and replace keeper.<br>Provide a door pull on each side of the door between 34" to 48" above the finished floor that does not require tight grasping, pinching or twisting of the wrist. | 2 | Labor<br>91<br><br><b>182</b> | \$182 |

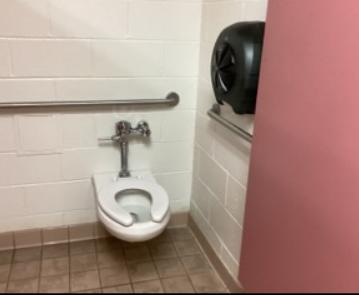
| ID | Location | Floor | Room | Element | Type | Photo | Issues | Current Measure | Recommendations | Quantity | Price | Cost Estimation |
|---|---|---|---|---|---|--|--|---|---|---|---|---|
| 135 | Women's Multi-User Toilet Room by Stair C | 2 | | Toilet Compartment | | | Noncompliant toilet paper dispenser | - | Relocate toilet paper so that it is 24" min. high, located under the grab bar, and between 7" and 9" from the front of the toilet./Replace dispenser as it does not allow continuous paper flow. | 1 | 500 | \$500 |

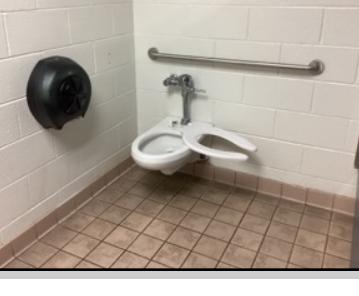
| ID | Location | Floor | Room | Element | Type | Photo | Issues | Current Measure | Recommendations | Quantity | Price | Cost Estimation |
|---|---|---|---|---|---|--|--|---|---|---|---|---|
| 137 | Men's Multi-User Toilet Room by Stair C | 2 | | Toilet Compartment | Accessible Compartment | | Grab bars not provided | - | Provide one grab bar on the side wall of the water closet and one on the rear wall.<br>Repair toilet seat. | 1 | 750 | \$750 |

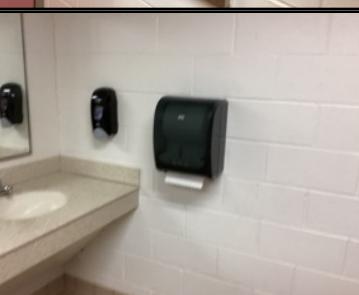
| ID | Location | Floor | Room | Element | Type | Photo | Issues | Current Measure | Recommendations | Quantity | Price | Cost Estimation |
|---|---|---|---|---|---|--|--|---|---|---|---|---|
| 139 | Girls' Locker Room Multi-User Toilet Room | G | | Dispensers | Paper Towel Dispenser | | Dispenser acts as a protruding object | 10" | Relocate paper towel dispenser out of the accessible route or provide a cane-detectable barrier 27" max. above the finished floor below the dispenser. | 1 | 398 | \$398 |

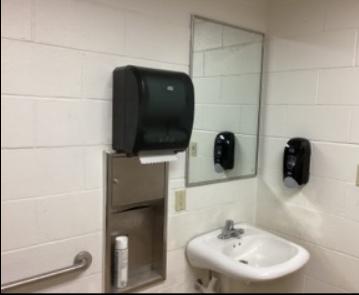
| ID | Location | Floor | Room | Element | Type | Photo | Issues | Current Measure | Recommendations | Quantity | Price | Cost Estimation |
|---|--|---|---|---|---|--|---|---|--|---|---|---|
| 140 | Boys' Locker Room Lavatory | G | | Dispensers | Paper Towel Dispenser | | Dispenser acts as a protruding object | 10" | Provide a cane-detectable barrier 27" max. above the finished floor under the paper towel dispenser. | 1 | 398 | \$398 |

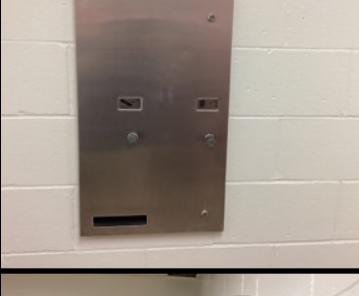
| ID | Location | Floor | Room | Element | Type | Photo | Issues | Current Measure | Recommendations | Quantity | Price | Cost Estimation |
|---|--|---|---|---|---|--|---|---|--|---|---|---|
| 142 | Women's Multi-User Toilet Room by Auditorium | 1 | | Dispensers | Tampon Dispenser | | Noncompliant operable part | - | Provide a sanitary napkin dispenser that can be operable with one hand and not require tight grasping, pinching, or twisting of the wrist. | 1 | 1000 | \$1000 |

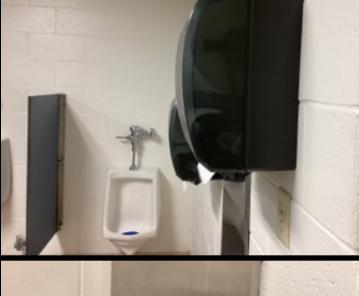
| ID | Location | Floor | Room | Element | Type | Photo | Issues | Current Measure | Recommendations | Quantity | Price | Cost Estimation |
|---|--|---|---|---|---|--|---|---|--|---|---|---|
| 143 | Men's Multi-User Toilet Room by Auditorium | 1 | | Dispensers | Paper Towel Dispenser | | Dispenser acts as a protruding object | 10" | Relocate paper towel dispenser out of the circulation path or provide a cane-detectable barrier 27" max. above the finished floor under the paper towel dispenser. | 1 | 398 | \$398 |

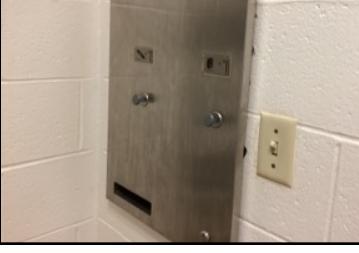
| ID | Location | Floor | Room | Element | Type | Photo | Issues | Current Measure | Recommendations | Quantity | Price | Cost Estimation |
|---|--|---|---|---|---|--|---|---|--|---|---|---|
| 144 | Nurse's Office Single-User Toilet Room | 1 | A129 | Dispensers | Tampon Dispenser | | Noncompliant operable part | - | Provide a sanitary napkin dispenser that can be operable with one hand and not require tight grasping, pinching, or twisting of the wrist. | 1 | 1000 | \$1000 |

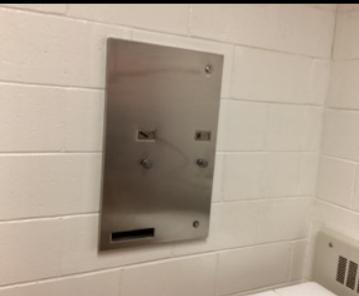
| ID | Location | Floor | Room | Element | Type | Photo | Issues | Current Measure | Recommendations | Quantity | Price | Cost Estimation |
|---|---|---|---|---|---|--|---|---|--|---|---|---|
| 145 | Women's Multi-User Project Success | 1 | | Dispensers | Tampon Dispenser | | Noncompliant operable part | - | Provide a sanitary napkin dispenser that can be operable with one hand and not require tight grasping, pinching, or twisting of the wrist. | 1 | 1000 | \$1000 |

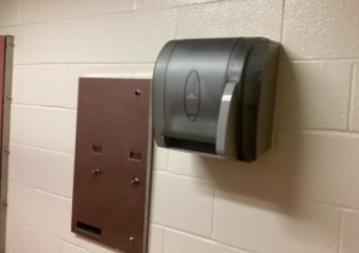
| ID | Location | Floor | Room | Element | Type | Photo | Issues | Current Measure | Recommendations | Quantity | Price | Cost Estimation |
|---|---|---|---|---|---|--|---|---|--|---|---|---|
| 146 | Women's Multi-User Toilet Room | 2 | | Dispensers | Paper Towel Dispenser | | Dispenser acts as a protruding object | 9" | Relocate paper towel dispenser out of the circulation path or provide a cane-detectable barrier 27" max. above the finished floor under the paper towel dispenser. | 1 | 398 | \$398 |

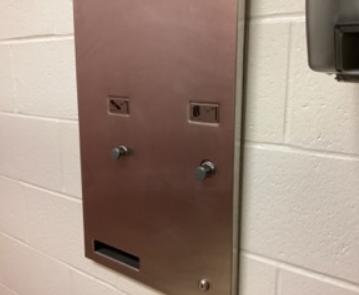
| ID | Location | Floor | Room | Element | Type | Photo | Issues | Current Measure | Recommendations | Quantity | Price | Cost Estimation |
|---|---|---|---|---|---|--|---|---|--|---|---|---|
| 147 | Women's Multi-User Toilet Room | 2 | | Dispensers | Tampon Dispenser | | Noncompliant operable part | - | Provide a dispenser that can be operable with one hand and not require tight grasping, pinching, or twisting of the wrist. | 1 | 1000 | \$1000 |

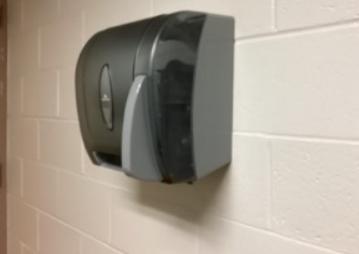
| ID | Location | Floor | Room | Element | Type | Photo | Issues | Current Measure | Recommendations | Quantity | Price | Cost Estimation |
|---|---|---|---|---|---|--|---|---|--|---|---|---|
| 148 | Men's Multi-User Toilet Room | 2 | | Dispensers | Paper Towel Dispenser | | Dispenser acts as a protruding object | 9" | Relocate paper towel dispenser out of the circulation path or provide a cane-detectable barrier 27" max. above the finished floor below the paper towel dispenser. | 1 | 398 | \$398 |

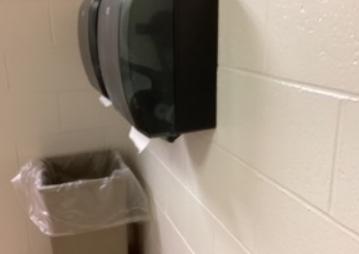
| ID | Location | Floor | Room | Element | Type | Photo | Issues | Current Measure | Recommendations | Quantity | Price | Cost Estimation |
|---|---|---|---|---|---|--|---|---|--|---|---|---|
| 149 | Women's Multi-User Toilet Room by Stair C | 2 | | Dispensers | Paper Towel Dispenser | | Dispenser acts as a protruding object | 9" | Relocate paper towel dispenser out of the circulation path or provide a cane-detectable barrier 27" max. above the finished floor below the paper towel dispenser. | 1 | 398 | \$398 |

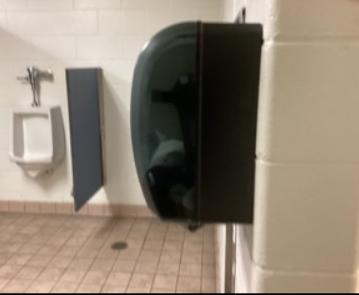
| ID | Location | Floor | Room | Element | Type | Photo | Issues | Current Measure | Recommendations | Quantity | Price | Cost Estimation |
|---|---|---|---|---|---|--|---|---|--|---|---|---|
| 150 | Men's Multi-User Toilet Room by Stair C | 2 | | Dispensers | Paper Towel Dispenser | | Dispenser acts as a protruding object | 9" | Relocate paper towel dispenser out of the circulation path or provide a cane-detectable barrier 27" max. above the finished floor below the paper towel dispenser. | 1 | 398 | \$398 |

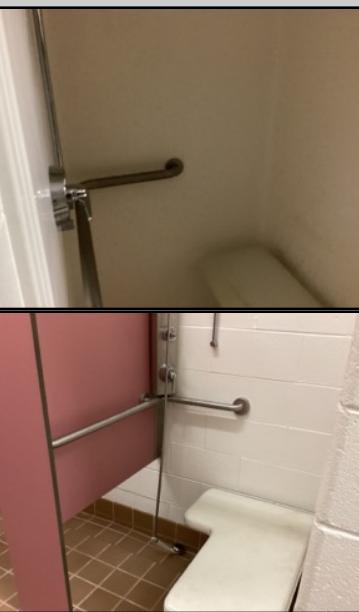
| ID | Location | Floor | Room | Element | Type | Photo | Issues | Current Measure | Recommendations | Quantity | Price | Cost Estimation |
|---|---|---|---|---|---|--|---|---|--|---|---|---|
| 151 | Girls' Locker Room Shower | G | | Shower Compartment | Transfer Type | | Shower spray hose < 59" long | - | Provide a spray unit with a hose 59" long min. | 1 | 829 | \$829 |

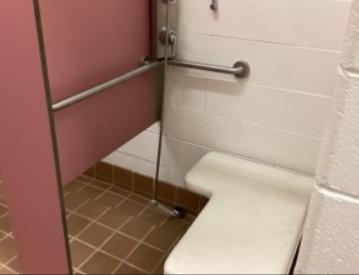
| ID | Location | Floor | Room | Element | Type | Photo | Issues | Current Measure | Recommendations | Quantity | Price | Cost Estimation |
|---|---|---|---|---|---|--|---|---|--|---|---|---|
| 152 | Girls' Locker Room Shower | G | | Shower Compartment | Transfer Type | | Controls not located opposite of seat (transfer type) | - | Relocate controls on the wall opposite the seat. | 1 | 3535 | \$3535 |

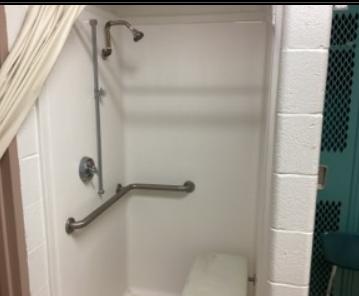
| ID | Location | Floor | Room | Element | Type | Photo | Issues | Current Measure | Recommendations | Quantity | Price | Cost Estimation |
|---|---|---|---|---|---|--|---|---|--|---|---|---|
| 153 | Boys' Locker Room Shower | G | | Shower Compartment | Transfer Type | | Shower spray hose < 59" long | - | Provide a spray unit with a hose 59" long min. | 1 | 829 | \$829 |

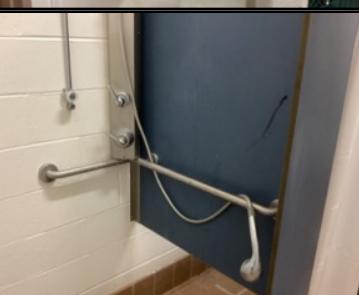
| ID | Location | Floor | Room | Element | Type | Photo | Issues | Current Measure | Recommendations | Quantity | Price | Cost Estimation |
|---|---|---|---|---|---|--|---|---|--|---|---|---|
| 154 | Boys' Locker Room Shower | G | D14 | Shower Compartment | Transfer Type | | Seat not provided (transfer compartment)<br>Controls not located opposite of seat (transfer type) | -<br>- | Provide a folding seat.<br>Relocate controls on the wall opposite the seat. | 1 | 780<br>3535 | \$4315 |

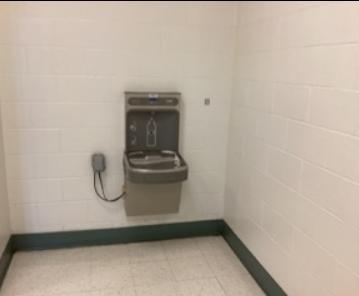
| ID | Location | Floor | Room | Element | Type | Photo | Issues | Current Measure | Recommendations | Quantity | Price | Cost Estimation |
|---|---|---|---|---|---|--|--|---|--|---|---|---|
| 155 | Hall Near B102 | 1 | | Drinking Fountains | Low | | No drinking fountain provided for standing users | - | Provide an additional drinking fountain for standing users or install a Hi-Lo drinking fountain. | 1 | 4028 | \$4028 |

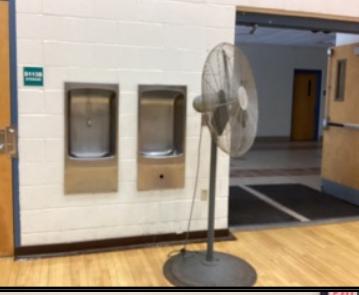
| ID | Location | Floor | Room | Element | Type | Photo | Issues | Current Measure | Recommendations | Quantity | Price | Cost Estimation |
|---|---|---|---|---|---|--|--|---|--|---|---|---|
| 156 | Gymnasium | 1 | | Drinking Fountains | Low | | No drinking fountain provided for standing users<br>Knee or toe clearance not provided | -<br>- | Provide an additional drinking fountain for standing users or install a Hi-Lo drinking fountain.<br>Provide knee and toe clearance, 27" min. high at drinking fountain for seated users.<br><b>Note:</b> Cost based on the provision of a new Hi-lo drinking fountain. | 1 | 4216 | \$4216 |

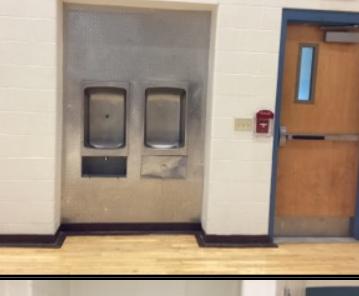
| ID | Location | Floor | Room | Element | Type | Photo | Issues | Current Measure | Recommendations | Quantity | Price | Cost Estimation |
|---|---|---|---|---|---|--|--|---|--|---|---|---|
| 157 | Gymnasium | 1 | | Drinking Fountains | Low | | No drinking fountain provided for standing users<br>Knee or toe clearance not provided | -<br>- | Provide an additional drinking fountain for standing users or install a Hi-Lo drinking fountain.<br>Provide knee and toe clearance, 27" min. high at drinking fountain for seated users.<br><b>Note:</b> Cost based on the provision of a new Hi-lo drinking fountain. | 1 | 4216 | \$4216 |

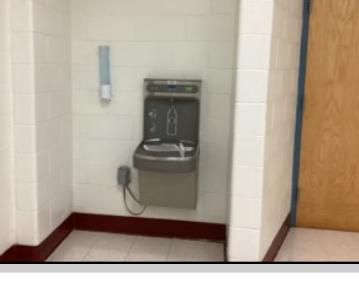
| ID | Location | Floor | Room | Element | Type | Photo | Issues | Current Measure | Recommendations | Quantity | Price | Cost Estimation |
|---|---|---|---|---|---|--|--|---|--|---|---|---|
| 158 | By Stair D | 2 | | Drinking Fountains | Low | | No drinking fountain provided for standing users | - | Provide an additional drinking fountain for standing users or install a Hi-Lo drinking fountain. | 1 | 4028 | \$4028 |

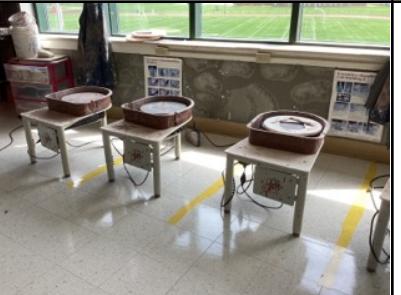
| ID | Location | Floor | Room | Element | Type | Photo | Issues | Current Measure | Recommendations | Quantity | Price | Cost Estimation |
|---|--|---|---|---|---|--|---|---|--|---|---|---|
| 165 | B208 Art | 2 | B208 | | | | | | Recommend providing at least one accessible potters wheel. | 1 | - | - |

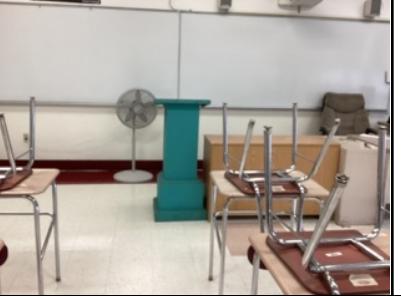
| ID | Location | Floor | Room | Element | Type | Photo | Issues | Current Measure | Recommendations | Quantity | Price | Cost Estimation |
|---|--|---|---|---|---|--|---|---|--|---|---|---|
| 166 | History | 2 | C209 | Podium | N/A | | | | Recommend providing an accessible adjustable height podium with knee and toe clearance. | 1 | - | - |

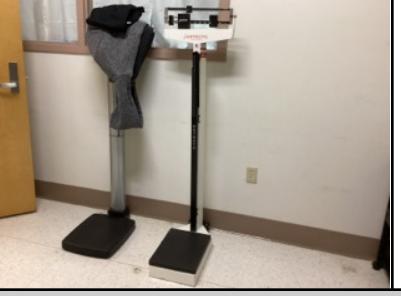
| ID | Location | Floor | Room | Element | Type | Photo | Issues | Current Measure | Recommendations | Quantity | Price | Cost Estimation |
|---|--|---|---|---|---|--|---|---|--|---|---|---|
| 167 | Nurse's Office Single-User Toilet Room | 1 | A129 | Scale | N/A | | | | Recommend providing an accessible scale. | 1 | - | - |

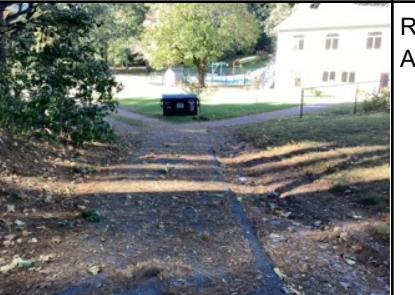
| ID | Location | Floor | Room | Element | Type | Photo | Issues | Current Measure | Recommendations | Quantity | Price | Cost Estimation |
|---|---|---|---|---|---|--|--|---|---|---|---|---|
| 1 | Path From Parking to Pond | Ext. | | Exterior Access Route | N/A | | Running slope > 1:20 (5.00%)<br>Accessible route not provided | 9.6%<br>- | Regrade to reduce running slope to be no steeper than 1:20 (5.00%) or 1:12 (8.33%) if an accessible ramp is provided to the pond and beach area. | 1 | Labor | Labor |

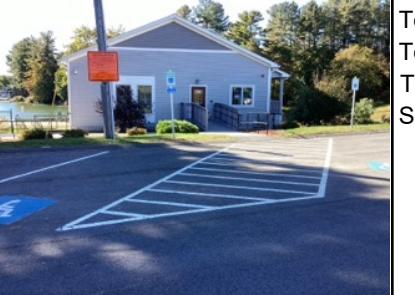
| ID | Location | Floor | Room | Element | Type | Photo | Issues | Current Measure | Recommendations | Quantity | Price | Cost Estimation |
|---|---|---|---|---|---|--|--|---|---|---|---|---|
| 2 | Parking by Main Entrance | Ext. | | Off-Street Parking Lot or Garage | N/A | | Total # of parking<br>Total # of designated car accessible parking spaces<br>Total # of designated van accessible spaces<br>Sign bottom < 60" above finished grade | 45<br>2<br>1<br>58" | Locate sign with the bottom of the sign 60" above the ground. | 1 | Labor | Labor |

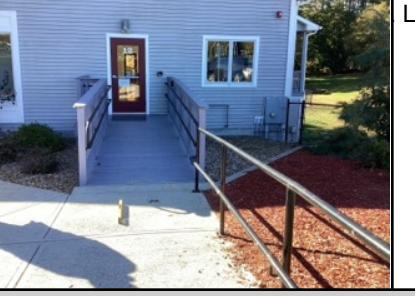
| ID | Location | Floor | Room | Element | Type | Photo | Issues | Current Measure | Recommendations | Quantity | Price | Cost Estimation |
|---|---|---|---|---|---|--|--|---|---|---|---|---|
| 3 | Ramp at Main Entrance North Side | Ext. | | Exterior Ramp | N/A | | Landing has a slope > 1:50 in either direction | 7.6% | Alter so that the slope in all directions is no greater than 1:50 (2.00%)./Rebuild the ramp to ensure that the slope of the landing does not exceed 1:50 (2.00%). | 1 | - | - |

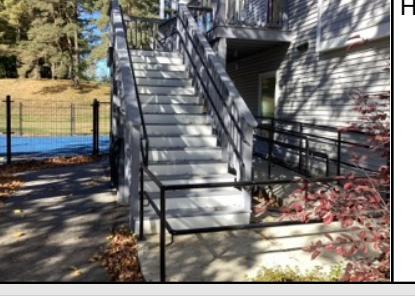
| ID | Location | Floor | Room | Element | Type | Photo | Issues | Current Measure | Recommendations | Quantity | Price | Cost Estimation |
|---|---|---|---|---|---|--|--|---|---|---|---|---|
| 4 | Exterior Stair to First Floor | Ext. | | Exterior Stair | N/A | | Handrails do not extend 12" from stair | - | Bottom: Ensure that the handrail extends at least 12" plus the width of one tread beyond the bottom riser. | 1 | - | - |

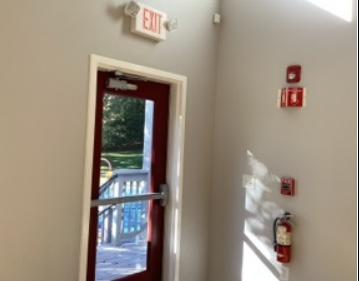
| ID | Location | Floor | Room | Element | Type | Photo | Issues | Current Measure | Recommendations | Quantity | Price | Cost Estimation |
|---|--|---|---|---|---|--|--|---|---|---|---|---|
| 5 | South Egress to Exterior Stairs | 1 | | Means of Egress | N/A | | Tactile exit sign not provided<br>Directional sign to accessible emergency exit not provided | -<br>- | Ensure that a tactile exit sign with raised characters and braille is provided at the exit door. Mount the sign between 48"- 60" above the finished floor located on the latch side of the door.<br>Provide a directional sign indicating the location of the nearest accessible emergency exit. | 2 | 250<br><br><b>500</b> | \$500 |

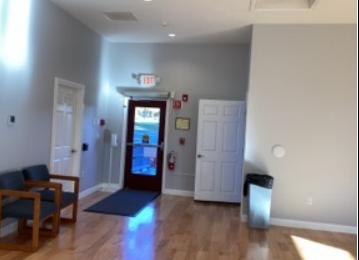
| ID | Location | Floor | Room | Element | Type | Photo | Issues | Current Measure | Recommendations | Quantity | Price | Cost Estimation |
|---|--|---|---|---|---|--|--|---|---|---|---|---|
| 6 | North Egress to Ramp and Parking | 1 | | Means of Egress | N/A | | Tactile exit sign not provided<br>Illuminated ISA symbol not provided (MAAB) | -<br>- | Ensure that a tactile exit sign with raised characters and braille is provided at the exit door. Mount the sign between 48"- 60" above the finished floor located on the latch side of the door.<br>When the illuminated exit sign is repaired or replaced, provide an illuminated sign with the International Symbol of Accessibility (ISA). | 1 | 250<br>200<br><br><b>450</b> | \$450 |

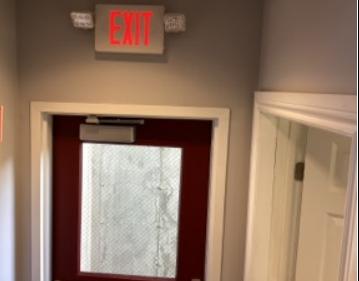
| ID | Location | Floor | Room | Element | Type | Photo | Issues | Current Measure | Recommendations | Quantity | Price | Cost Estimation |
|---|--|---|---|---|---|--|--|---|---|---|---|---|
| 7 | Basement East Egress | B | | Means of Egress | N/A | | Tactile exit sign not provided | - | Ensure that a tactile exit sign with raised characters and braille is provided at the exit door. Mount the sign between 48"- 60" above the finished floor located on the latch side of the door. | 1 | 250<br><br><b>250</b> | \$250 |

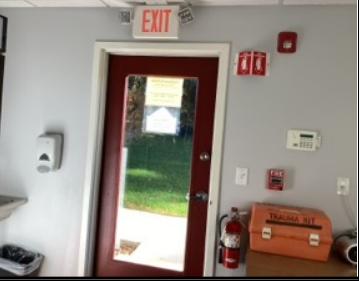
| ID | Location | Floor | Room | Element | Type | Photo | Issues | Current Measure | Recommendations | Quantity | Price | Cost Estimation |
|---|--|---|---|---|---|--|--|---|---|---|---|---|
| 8 | Lifeguard Room Southeast Egress | B | | Means of Egress | N/A | | Tactile exit sign not provided<br>Directional sign to accessible emergency exit not provided | -<br>- | Ensure that a tactile exit sign with raised characters and braille is provided at the exit door. Mount the sign between 48"- 60" above the finished floor located on the latch side of the door.<br>Provide a directional sign indicating the location of the nearest accessible emergency exit. | 2 | 250<br><br><b>500</b> | \$500 |

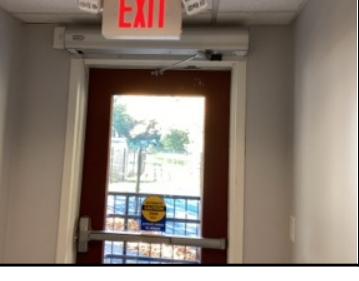
| ID | Location | Floor | Room | Element | Type | Photo | Issues | Current Measure | Recommendations | Quantity | Price | Cost Estimation |
|---|--|---|---|---|---|--|--|---|---|---|---|---|
| 9 | South Side Egress From Basement to Ramp and Pond | B | | Means of Egress | N/A | | Tactile exit sign not provided<br>Illuminated ISA symbol not provided (MAAB) | -<br>- | Ensure that a tactile exit sign with raised characters and braille is provided at the exit door. Mount the sign between 48"- 60" above the finished floor located on the latch side of the door.<br>When the illuminated exit sign is repaired or replaced, provide an illuminated sign with the International Symbol of Accessibility (ISA). | 1 | 250<br>200<br><br><b>450</b> | \$450 |

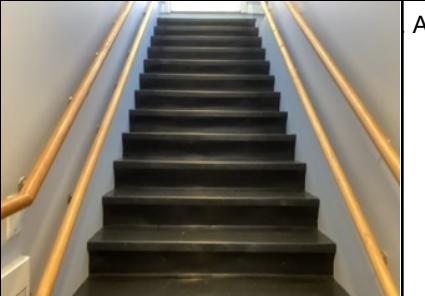
| ID | Location | Floor | Room | Element | Type | Photo | Issues | Current Measure | Recommendations | Quantity | Price | Cost Estimation |
|---|---|---|---|---|---|--|--|---|--|---|---|---|
| 10 | Stair to Basement | 1 | | Interior Access Route | N/A | | Accessible vertical route not provided | - | Provide accessible vertical access. Cost based on a two stop Limited Access Limited Use (LULA) elevator. Note design and additional renovation costs are beyond the scope of this survey. | 1 | 90000 | \$90000 |

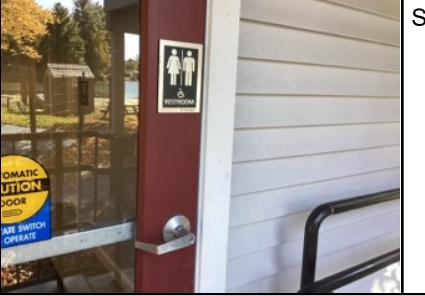
| ID | Location | Floor | Room | Element | Type | Photo | Issues | Current Measure | Recommendations | Quantity | Price | Cost Estimation |
|---|---|---|---|---|---|--|--|---|--|---|---|---|
| 11 | Southwest Basement Entrance at Ramp | Ext. | | Signage | Informational | | Sign not located on the latch side of the door | - | Locate the sign at permanent rooms alongside the door on the latch side. | 1 | Labor | Labor |

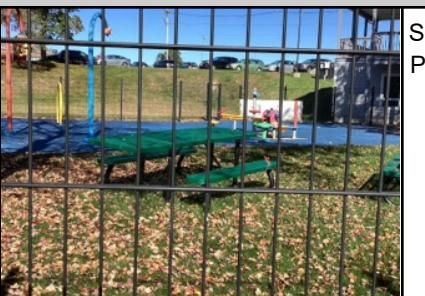
| ID | Location | Floor | Room | Element | Type | Photo | Issues | Current Measure | Recommendations | Quantity | Price | Cost Estimation |
|---|---|---|---|---|---|--|--|---|--|---|---|---|
| 12 | Splash Pad Picnic Table | Ext. | | Picnic Tables | N/A | | Surface not stable, firm and slip-resistant<br>Picnic table not on an accessible route | - | Ensure that the accessible picnic table is connected to a stable, firm and slip resistant accessible route. Either provide an accessible route to and around the accessible picnic table, or relocate the accessible picnic table to an accessible location. | 1 | - | - |

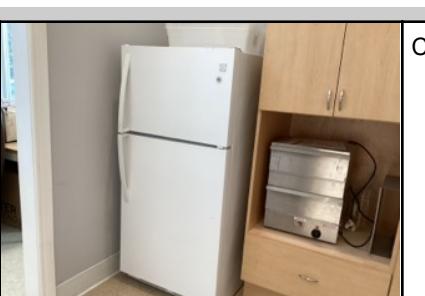
| ID | Location | Floor | Room | Element | Type | Photo | Issues | Current Measure | Recommendations | Quantity | Price | Cost Estimation |
|---|---|---|---|---|---|--|--|---|--|---|---|---|
| 13 | Kitchenette | 1 | | Kitchens and Kitchenettes | N/A | | Clear floor space at refrigerator not provided | - | Relocate refrigerator as to provide a 30" x 48" clear floor space that is centered to the refrigerator. | 1 | Labor | Labor |

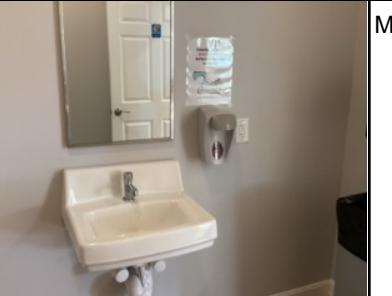
| ID | Location | Floor | Room | Element | Type | Photo | Issues | Current Measure | Recommendations | Quantity | Price | Cost Estimation |
|---|---|---|---|---|---|--|--|---|--|---|---|---|
| 14 | Women's Single-User Toilet Room | 1 | | Lavatory | N/A | | Mirror above lavatory w/reflective surface > 40" | 41" | Lower mirror so that the bottom surface is at 40" max. above the finished floor. | 1 | 500 | \$500 |

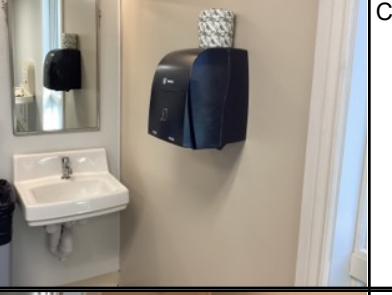
| ID | Location | Floor | Room | Element | Type | Photo | Issues | Current Measure | Recommendations | Quantity | Price | Cost Estimation |
|---|---|---|---|---|---|--|--|---|--|---|---|---|
| 15 | Men's Multi-User Toilet Room | B | | Lavatory | N/A | | Clear floor space not provided at lavatory | - | Relocate dispenser out of circulation path. Dispenser is a protruding object and interferes with a 30" min. by 48" min. clear floor space positioned for a forward approach at the lavatory. | 1 | 500 | \$500 |

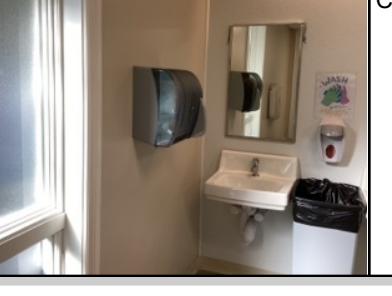
| ID | Location | Floor | Room | Element | Type | Photo | Issues | Current Measure | Recommendations | Quantity | Price | Cost Estimation |
|---|---|---|---|---|---|--|--|---|--|---|---|---|
| 16 | Women's Multi-User Toilet Room | B | | Lavatory | N/A | | Clear floor space not provided at lavatory | - | Relocate dispenser out of circulation path. Dispenser is a protruding object and interferes with a 30" min. by 48" min. clear floor space positioned for a forward approach at the lavatory. | 1 | 500 | \$500 |

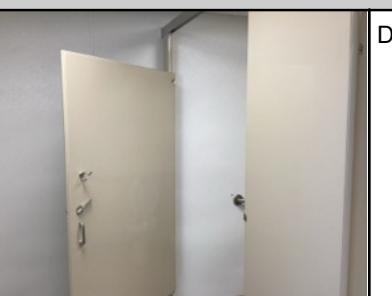
| ID | Location | Floor | Room | Element | Type | Photo | Issues | Current Measure | Recommendations | Quantity | Price | Cost Estimation |
|---|---|---|---|---|---|--|--|---|--|---|---|---|
| 17 | Men's Multi-User Toilet Room | B | | Toilet Compartment | Accessible Compartment | | Door has malfunctioning self-closing hinge | - | Repair hinge. | 1 | Labor | Labor |

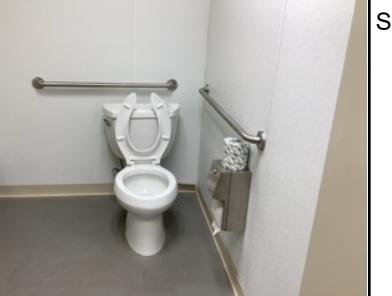
| ID | Location | Floor | Room | Element | Type | Photo | Issues | Current Measure | Recommendations | Quantity | Price | Cost Estimation |
|---|---|---|---|---|---|--|--|---|--|---|---|---|
| 18 | Women's Multi-User Toilet Room | 1 | | Toilet Compartment | Accessible Compartment | | Side grab bar < 54" from back wall | - | Provide a side wall grab bar that is 42" long min. located 12" max. from the rear wall. | 1 | 750 | \$750 |

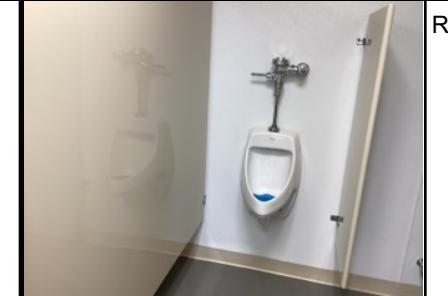
| ID | Location | Floor | Room | Element | Type | Photo | Issues | Current Measure | Recommendations | Quantity | Price | Cost Estimation |
|---|---|---|---|---|---|--|--|---|--|---|---|---|
| 19 | Men's Multi-User Toilet Room | B | | Urinal | N/A | | Rim > 17" high | 25" | Provide at least one urinal with the rim no higher than 17" above the finished floor. | 1 | 4222 | \$4222 |

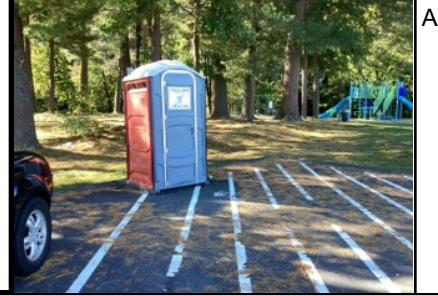
| ID | Location | Floor | Room | Element | Type | Photo | Issues | Current Measure | Recommendations | Quantity | Price | Cost Estimation |
|---|---|---|---|---|---|--|--|---|--|---|---|---|
| 20 | By Playground | Ext. | | Portable Toilet | N/A | | Accessible portable toilets not provided | - | If portable toilets are provided for the Carbuncle Beach House, ensure that at least 5% of the portable toilets are accessible and located on an accessible route. | 1 | 4600 | \$4600 |

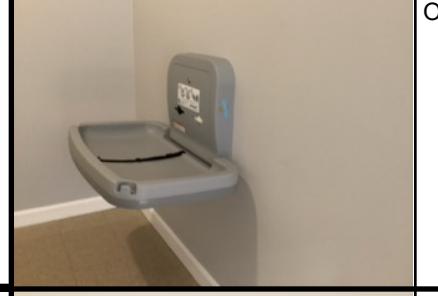
| ID | Location | Floor | Room | Element | Type | Photo | Issues | Current Measure | Recommendations | Quantity | Price | Cost Estimation |
|---|---|---|---|---|---|--|--|---|--|---|---|---|
| 21 | Men's Single-User Toilet Room | 1 | | Baby Changing Table | N/A | | Operable part > 48" high | 51" | When the toilet room is renovated, lower the baby changing table so that the table opening pull control is located no higher than 48" above the finished floor. | 1 | - | - |

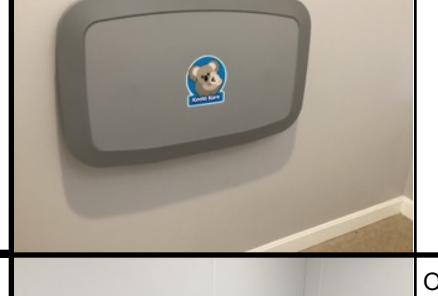
| ID | Location | Floor | Room | Element | Type | Photo | Issues | Current Measure | Recommendations | Quantity | Price | Cost Estimation |
|---|---|---|---|---|---|--|--|---|--|---|---|---|
| 22 | Women's Single-User Toilet Room | 1 | | Baby Changing Table | N/A | | Operable part > 48" high | 51" | When the toilet room is renovated, lower the baby changing table so that the table opening pull control is located no higher than 48" above the finished floor. | 1 | - | - |

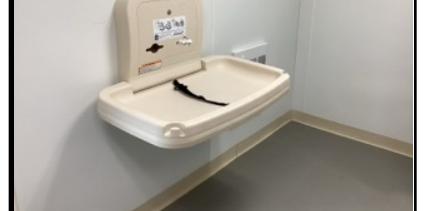
| ID | Location | Floor | Room | Element | Type | Photo | Issues | Current Measure | Recommendations | Quantity | Price | Cost Estimation |
|---|---|---|---|---|---|--|--|---|--|---|---|---|
| 23 | Men's Multi-User Toilet Room | B | | Baby Changing Table | N/A | | Operable part > 48" high | 52" | When the toilet room is renovated, lower the baby changing table so that the table opening pull control is located no higher than 48" above the finished floor. | 1 | - | - |

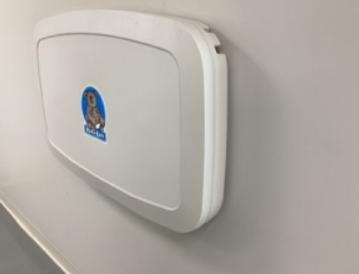
| ID | Location | Floor | Room | Element | Type | Photo | Issues | Current Measure | Recommendations | Quantity | Price | Cost Estimation |
|---|---|---|---|---|---|--|--|---|---|---|---|---|
| 24 | Women's Multi-User Toilet Room | 1 | | Baby Changing Table | N/A | | Operable part > 48" high | 52" | When the toilet room is renovated, lower the baby changing table so that the table opening pull control is located no higher than 48" above the finished floor. | 1 | - | - |

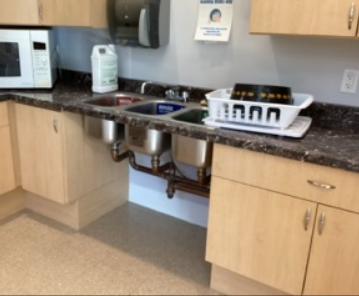
| ID | Location | Floor | Room | Element | Type | Photo | Issues | Current Measure | Recommendations | Quantity | Price | Cost Estimation |
|---|---|---|---|---|---|--|--|---|---|---|---|---|
| 25 | Kitchenette | 1 | | Sink | N/A | | Toe and knee clearances not provided<br>Exposed plumbing underneath sink<br>Dispenser not within reach range | 25" - 54" | Ensure there is a 27" min. knee clearance positioned for a forward approach.<br>Insulate or otherwise configure pipes at sink.<br>Ensure there is a 27" min. knee clearance positioned for a forward approach.<br>When kitchen is renovated, relocate dispenser 48" max. above the finished floor or ground. | 1 | 2192 150<br><br><b>2342</b> | \$2342 |

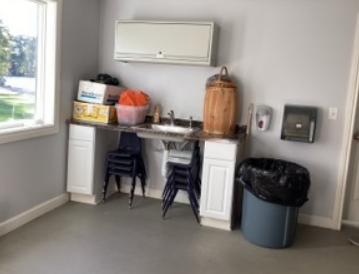
| ID | Location | Floor | Room | Element | Type | Photo | Issues | Current Measure | Recommendations | Quantity | Price | Cost Estimation |
|---|---|---|---|---|---|--|--|---|---|---|---|---|
| 26 | Crafts Room | B | | Sink | N/A | | Toe and knee clearances not provided<br>Rim or counter > 34" | - 36" | Relocate stored items to ensure there is a 27" min. knee clearance positioned for a forward approach.<br>Relocate sink with the front of the rim or counter no higher than 34" above the finished floor. | 1 | Labor 4022<br><br><b>4022</b> | \$4022 |

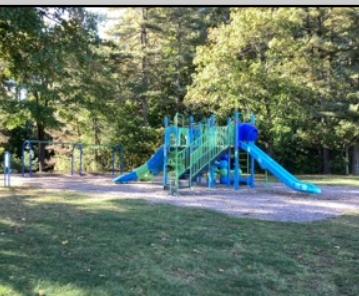
| ID | Location | Floor | Room | Element | Type | Photo | Issues | Current Measure | Recommendations | Quantity | Price | Cost Estimation |
|---|---|---|---|---|---|--|--|---|---|---|---|---|
| 27 | Playground | Ext. | | Play Areas | N/A | | Accessible route not provided to playground<br>Accessible route not provided around playground<br>Accessible route not provided to play components | - - - | Install a stable, firm and slip resistant accessible route to and around the playground. Ensure the route around the playground is 48" wide min.<br>Provide a compliant impact-attenuating surface to and around the play components.<br>Note: The MAAB does not consider engineered wood fiber (EWF) to comply with its regulation requiring an accessible route to each play component and around the playground. | 1 | - | - |

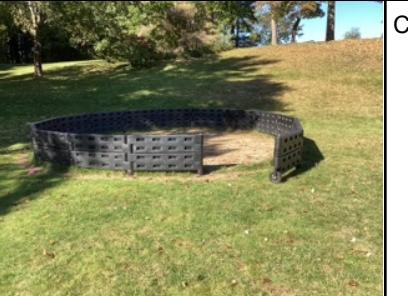
| ID | Location | Floor | Room | Element | Type | Photo | Issues | Current Measure | Recommendations | Quantity | Price | Cost Estimation |
|---|---|---|---|---|---|--|---|---|---|---|---|---|
| 28 | Gaga Ball | Ext. | | Court | Gaga Ball | | Court is not connected to an accessible route | -<br>- | Provide a stable, firm and slip resistant accessible route, 48" wide min., to the gaga ball court or relocate the gaga ball court to an accessible location. | 1 | - | - |

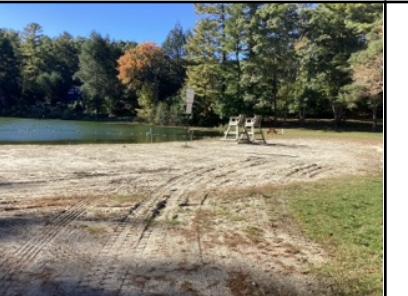
| ID | Location | Floor | Room | Element | Type | Photo | Issues | Current Measure | Recommendations | Quantity | Price | Cost Estimation |
|---|---|---|---|---|---|--|---|---|---|---|---|---|
| 29 | Beach | Ext. | | Beach | N/A | | | | Recommend providing a 60" wide min. beach mat across the sand to the normal recreational water level at the pond and to at least one life guard station. | 1 | - | - |

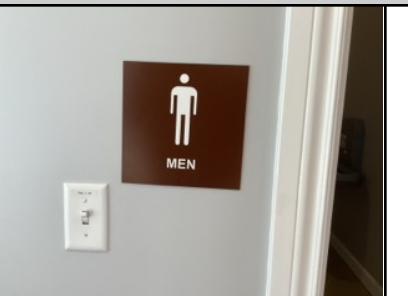
| ID | Location | Floor | Room | Element | Type | Photo | Issues | Current Measure | Recommendations | Quantity | Price | Cost Estimation |
|---|---|---|---|---|---|--|---|---|---|---|---|---|
| 30 | Men's and Women's Single-User Toilet Room | 1 | | Designation Sign | N/A | | | | Recommend provide a sign with the International Symbol of Accessibility (ISA). (Since all of the toilet rooms in Carbuncle Beach House are accessible, a sign with the ISA is not required at the accessible toilet rooms, but the sign could be helpful for some users.) | 2 | - | - |

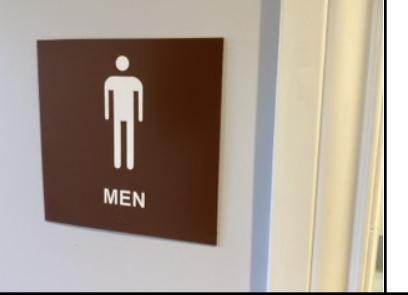
| ID | Location | Floor | Room | Element | Type | Photo | Issues | Current Measure | Recommendations | Quantity | Price | Cost Estimation |
|---|---|---|---|---|---|--|---|---|---|---|---|---|
| 31 | Men's and Women's Multi-User Toilet Room | B | | Designation Sign | N/A | | | | Recommend provide a sign with the International Symbol of Accessibility (ISA). (Since all of the toilet rooms in Carbuncle Beach House are accessible, a sign with the ISA is not required at the accessible toilet rooms, but the sign could be helpful for some users.) | 2 | - | - |

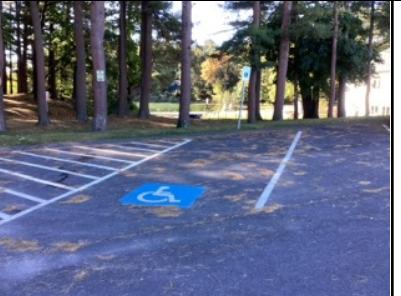
| ID | Location | Floor | Room | Element | Type | Photo | Issues | Current Measure | Recommendations | Quantity | Price | Cost Estimation |
|---|---|---|---|---|---|---|---|---|--|---|---|---|
| 32 | Parking by Walkway to Pond and Beach | Ext. | | Parking | N/A | | | | Recommend making this angled parking space near the path to the pond a compliant van accessible parking space with the access aisle located on the passenger side of the parking space, the space and access aisle each at least 8 feet wide, and with a designation sign with the words, "Van Accessible" at the existing identification sign with the International Symbol of Accessibility (ISA). | 1 | Labor | Labor |

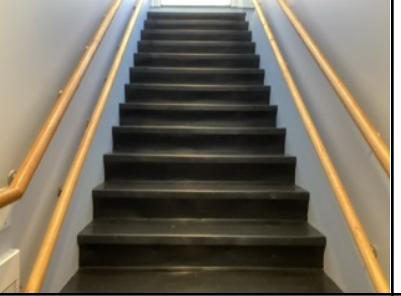
| ID | Location | Floor | Room | Element | Type | Photo | Issues | Current Measure | Recommendations | Quantity | Price | Cost Estimation |
|---|---|---|---|---|---|---|---|---|--|---|---|---|
| 33 | Stair to Basement | 1 | | Stair | N/A | | | | Recommend visual contrast strips on all interior and exterior stairs. | 1 | - | - |
