Town of Oxford

# ADA Self-Evaluation and Transition Plan

July 2024

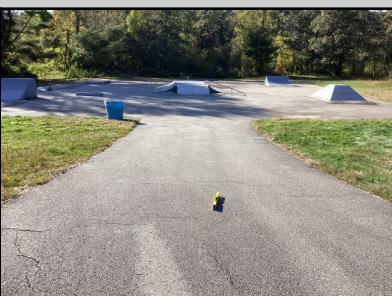
| ID | Location | Floor | Room | Element | Type | Photo | Issues | Current Measure | Recommendations | Quantity | Price | Cost Estimation |
|---|---|---|---|---|---|--|---|---|--|---|---|---|
| 1 | Skateboard Park | Ext. | | Exterior Access Route | Exterior | | Running slope > 1:20 (5.00%) | 11% | If this area is considered part of the accessible route to the skateboard park and not part of the park itself, reduce the running slope to be no steeper than 1:20 (5.00%).<br>Note: Due to the location of cement barriers, visitors can't drive a car down this path towards the main portion of the skateboard park. | 1 | - | - |

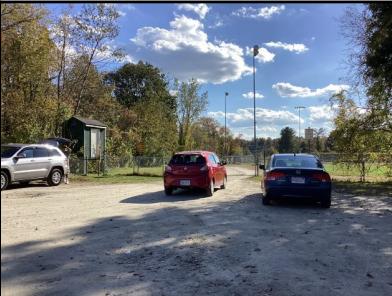
| ID | Location | Floor | Room | Element | Type | Photo | Issues | Current Measure | Recommendations | Quantity | Price | Cost Estimation |
|---|---|---|---|---|---|--|---|---|--|---|---|---|
| 2 | Parking at Park Entry | Ext. | | Off-Street Parking Lot or Garage | Visitor | | Total # of parking<br>Total # of designated car accessible parking spaces<br>Total # of designated van accessible spaces<br>Access aisle not provided<br>Sign with the International Symbol of Acc. not provided<br>Sign does not have the designation "Van Accessible" | 5<br>-<br>-<br>-<br>-<br>- | Provide one van accessible parking space 96" wide min. with a marked access aisle 96" wide min.<br>Provide a sign with the International Symbol of Accessibility (ISA) with the bottom of the sign 60" min. above the ground and the top of the sign 96" max. above the ground.<br>Add the designation "Van Accessible" to the sign located at the van accessible space. | 1 | 500 | \$500 |

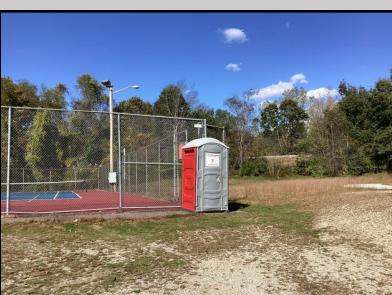
| ID | Location | Floor | Room | Element | Type | Photo | Issues | Current Measure | Recommendations | Quantity | Price | Cost Estimation |
|---|---|---|---|---|---|--|---|---|--|---|---|---|
| 4 | Portable Toilet by Tennis Courts | Ext. | | Portable Toilet | N/A | | Not located on an accessible route<br>Accessible portable toilets not provided | -<br>- | Locate portable toilet on an accessible route.<br>Ensure that at least 5% of portable toilets (with a minimum of one) are accessible in each area where portable toilets are provided. | 1 | -<br>4600<br><br>4600 | \$4600 |

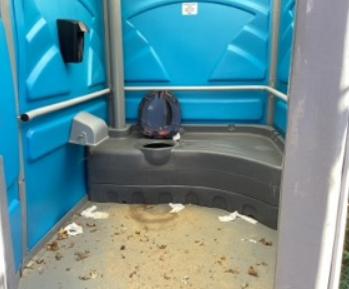
| ID | Location | Floor | Room | Element | Type | Photo | Issues | Current Measure | Recommendations | Quantity | Price | Cost Estimation |
|---|---|---|---|---|---|--|--|---|--|---|---|---|
| 5 | Second Portable Toilet | Ext. | | Portable Toilet | N/A | | Item mounted over grab bar (MAAB)<br>60" by 72" clear space not provided | -<br>60" | Relocate the hand sanitizer dispenser so that it is not mounted over the grab bar.<br>Provide an accessible portable toilet that has 60" wide and 72" deep at the toilet (MAAB). | 1 | -<br>4600<br><br><b>4600</b> | \$4600 |

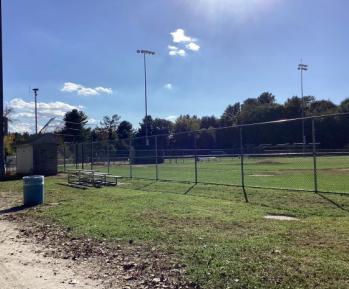
| 6 | North Baseball Field by Parking | Ext. | | Field | Baseball | | Accessible spaces not provided at sidelines seating<br>Not connected to an accessible-route<br>No accessible route to all areas of sport activity | -<br>-<br>- | Provide a 36" x 60" stable, firm and slip resistant clear floor space at sidelines seating.<br>Provide an accessible route to sideline seating and to the boundary of sport activity at the baseball field.<br>Install an accessible route between all areas of sports activity. | 1 | - | - |

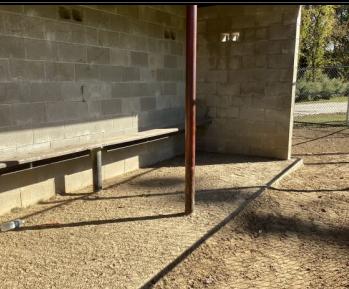
| 7 | North and South Baseball Field Team Seating Dugouts | Ext. | | Field | Baseball | | Accessible spaces are not provided at team seating<br>Not connected to an accessible-route | -<br>2" | Provide a 36" x 48" clear floor space at team seating.<br>Provide an accessible route to the team seating with a maximum change in level between the bullpen and field of 1/2" beveled. | 4 | - | - |

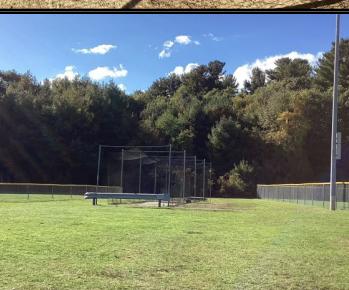
| 8 | Batting Cage | Ext. | | Field | Baseball | | Practice areas are not on an accessible route | - | Provide a stable, firm and slip resistant accessible route to the batting cage. | 1 | - | - |

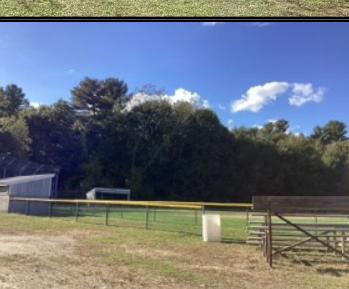
| 9 | South Baseball Field | Ext. | | Field | Baseball | | Accessible spaces not provided at sidelines seating<br>Not connected to an accessible-route<br>No accessible route to all areas of sport activity | -<br>-<br>- | Provide a 36" x 60" stable, firm and slip resistant clear floor space at sidelines seating.<br>Provide an accessible route to sideline seating and to the boundary of sport activity at the baseball field.<br>Install an accessible route between all areas of sports activity. | 1 | - | - |

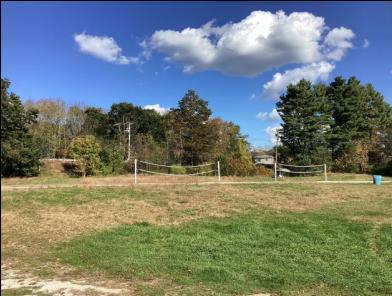
| ID | Location | Floor | Room | Element | Type | Photo | Issues | Current Measure | Recommendations | Quantity | Price | Cost Estimation |
|---|---|---|---|---|---|--|--|---|---|---|---|---|
| 10 | Volleyball Courts | Ext. | | Court | Volleyball | | Not connected to accessible route<br>No accessible route between all areas of sport activity | | Provide an accessible route to the boundary of sport activity at the volleyball courts.<br>Install an accessible route between all areas of sport activity. | 1 | - | - |

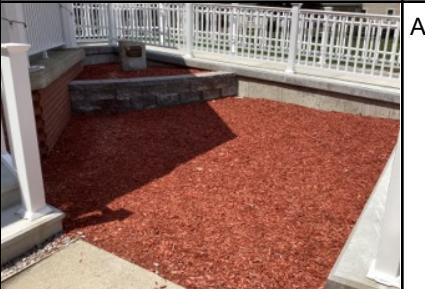
| ID | Location | Floor | Room | Element | Type | Photo | Issues | Current Measure | Recommendations | Quantity | Price | Cost Estimation |
|---|---|---|---|---|---|--|---|---|--|---|---|---|
| 1 | Bandstand Monument | Ext. | | Exterior Access Route | Exterior | | Accessible route not provided | - | Ensure an accessible route is provided to the monument by the gazebo. | 1 | - | - |

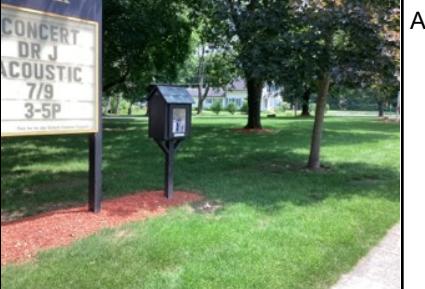
| ID | Location | Floor | Room | Element | Type | Photo | Issues | Current Measure | Recommendations | Quantity | Price | Cost Estimation |
|---|---|---|---|---|---|--|---|---|--|---|---|---|
| 2 | Book Exchange Receptacle | Ext. | | Exterior Access Route | Exterior | | Accessible route not provided | - | Ensure an accessible route is provided to the book exchange bin. | 1 | - | - |

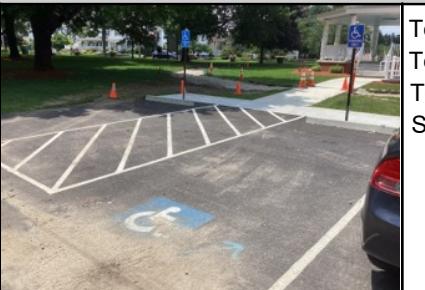
| ID | Location | Floor | Room | Element | Type | Photo | Issues | Current Measure | Recommendations | Quantity | Price | Cost Estimation |
|---|---|---|---|---|---|--|---|---|--|---|---|---|
| 3 | Parking | Ext. | | Off-Street Parking Lot or Garage | Visitor | | Total # of parking<br>Total # of designated car accessible parking spaces<br>Total # of designated van accessible spaces<br>Sign does not have the designation "Van Accessible" | 3<br>1<br>1<br>- | Add the designation "Van Accessible" to the sign located at the van accessible space. | 1 | 500 | \$500 |

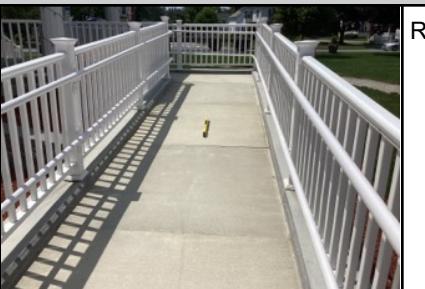
| ID | Location | Floor | Room | Element | Type | Photo | Issues | Current Measure | Recommendations | Quantity | Price | Cost Estimation |
|---|---|---|---|---|---|--|---|---|--|---|---|---|
| 4 | Bandstand Ramp | Ext. | | Ramps | Exterior | | Running slope >1:12 (8.33%) | 9.3% | Reduce running slope to be no steeper than 1:12 (8.33%). Further study will be needed to determine whether it is technically feasible to bring the ramp into full compliance with the ADA Standards. | 1 | - | - |

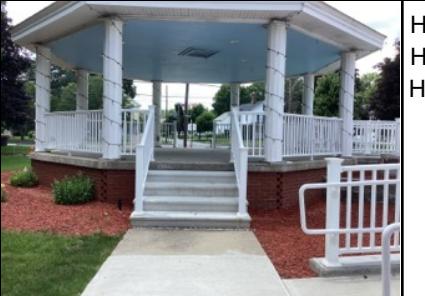
| ID | Location | Floor | Room | Element | Type | Photo | Issues | Current Measure | Recommendations | Quantity | Price | Cost Estimation |
|---|---|---|---|---|---|--|---|---|---|---|---|---|
| 5 | Bandstand Stairs | Ext. | | Stairways | Exterior | | Handrails do not extend 12" from stairs<br>Handrails have noncompliant cross section<br>Handrails not continuous where required | -<br>3"<br>- | Top: Ensure handrails extend horizontally above the landing for 12" min. beginning above the first riser nosing.<br>Bottom: Ensure that the handrail extends at least 12" plus the width of one tread beyond the bottom riser.<br>Provide handrails with a 1 1/4" - 2" circular cross section.<br>Provide continuous handrails. | 2 | - | - |

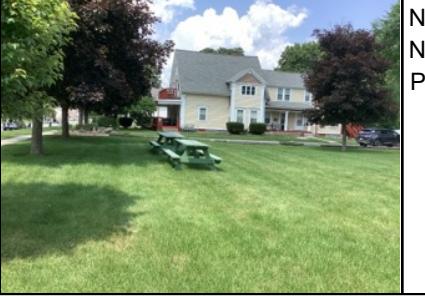
| ID | Location | Floor | Room | Element | Type | Photo | Issues | Current Measure | Recommendations | Quantity | Price | Cost Estimation |
|---|---|---|---|---|---|--|---|---|---|---|---|---|
| 6 | Picnic Tables | Ext. | | Picnic Tables | N/A | | Number of seating spaces at picnic tables<br>Number of accessible seating spaces<br>Picnic table not on an accessible route | 2<br>1<br>- | Ensure that the picnic table is connected to an accessible route. | 1 | - | - |

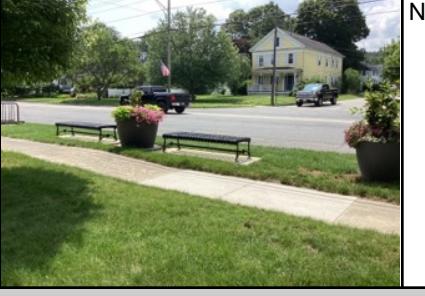
| ID | Location | Floor | Room | Element | Type | Photo | Issues | Current Measure | Recommendations | Quantity | Price | Cost Estimation |
|---|---|---|---|---|---|--|---|---|---|---|---|---|
| 7 | Benches by Main Street | Ext. | | Benches | N/A | | No accessible route to one bench in this area | - | Provide an accessible route to at least one bench in this area or relocate one bench on an accessible route. | 1 | - | - |

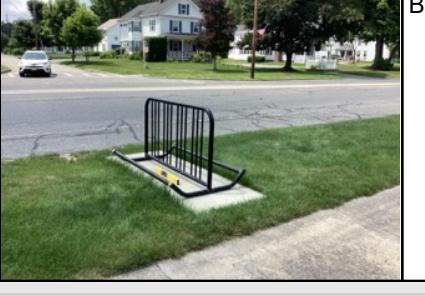
| ID | Location | Floor | Room | Element | Type | Photo | Issues | Current Measure | Recommendations | Quantity | Price | Cost Estimation |
|---|---|---|---|---|---|--|---|---|---|---|---|---|
| 8 | Bike Rack | Ext. | | Bike Racks | N/A | | Bike rack is not connected to an accessible route | - | Ensure bike racks are connected to an accessible route. | 1 | - | - |

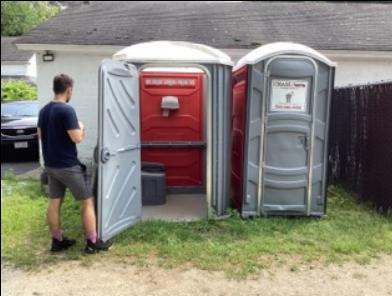
| ID | Location | Floor | Room | Element | Type | Photo | Issues | Current Measure | Recommendations | Quantity | Price | Cost Estimation |
|---|---|---|---|---|---|--|---|---|---|---|---|---|
| 9 | Portable Toilet | Ext. | | Portable Toilet | N/A | | Not located on an accessible route<br>Noncompliant toilet paper dispenser<br>Item mounted over grab bar (MAAB)<br>60" by 72" clear space not provided | -<br>55"<br>-<br>57" | Locate portable toilet on an accessible route.<br>Relocate the toilet paper so that it is 24" min.<br>high, located under the grab bar, and between 7"<br>and 9" from the front of the toilet./Replace<br>dispenser as it does not allow continuous paper<br>flow.<br>Provide an accessible portable toilet that has 60"<br>wide and 72" deep at the toilet per MAAB. | 1 | 4600 | \$4600 |

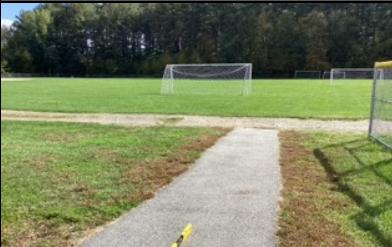
| ID | Location | Floor | Room | Element | Type | Photo | Issues | Current Measure | Recommendations | Quantity | Price | Cost Estimation |
|---|---|---|---|---|---|--|---|---|--|---|---|---|
| 1 | To Soccer Field | Ext. | | Exterior Access Route | Exterior | | Running slope > 1:20 (5.00%) | 7.3% | Reduce the running slope to be no steeper than 1:20 (5.00%). | 1 | - | - |

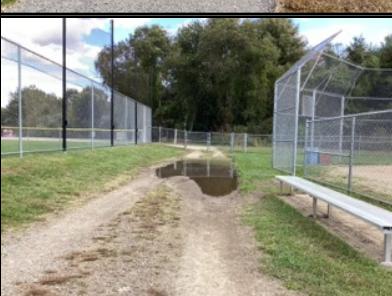
| ID | Location | Floor | Room | Element | Type | Photo | Issues | Current Measure | Recommendations | Quantity | Price | Cost Estimation |
|---|---|---|---|---|---|--|---|---|--|---|---|---|
| 2 | South Softball Field | Ext. | | Exterior Access Route | Exterior | | Does not prevent accumulation of water | - | Repair the surface. | 1 | - | - |

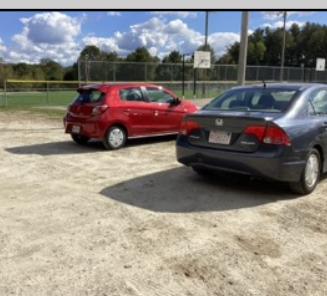
| ID | Location | Floor | Room | Element | Type | Photo | Issues | Current Measure | Recommendations | Quantity | Price | Cost Estimation |
|---|---|---|---|---|---|--|---|---|--|---|---|---|
| 3 | Parking | Ext. | | Off-Street Parking Lot or Garage | N/A | | Total # of parking<br>Total # of designated car accessible parking spaces<br>Total # of designated van accessible spaces<br>Access aisle not provided<br>Sign with the International Symbol of Acc. not provided<br>Sign does not have the designation "Van Accessible" | 50<br>-<br>-<br>-<br>-<br>- | Provide one van accessible parking space 96" wide min. with a marked access aisle 96" wide min. and one car accessible parking space 96" wide min. sharing the same access aisle.<br>Provide a sign at both spaces with the International Symbol of Accessibility (ISA) with the bottom of the sign 60" min. above the ground. Add the designation "Van Accessible" to the sign located at the van accessible space. | 1 | - | - |

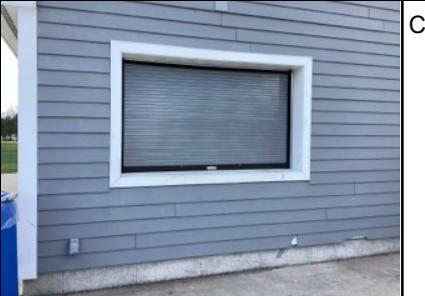
| ID | Location | Floor | Room | Element | Type | Photo | Issues | Current Measure | Recommendations | Quantity | Price | Cost Estimation |
|---|--|---|---|---|---|--|---|---|--|---|---|---|
| 5 | Concession Stand | Ext. | | Service Counter | N/A | | Counter > 36" high | 38" | Provide a counter that is 36" max. above the ground. | 1 | 1144 | \$1144 |

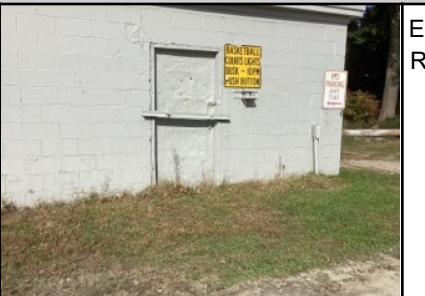
| ID | Location | Floor | Room | Element | Type | Photo | Issues | Current Measure | Recommendations | Quantity | Price | Cost Estimation |
|---|--|---|---|---|---|--|---|---|--|---|---|---|
| 6 | Exterior Light Control Switch North of Parking by Basketball Court | Ext. | | Operable Parts / Reach Range | N/A | | Element not on an accessible route<br>Reach < 15" or > 48"(forward/side approach) | - 60" | If used by members of the public, ensure the control is located on an accessible route. Relocate control so that controls are between 15"- 48" above the finished floor. /Ensure that staff is available to assist visitors who need assistance. | 1 | - | - |

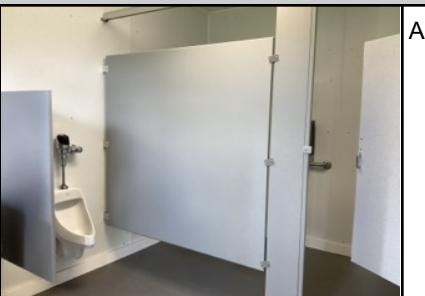
| ID | Location | Floor | Room | Element | Type | Photo | Issues | Current Measure | Recommendations | Quantity | Price | Cost Estimation |
|---|--|---|---|---|---|--|---|---|--|---|---|---|
| 7 | Men's and Women's Toilet Rooms | 1 | | Overall Access | Toilet Room | | Audible and visible alarm not provided | | When fire system is updated, ensure that a visible and audible fire alarm is installed. | 2 | - | - |

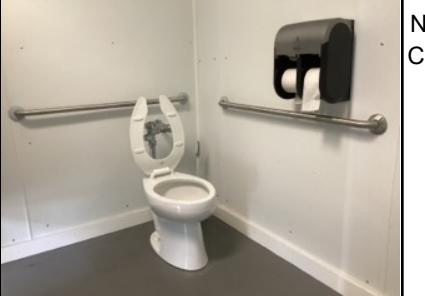
| ID | Location | Floor | Room | Element | Type | Photo | Issues | Current Measure | Recommendations | Quantity | Price | Cost Estimation |
|---|--|---|---|---|---|--|---|---|--|---|---|---|
| 8 | Men's Toilet Room | 1 | | Toilet Compartment | Accessible Compartment | | Noncompliant toilet paper dispenser<br>Centerline < or > 18" (MAAB) | - 19" | Relocate toilet paper so that it is 24" min high, located under the grab bar, and between 7" and 9" from the front of the toilet./Replace dispenser as it does not allow continuous paper flow. Relocate toilet so the centerline is 18" from the side wall. | 1 | 500 3676 | \$4176 |

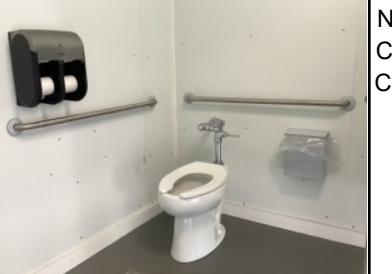
| ID | Location | Floor | Room | Element | Type | Photo | Issues | Current Measure | Recommendations | Quantity | Price | Cost Estimation |
|---|---|---|---|---|---|--|--|---|---|---|---|---|
| 9 | Women's Toilet Room | 1 | | Toilet Compartment | Accessible Compartment | | Noncompliant toilet paper dispenser<br>Clearance at toilet < 60" clear width<br>Centerline < or > 18" (MAAB) | - 19" | Relocate toilet paper so that it is 24" min high, located under the grab bar, and between 7" and 9" from the front of the toilet./Replace dispenser as it does not allow continuous paper flow.<br>Provide a wheelchair accessible compartment that is 60" wide min. (Relocate trash container under rear grab bar to side wall.)<br>Relocate toilet so the centerline is 18" from the side wall. | 1 | 500<br>500<br>3676 | \$4676<br><br><b>4676</b> |

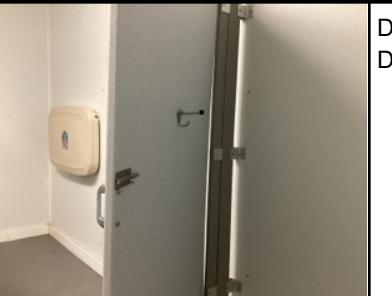
| ID | Location | Floor | Room | Element | Type | Photo | Issues | Current Measure | Recommendations | Quantity | Price | Cost Estimation |
|---|---|---|---|---|---|--|--|---|---|---|---|---|
| 10 | Men's and Women's Toilet Rooms | 1 | | Toilet Compartment | Accessible Compartment | | Door has malfunctioning self-closing hinge<br>Door pull not provided | - | Repair hinge.<br>Provide a door pull on each side of the door between 34" to 48" above the finished floor that does not require tight grasping, pinching or twisting of the wrist. | 2 | Labor 91 | \$182<br><br><b>182</b> |

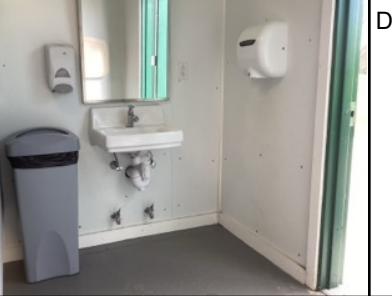
| ID | Location | Floor | Room | Element | Type | Photo | Issues | Current Measure | Recommendations | Quantity | Price | Cost Estimation |
|---|---|---|---|---|---|--|--|---|---|---|---|---|
| 11 | Men's and Women's Toilet Rooms | 1 | | Dispensers | Hand Dryer | | Dispenser acts as a protruding object | | Relocate hand dryer out of the circulation path or provide a cane-detectable barrier under the hand dryer located 27" max. above the finished floor. | 1 | 398 | \$398<br><br><b>398</b> |

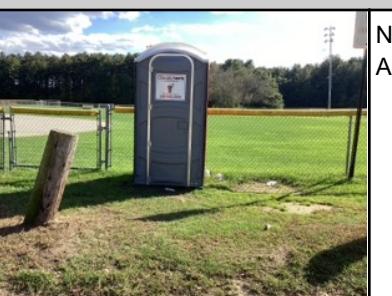
| ID | Location | Floor | Room | Element | Type | Photo | Issues | Current Measure | Recommendations | Quantity | Price | Cost Estimation |
|---|---|---|---|---|---|--|--|---|---|---|---|---|
| 12 | Portable Toilet | Ext. | | Portable Toilet | N/A | | Not located on an accessible route<br>Accessible portable toilets not provided | | Locate portable toilet on an accessible route.<br>Ensure that at least 5% of portable toilets (with a minimum of one) are accessible. | 1 | 4600 | \$4600<br><br><b>4600</b> |

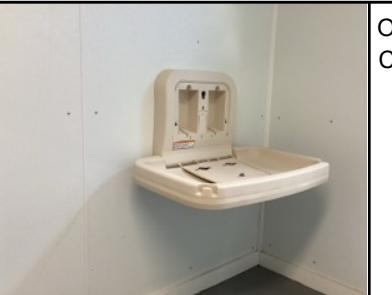
| ID | Location | Floor | Room | Element | Type | Photo | Issues | Current Measure | Recommendations | Quantity | Price | Cost Estimation |
|---|---|---|---|---|---|--|--|---|---|---|---|---|
| 13 | Men's Toilet Room | 1 | | Baby Changing Table | N/A | | Operable part > 48" high<br>Changing table requires > 5 lbs. of force | 51" 8 lbs. | When toilet room is renovated lower the baby changing table so that the table pull control is located no higher than 48" above finished floor.<br>Repair table so that it does not require greater than 5 lbs. of force to operate. | 1 | - | - |

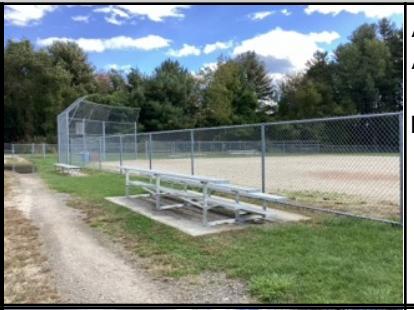
| 15 | South Softball Field | Ext. | | Field | Softball | | Accessible spaces are not provided at team seating<br>Accessible spaces not provided at sidelines seating<br>Not connected to an accessible-route<br>No accessible route to all areas of sport activity | | Provide a 36" x 48" clear floor space at team seating.<br>Provide a 36" x 60" clear floor space at sidelines seating.<br>Provide an accessible route to the boundary of sport activity at the softball field.<br>Install an accessible route between all areas of sports activity. | 1 | - | - |

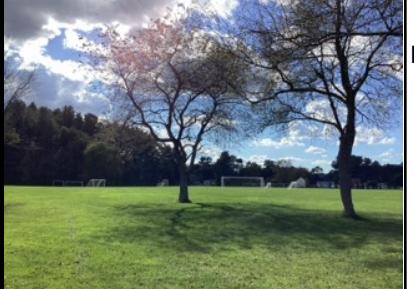
| 16 | West Soccer Fields | Ext. | | Field | Soccer | | Not connected to an accessible-route<br>No accessible route to all areas of sport activity | | Provide an accessible route to the boundary of sport activity at the soccer fields.<br>Install an accessible route between all areas of sports activity. | 1 | - | - |

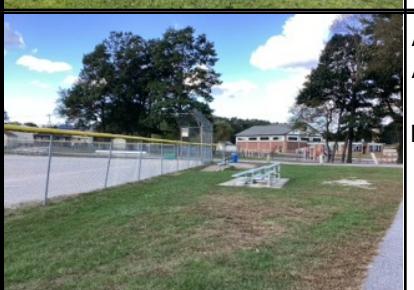
| 17 | West Baseball Field | Ext. | | Field | Baseball | | Accessible spaces are not provided at team seating<br>Accessible spaces not provided at sidelines seating<br>Not connected to an accessible-route<br>No accessible route to all areas of sport activity | | Provide a 36" x 48" clear floor space at team seating.<br>Provide a 36" x 60" clear floor space at sidelines seating.<br>Provide an accessible route to the boundary of sport activity at the field.<br>Install an accessible route between all areas of sports activity. | 1 | - | - |

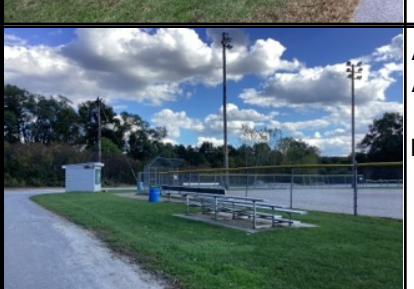
| 18 | North Baseball Field | Ext. | | Field | Baseball | | Accessible spaces are not provided at team seating<br>Accessible spaces not provided at sidelines seating<br>Not connected to an accessible-route<br>No accessible route to all areas of sport activity | | Provide a 36" x 48" clear floor space at team seating.<br>Provide a 36" x 60" clear floor space at sidelines seating.<br>Provide an accessible route to the boundary of sport activity at the field.<br>Install an accessible route between all areas of sports activity. | 1 | - | - |

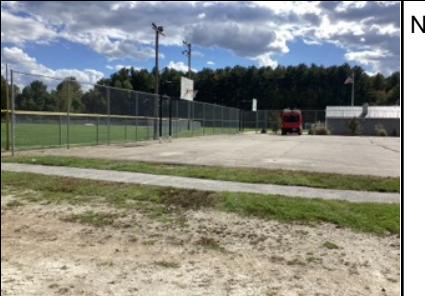
| ID | Location | Floor | Room | Element | Type | Photo | Issues | Current Measure | Recommendations | Quantity | Price | Cost Estimation |
|---|---|---|---|---|---|--|--|---|---|---|---|---|
| 19 | Basketball | Ext. | | Court | Basketball | | Not connected to accessible route | - | Provide a stable, firm and slip resistant accessible route, 48" wide min., to the boundary of sport activity at the basketball court. | 1 | - | - |

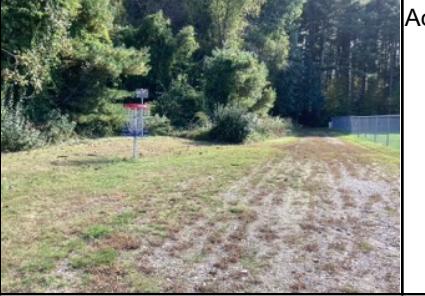
| ID | Location | Floor | Room | Element | Type | Photo | Issues | Current Measure | Recommendations | Quantity | Price | Cost Estimation |
|---|---|---|---|---|---|--|--|---|---|---|---|---|
| 20 | Disc Golf, Hole 1 | Ext. | | Golf Facilities | Disk Golf | | Acc. route to boundary of sport activity not provided. | - | Provide an accessible route to the boundary of sport activity at the first hole tee stations and back from the final hole location. | 1 | - | - |

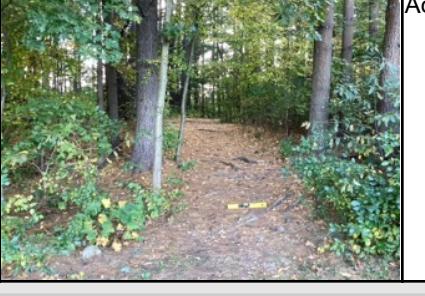
| ID | Location | Floor | Room | Element | Type | Photo | Issues | Current Measure | Recommendations | Quantity | Price | Cost Estimation |
|---|---|---|---|---|---|--|--|---|---|---|---|---|
| 21 | Disc Golf Course | Ext. | | Golf Facilities | Disc Golf | | Acc. route to 5% of teeing stations not provided | - | Provide an accessible route to at least 5% of teeing stations on the 9 hole course. If that is not possible, at the first tee and on the facility web site provide information about the nature of the route to the other tees such as the nature of the surface, maximum change in level (tree routes of about 4" were observed) and maximum running and cross slopes (cross slopes of up to 10% were observed.) | 1 | - | - |

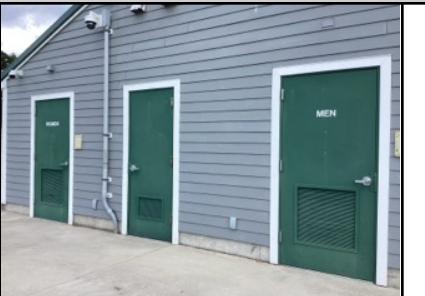
| ID | Location | Floor | Room | Element | Type | Photo | Issues | Current Measure | Recommendations | Quantity | Price | Cost Estimation |
|---|---|---|---|---|---|--|--|---|---|---|---|---|
| 22 | Men's and Women's Toilet Rooms | Ext. | | Designation Signage | N/A | | | | Recommend, at the men's and women's multi-user toilet rooms, providing designation signage located on the latch side of the door with raised characters, braille and the International Symbol of Accessibility (ISA). | 2 | - | - |

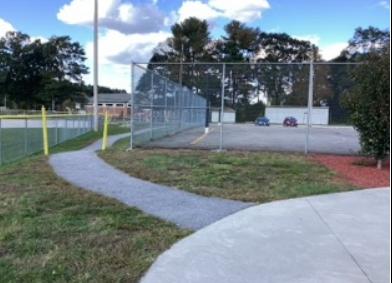
| ID | Location | Floor | Room | Element | Type | Photo | Issues | Current Measure | Recommendations | Quantity | Price | Cost Estimation |
|---|---|---|---|---|---|--|---|---|--|---|---|---|
| 23 | Basketball Court (Southwest Side) | Ext. | | Walkway | N/A | | | | Recommend providing a directional sign to this walkway on the east side of the basketball court where visitors may not be aware of the presence of this walkway. | 1 | - | - |
